INVESTIGATION NO. 2457

THE ATLANTIC COAST LINE RAILROAD COMPANY

REPORT IN RE ACCIDENT

AT LAKE ALFRED, FLA., ON

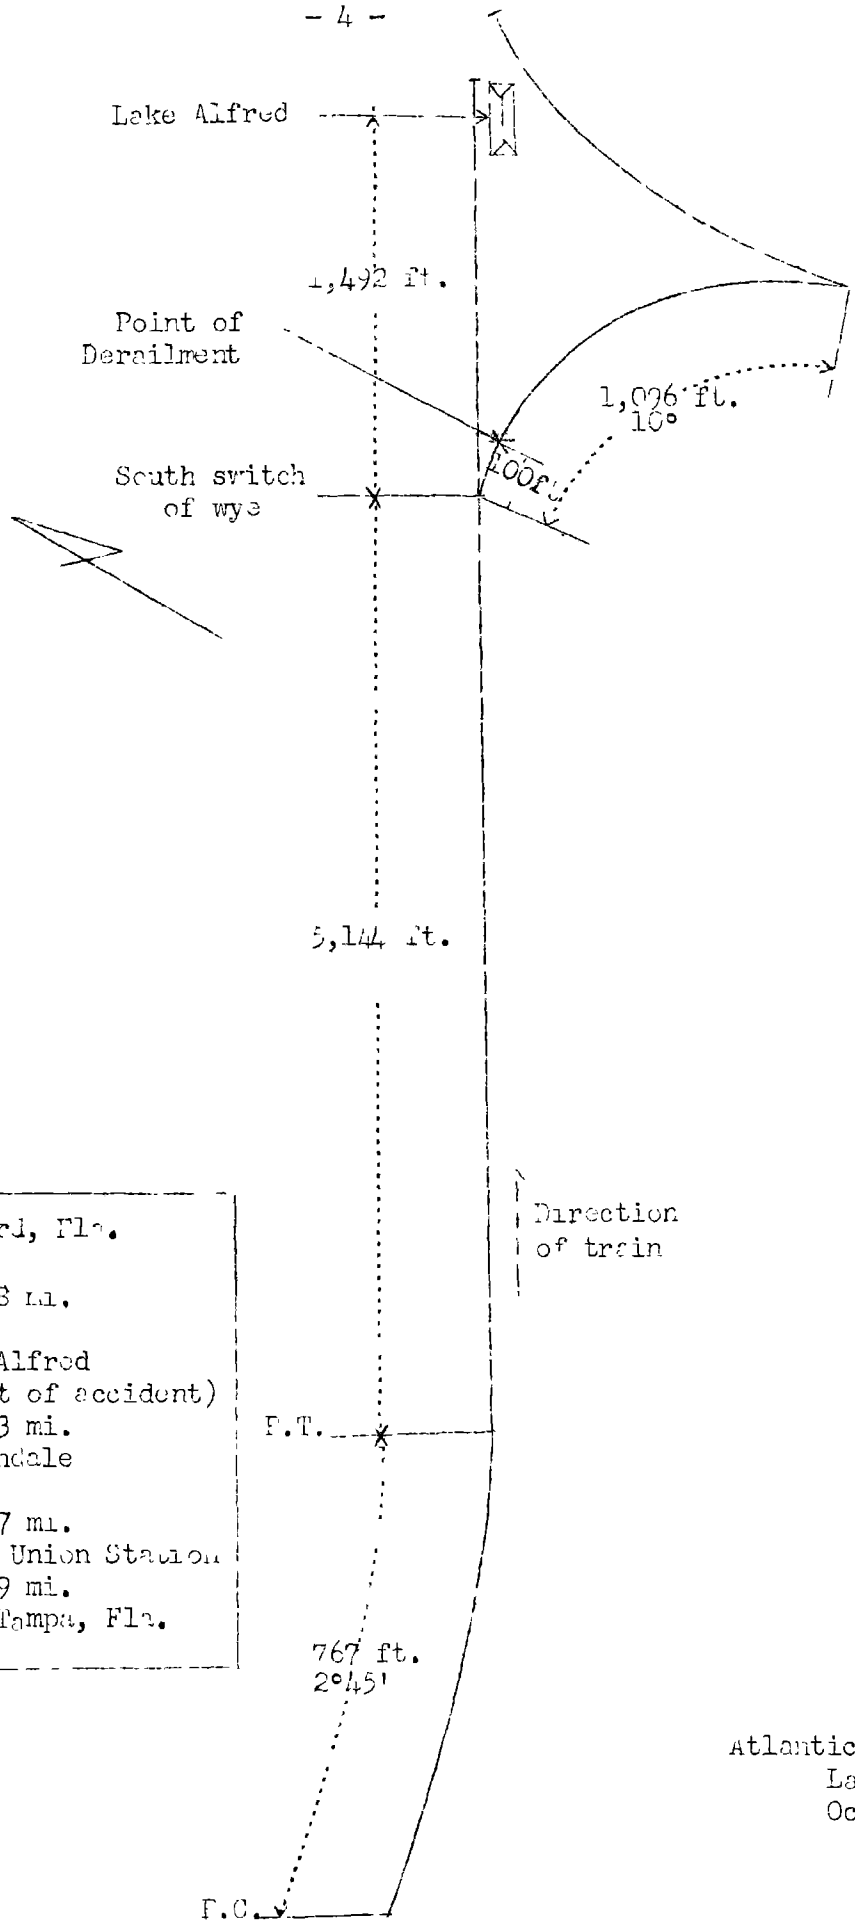
- o Sanford, Fla.
- 67.8 mi.
- o Lake Alfred (Point of accident)
- 4.3 mi.
- o Auburndale
- 41.7 mi.
- o Tampa Union Station
- 9.9 mi.
- o Port Tampa, Fla.

This accident occurred on that part of the Tampa District which extends between Sanford and Fort Tampa, Fla., a distance of 123.7 miles. In the vicinity of the point of accident this is a single-track line over which trains are operated by timetable and train orders; there is no block system in use. At Lake Alfred a wye lies to the east of the main track, the south leg of which is 1,093 feet long and entry to which is made through a No. 10 turnout located 1,492 feet south of the station. The turnout is provided with a No. 10, 100-pound, spring-type frog having a foot-plate 4 feet long; a 100-pound guard rail, 11 feet long, is provided. The switch points are 15 feet long and are connected by two switch rods. The derailment occurred on this turnout at a point about 100 feet east of the switch points. As the point of accident is approached from the south on the main track there is a 2°45' curve to the left 767 feet in length, which is followed by a tangent extending 5,144 feet to the south switch of the wye and a considerable distance beyond. At the point where the accident occurred the grade for north-bound trains is 1.06 percent ascending. Beginning at a point about 100 feet east of the switch the south leg of the wye has a curvature of 10° and a superelevation of 2 inches.
