INVESTIGATION NO. 2718

THE ATLANTIC COAST LINE RAILROAD COMPANY

REPORT IN RE ACCIDENT

Accident near Oaks, Fla., on August 5, 1943, caused by  
an obstruction on rail.

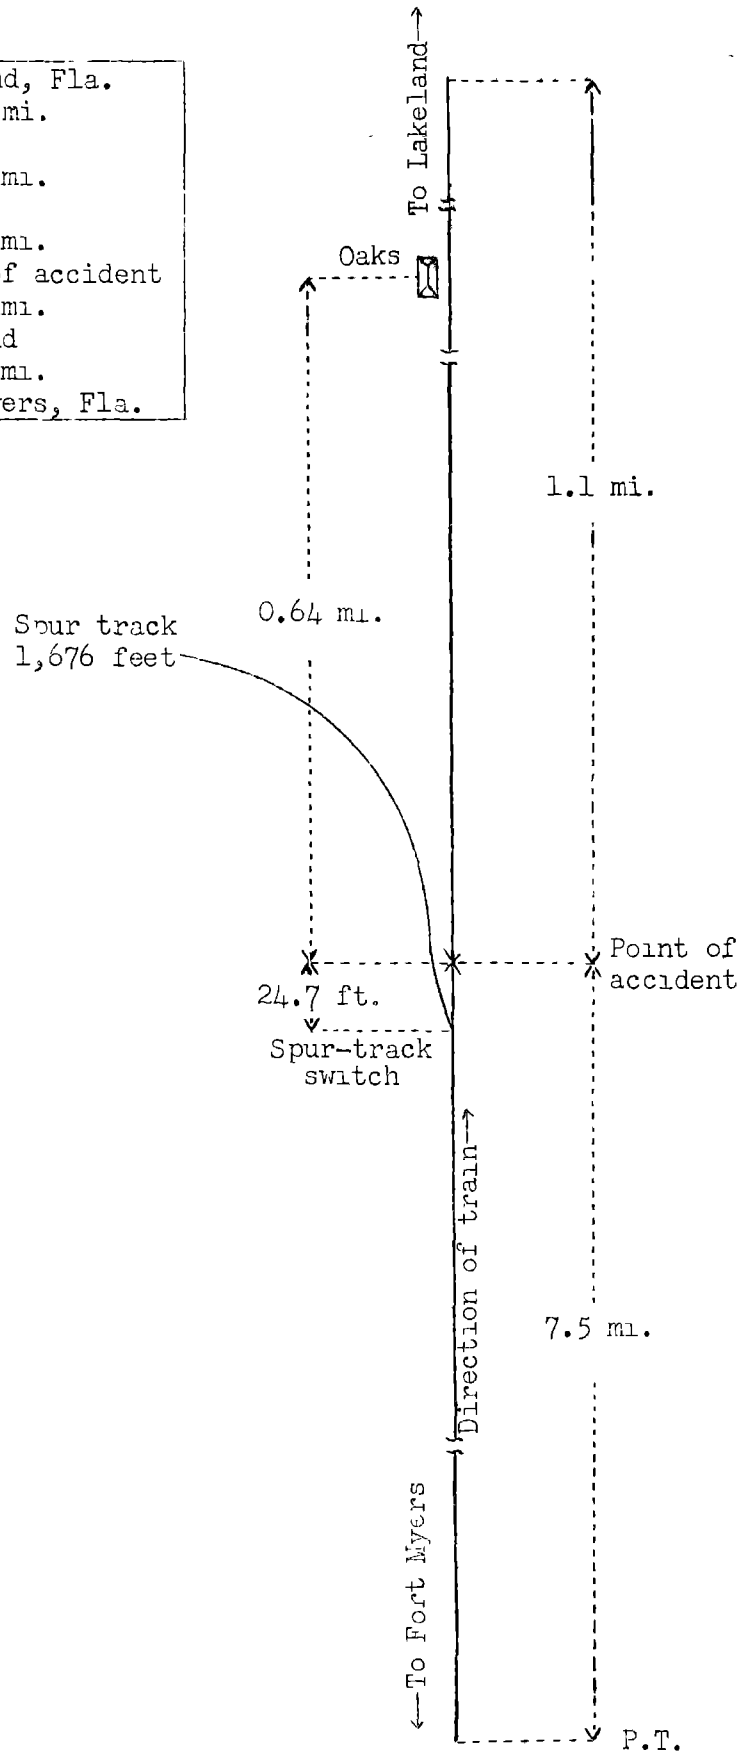
Inv. No. 2718  
Atlantic Coast Line Railroad  
Oaks, Fla.  
August 5, 1943

o	Lakeland, Fla.
	13.00 mi.
o	Bartow
	0.80 mi.
o	Oaks
	0.64 mi.
X	Point of accident
	4.76 mi.
o	Homeland
	94.80 mi.
o	Fort Myers, Fla.

The front wheels of the engine truck were derailed to the left at a point 24.7 feet north of the spur-track switch and continued in line with the main track a distance of about 60 feet to the frog of the switch, where the general derailment occurred. The engine stopped on its right side at right angles to the track, with the front end about 410 feet north of the point of derailment and about 50 feet west of the track. The engine truck was detached, the cab was demolished, steam and water connections were broken, and the engine was otherwise badly damaged. The tender became detached from the engine and stopped on its right side, badly damaged, across the track and at right angles to it. The first car became separated from the tender and the second car, and stopped upright, south of the tender, across the track and at right angles to it. The second, third, fourth and fifth cars were derailed to the west and stopped practically
