# INTERSTATE COMMERCE COMMISSION WASHINGTON

INVESTIGATION NO. 3156

ATLANTIC COAST LINE RAILROAD COMPANY
REPORT IN RE ACCIDENT
NEAR PIDCOCK, GA., ON
JANUARY 11, 1948

Accident near Pidcock, Ga., on January 11, 1948, caused by a broken rail.

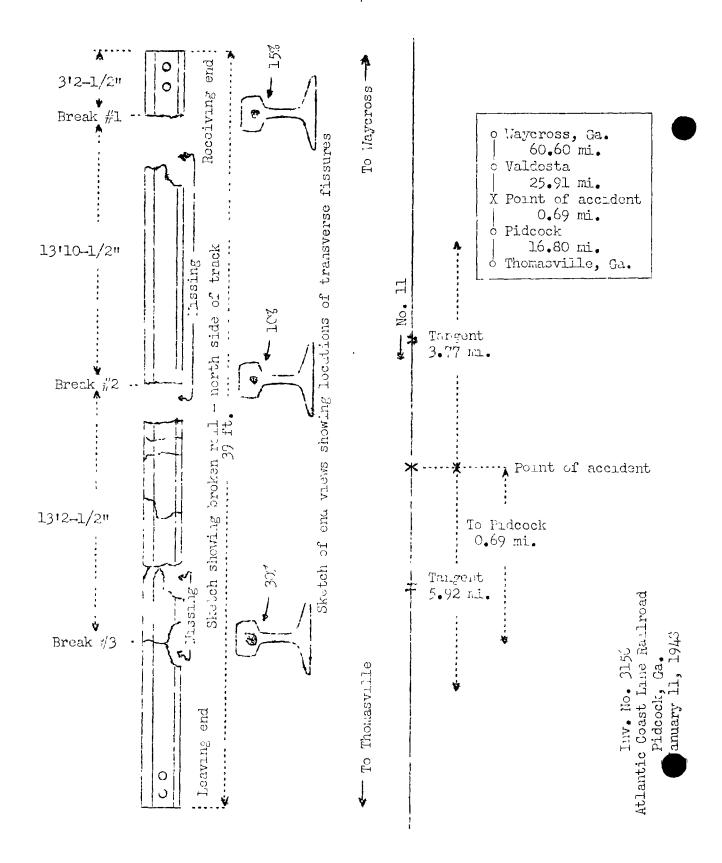
# Location of Accident and Method of Operation

Immediately after the derailment separations occurred between the second and third cars, between the third and fourth cars, and between the fifth and sixth cars. The engine and the first two cars stopped with the front of the engine 2,087 feet west of the point of derailment. The third to eighth cars, inclusive, stopped, practically upright, north of the track and in line with it, with the west end of the third car and the east end of the eighth car, respectively, 639 feet and 116 feet west of the point of derailment. The derailed equipment was considerably damaged.

After the accident occurred, a broken rail was found on the north side of the track. This rail was broken into many pieces, eight of which were recovered. At breaks Nos. 1, 2 and 3, which occurred at points, respectively, 3 feet 2-1/2 inches, 17 feet 1 inch, and 30 feet 3-1/2 inches west of the receiving end of the rail, there were transverse fissures which covered, respectively, 15 percent, 10 percent, and 30 percent of the cross-sectional area of the head of the rail. None of these fissures extended to the surface of the rail. The failure of the rail occurred when the front portion of the train passed over it, then the broken pieces became displaced, and the derailment followed.
