INVESTIGATION NO. 3103
ATLANTIC COAST LINE RAILROAD COMPANY
REPORT IN RE ACCIDENT
AT VALDOSTA, GA., ON
MAY 9, 1947

Railroad: Atlantic Coast Line
Date: May 9, 1947
Location: Valdosta, Ga.
Kind of accident: Rear-end collision
Trains involved: Freight : Passenger
Train numbers: 215 : 57
Engine numbers: 1751 : 1519
Consists: 59 cars, caboose : 11 cars
Estimated speeds: 7 m. p. h. : 25 m. p. h.
Operation: Timetable and train orders;
yard limits
Track: Single; tangent; 0.34 percent
ascending grade westward
Weather: Clear
Time: 11:47 p. m.
Casualties: 44 injured
Cause: Failure to provide adequate protection
for preceding train

Accident at Valdosta, Ga., on May 9, 1947, caused by
failure to provide adequate protection for the
preceding train.

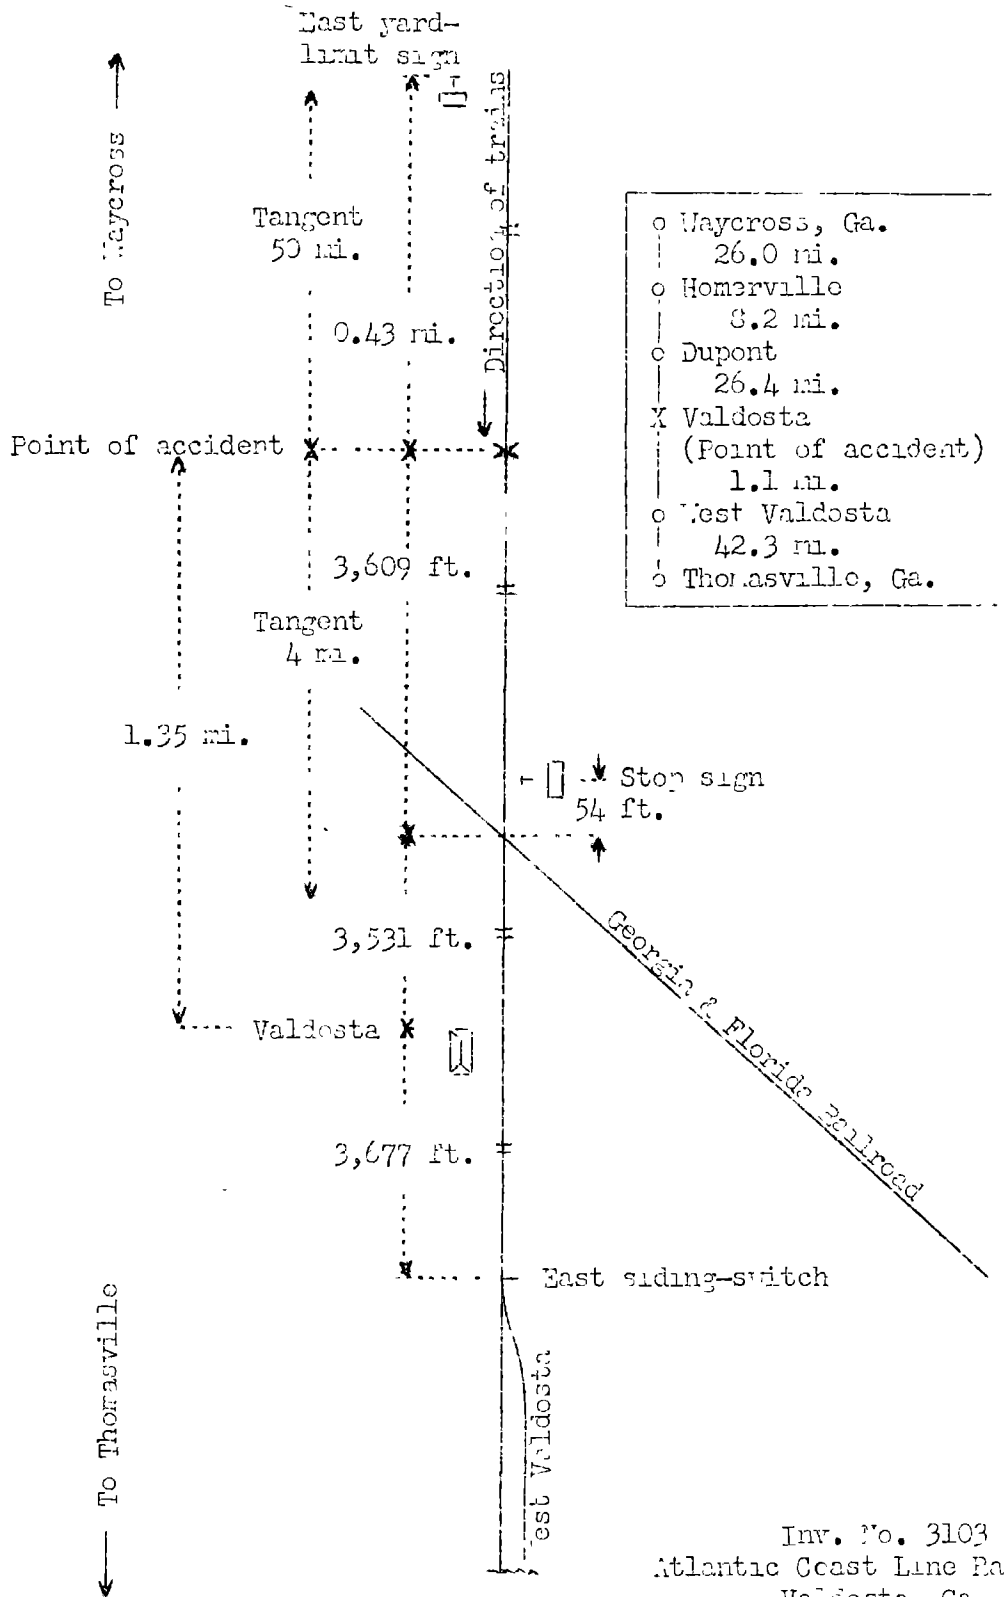
Inv. No. 3103
 Atlantic Coast Line Railroad
 Valdosta, Ga.
 May 9, 1947

- o Waycross, Ga. 26.0 mi.
- o Homerville 8.2 mi.
- o Dupont 26.4 mi.
- X Valdosta (Point of accident) 1.1 mi.
- o West Valdosta 42.3 mi.
- o Thomasville, Ga.

Location of Accident and Method of Operation

This accident occurred on that part of the Southern Division extending between Waycross and Thomasville, Ga., 104 miles, a single-track line, over which trains are operated by timetable and train orders. There is no block system in use. At Valdosta, 60.6 miles west of Waycross, a single-track line of the Georgia & Florida Railroad intersects the main track of the Atlantic Coast Line at an angle of 48°, at a point 3,531 feet east of the station. The accident occurred within yard limits on the main track at a point 0.43 mile west of the east yard-limit sign, 1.35 miles east of the station and 3,609 feet east of the crossing. The main track is tangent throughout a distance of 50 miles immediately east of the point of accident, and 4 miles westward. The grade for west-bound trains is 0.77 percent descending 1,200 feet, practically level 1,000 feet, then it is 0.34 percent ascending 310 feet to the point of accident and 1,090 feet westward.
