REPORT OF THE DIRECTOR  
BUREAU OF SAFETY

ACCIDENT ON THE  
ATLANTIC COAST LINE RAILROAD

WILMINGTON, N. C.

INVESTIGATION NO. 2388

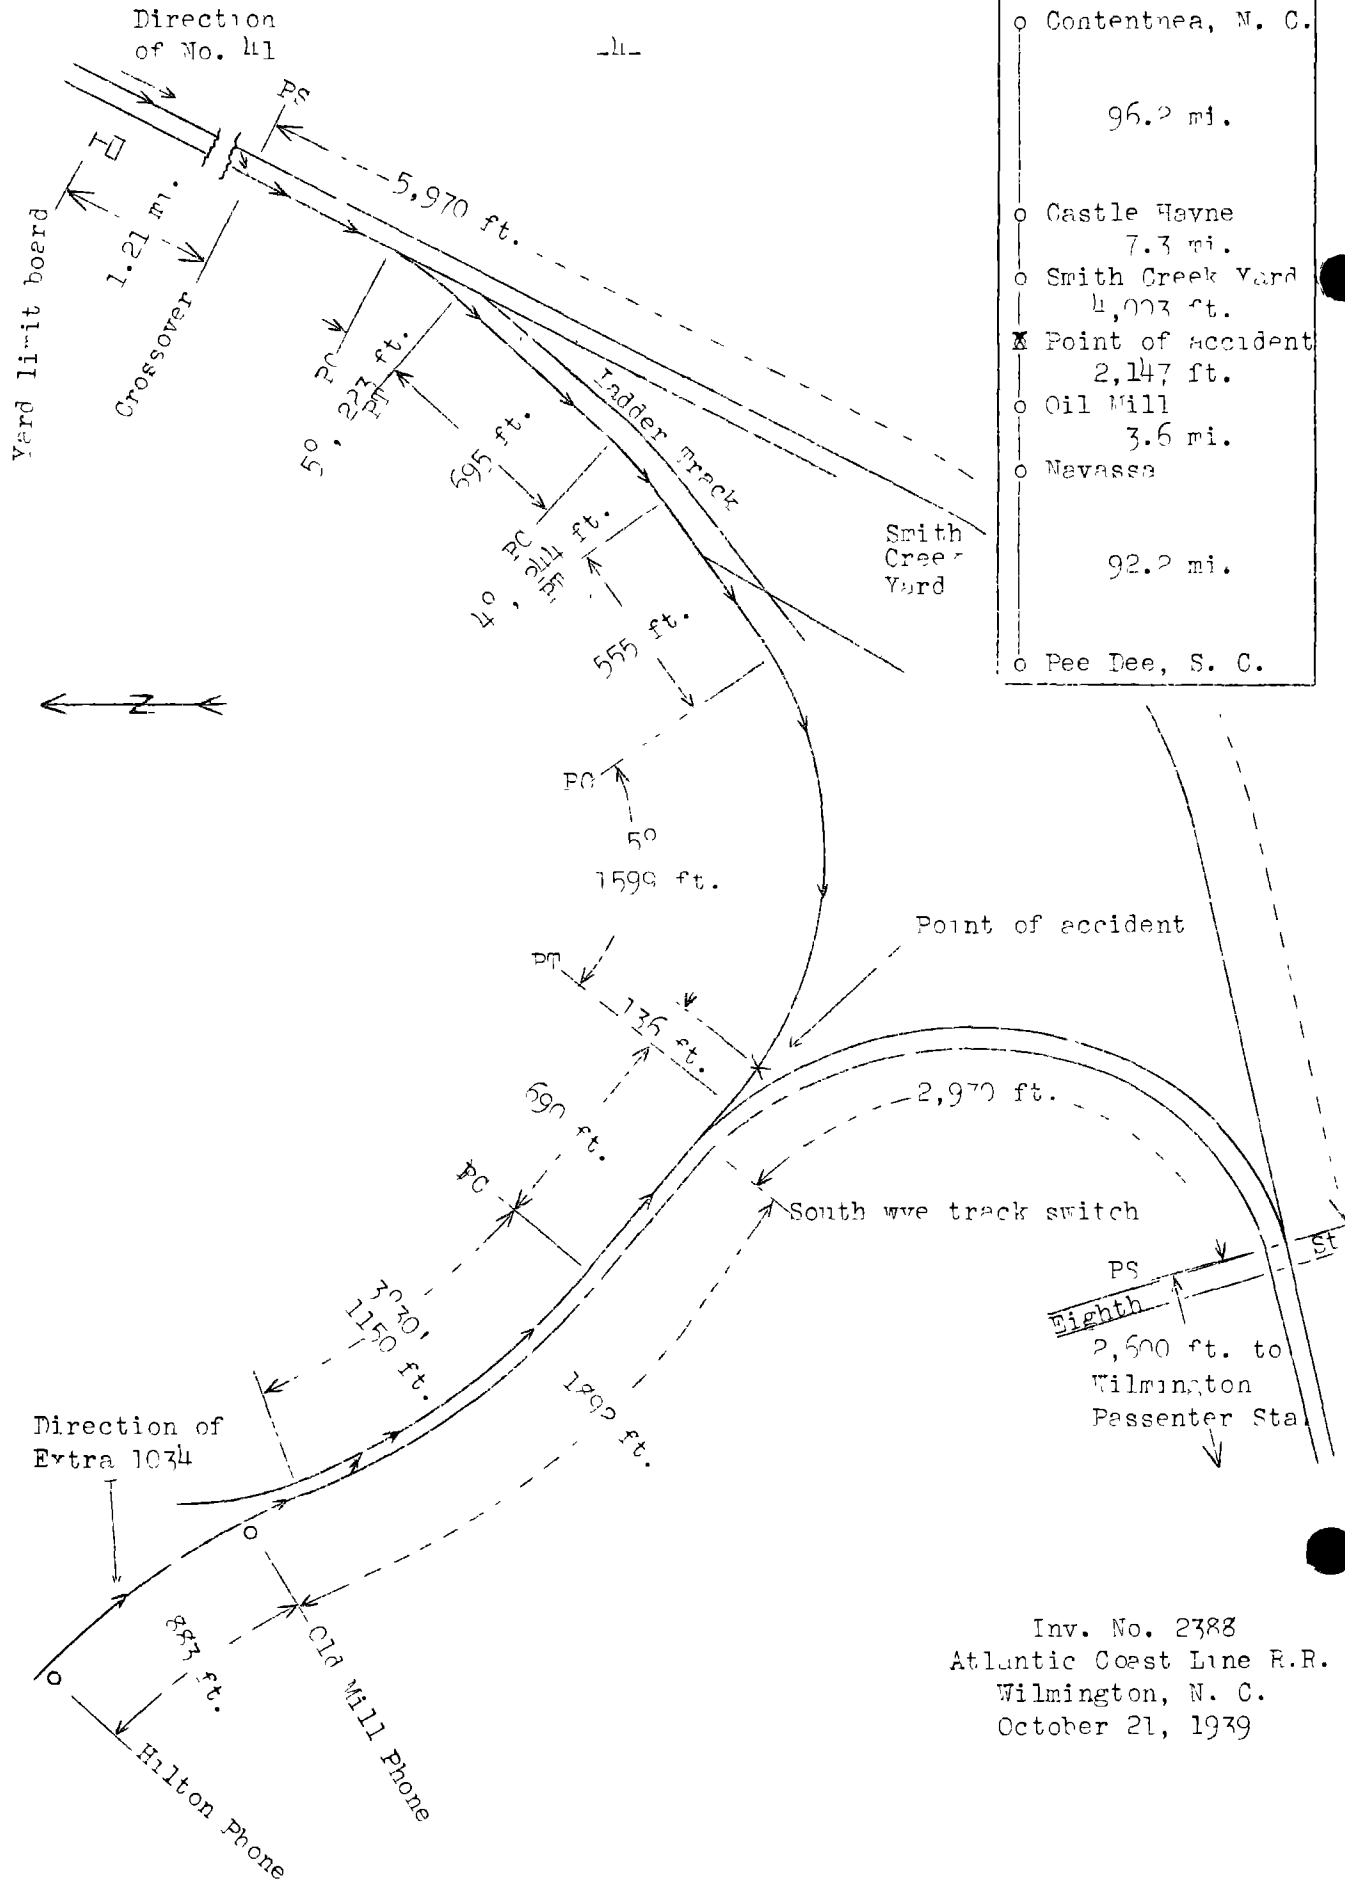
Inv. No. 2388  
 Atlantic Coast Line R.R.  
 Wilmington, N. C.  
 October 21, 1939

o	Contentnea, N. C.	96.2 mi.
o	Castle Hayne	7.3 mi.
o	Smith Creeper Yard	4,003 ft.
X	Point of accident	2,147 ft.
o	Oil Mill	3.6 mi.
o	Navassa	
		92.2 mi.
o	Pee Dee, S. C.

The main track entering Wilmington from the north extends from northeast to southwest; the main track from the south extends from northwest to southeast and converges with the north main track at Eighth Street, 2,600 feet north of the station. A wye track, which extends generally north and south and is 3,535 feet in length, connects these main tracks at points on the north and south tracks, respectively, 5,970 feet and 2,970 feet from the junction at Eighth Street. The accident occurred on this wye track at a point 254.8 feet from its south end. Smith Creek Yard lies in the angle formed by the main track from the north and the wye track. A ladder track leading to the yard tracks branches off from the extreme north end of the wye track. Yard limits extend from a point approximately 2 miles north to a point 5 miles south of the point of accident.

Approaching the point of accident from the north, there is a tangent for a considerable distance, which is followed in succession by a 5° curve to the right 223 feet long, a tangent 695 feet long, a 4° curve to the right 244 feet long, a tangent 555 feet long, and a 5° curve to the right 1,599 feet long; the accident occurred at a point 136 feet from the south end of the last-mentioned curve. Approaching from the south there are, in succession, a 3°30' curve to the left 1,150 feet long, a tangent 690 feet long, and the 5° curve to the left on which the accident occurred. Approaching from the north the grade is 0.19 percent ascending for more than 4,000 feet. Approaching from the south the grade is 0.28 percent to 0.43 percent ascending for more than 3,000 feet; the accident occurred at the apex of the
