REPORT NO. 3690

THE BALTIMORE AND OHIO RAILROAD COMPANY

IN RE ACCIDENT

NEAR CORNWALLIS, W. VA., ON

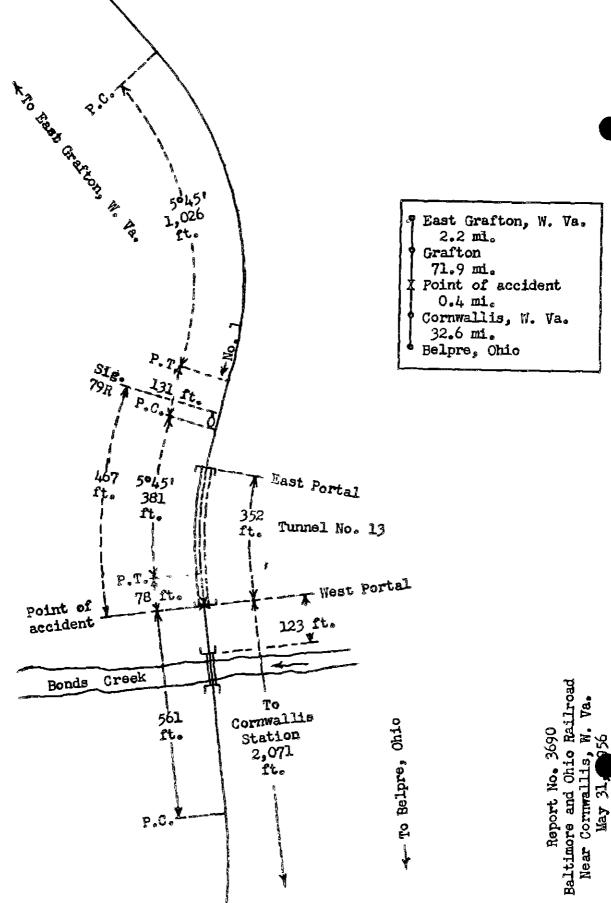
This accident occurred on that part of the Monongah Division extending between East Grafton, W. Va., and Belpre, Ohio, 107.1 miles. In the vicinity of the point of accident this is a single-track line, over which trains are operated by signal indications. The accident occurred on the main track at the west portal of Tunnel No. 13, 74.1 miles west of East Grafton and 2,071 feet east of the station at Cornwallis, W. Va. From the east there are, in succession, a 5°45' curve to the right 1,026 feet in length, a tangent 131 feet, a 5°45' curve to the left 381 feet, and a tangent 78 feet to the point of accident and 561 feet westward. The grade is practically level at the point of accident.

The Diesel-electric units, the first to the sixth cars, inclusive, and the front truck of the seventh car were derailed. The first Diesel-electric unit was broken in two. The front portion stopped in the center of Bonds Creek about 40 feet north of the bridge. The rear portion stopped in the creek with the west end against the west abutment of the bridge. The second Diesel-electric unit stopped on its right side with the front end on top of the rear portion of the first unit and the rear end on the east abutment of the bridge. The first car stopped several feet north of the track and parallel to it. It leaned to the north at an angle of approximately 45 degrees. The other derailed cars remained upright and approximately in line with the track. With the exception of the separation between the two Dieselelectric units, there were no separations between the units of the train. The third car did not pass the portal of the of the train. tunnel. This car and the following cars were derailed as a result of the shock of the impact. The first Dieselelectric unit was destroyed, the second unit was badly damaged, the first three cars were considerably damaged, and the other derailed cars were somewhat damaged.

After the accident occurred it was found that approximately 615 tons of rock had become dislodged from the hill-side above the portal of the tunnel and had fallen on and near the track. This rock had become dislodged from a horizontal stratum of hard sandstone approximately 35 feet in thickness. It had fallen from an area about 25 feet back of the portal of the tunnel, between 35 feet 9 inches and 71 feet above the top of the portal, and between 12 feet 6 inches and 40 feet 6 inches south of the center-line of the track. The slide contained a number of large rocks, the largest of which measured 22 feet by 15 feet by 15 feet. The conductor of No. 1 said that rock continued to fall on the track for some time after the accident occurred.
