RAILROAD ACCIDENT INVESTIGATION

Report No. 4120

THE BALTIMORE AND OHIO RAILROAD COMPANY

EAST DILLARD, O.

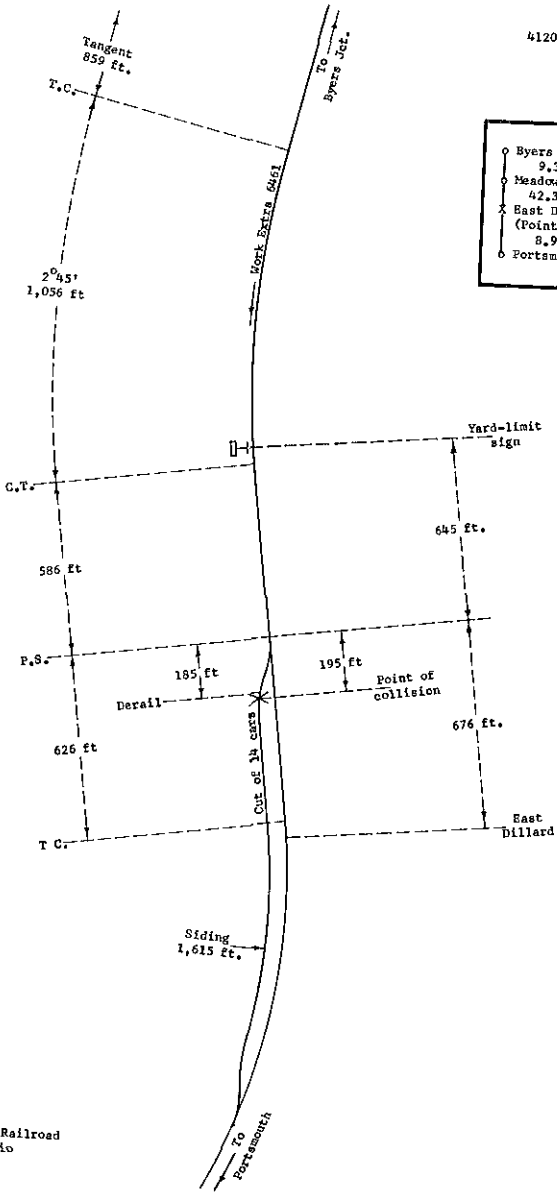
Examination of the east-siding switch after the accident disclosed that it was in reverse position, lined for movement from the main track to the siding. The operating lever of the switch stand was also in reverse position and was locked with the switch stand padlock. The target of the switch stand was displaying its red vanes, indicating that the switch was in reverse position. The 3-inch glass reflectors attached to the vanes were broken and remnants of the reflectors were scattered on the ground, at the base of the switch stand. The keeper assembly for securing the operating lever of the switch stand in normal position was dislodged and was found east of the switch stand on the north side of the main track structure.

The derail near the east end of the East Dillard siding and the target of the switch stand for the derail were dislodged and were found in the wreckage. Since the road foreman saw the target of the derail switch stand displaying a yellow banner and the front of the locomotive passed the derail without derailing, it is evident the derail was not in derailing position when the train entered the siding and collided with the cut of 14 cars.

The six diesel-electric units and first 9 cars were derailed and stopped in various positions on or near the structures of the siding and main track. The two easternmost cars of the cut of 14 cars were also derailed. The 6 diesel-electric units were heavily damaged. Of the 11 cars derailed, 2 were destroyed, 5 were heavily damaged and 4 were somewhat damaged.
