REPORT NO. 1643
THE BALTIMORE AND OHIO RAIL ROAD COMPANY
IN RE ACCIDENT
NEAR LUMBERTON, W. VA., ON
JULY 31 1955

Date	July 21, 1955
Railroad.	Baltimore and Ohio
Location.	Lumberport, W. Va.
Kind of accident:	Head-end collision
Trains involved	Freight Locomotive
Train numbers:	Extra 904 East : Extra 4433 West
Engine numbers:	Diesel-electric 4433 Unit 904
Consist:	34 cars, caboose
Estimated speeds.	17 m. p. h. : 10-20 m. p. h.
Operation:	Timetable and train orders
Track.	Single, 6°55' curve, 1.00 percent descending grade eastward
Weather.	Clear
Time.	6:15 p. m.
Casualties:	1 killed; 7 injured
Cause:	Overlapping of authority of two opposing extra trains

Accident near Lumberport, W. Va., on July 21, 1955,
caused by overlapping of authority of two
approaching extra trains.

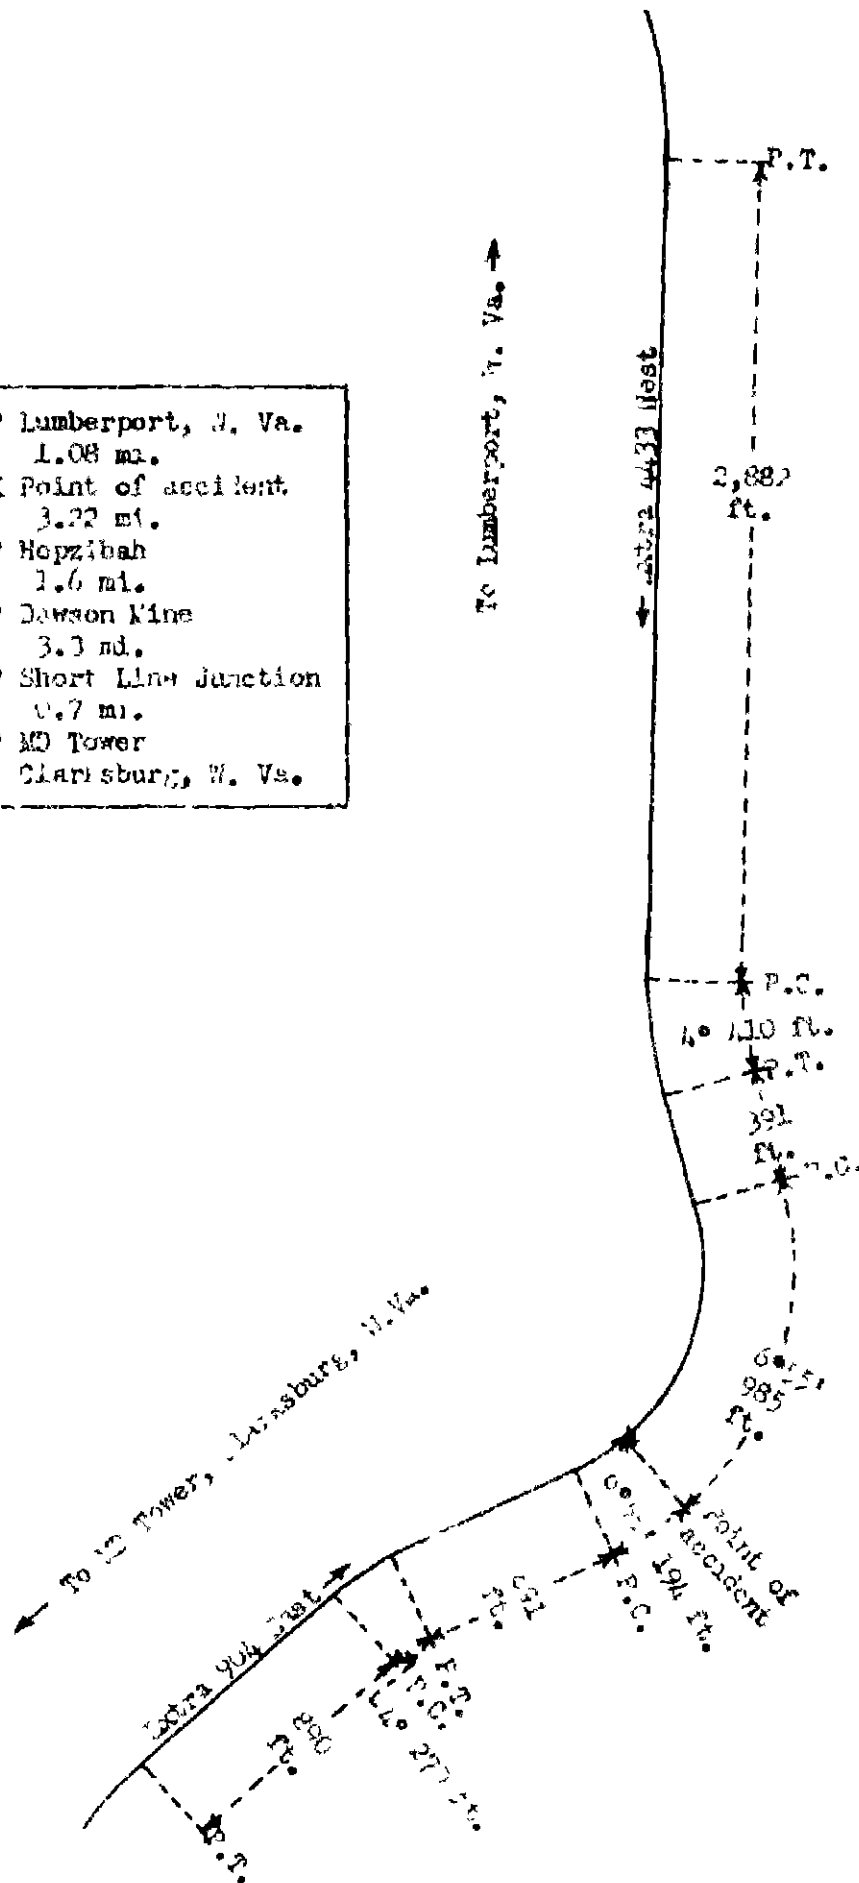
Report No. 3042
Baltimore and Ohio Railroad
at Lumberport, W. Va.
July 21, 1955

•	Lumberport, W. Va.
	1.08 mi.
X	Point of accident
	3.22 mi.
•	Hopzibah
	1.6 mi.
•	Dawson Mine
	3.3 mi.
•	Short Line Junction
	0.7 mi.
•	MD Tower
	Clarksburg, W. Va.

This accident occurred on that part of the Monongah Division extending between MD Tower, near Clarksburg, and Lumberport, W. Va., 9.90 miles. In the vicinity of the point of accident this is a single-track line, over which trains are operated by timetable and train orders. There is no block system in use. The accident occurred on the main track 8.82 miles east of MD Tower and 1.08 miles west of the station at Lumberport. From the west there are, in succession, a tangent 890 feet in length, a 4° curve to the right 270 feet, a tangent 621 feet, and a 6°55' curve to the left 194 feet to the point of accident and 265 feet eastward. From the east there are, in succession, a tangent 2,882 feet in length, a 4° curve to the left 410 feet, a tangent 391 feet, and the curve on which the accident occurred. The grade is 1.00 percent descending eastward at the point of accident. Between points 139 feet west and 61 feet east of the point of accident the track is laid in a shallow sidehill cut. The north wall of this cut rises above the track on a slope of approximately 2 in 1.
