INVESTIGATION NO. 3263
THE BALTIMORE AND OHIO RAILROAD COMPANY
REPORT IN RE ACCIDENT
NEAR DEER PARK, MD., ON
JULY 3, 1949

Inv. No. 3263
 Baltimore and Ohio Railroad
 Deer Park, Md.
 July 3, 1949

Location of Accident and Method of Operation

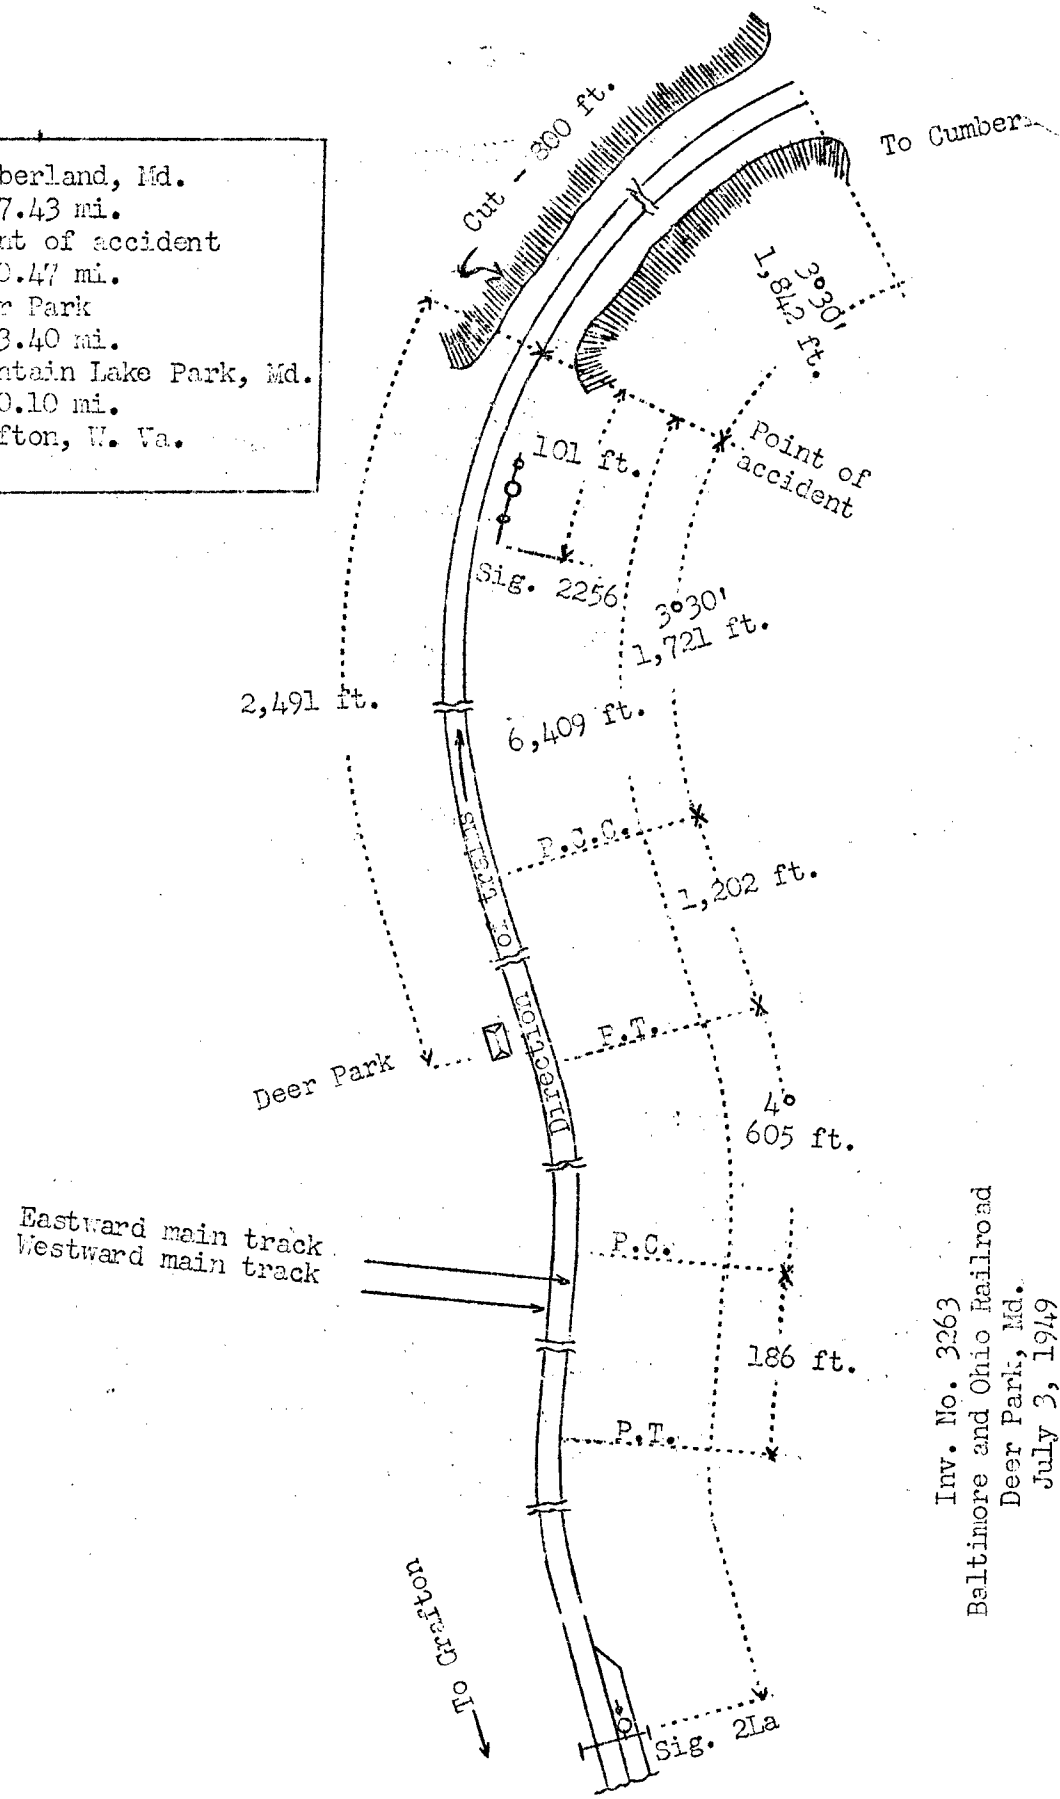
- Cumberland, Md.
- | 47.43 mi.
- X Point of accident
- | 0.47 mi.
- Deer Park
- | 3.40 mi.
- Mountain Lake Park, Md.
- | 50.10 mi.
- Grafton, W. Va.
