INVESTIGATION NO. 2621
THE BALTIMORE & OHIO RAILROAD COMPANY
REPORT IN RE ACCIDENT
NEAR DORFEE, W. VA., ON
AUGUST 23, 1942

Accident near Dorfee, W. Va., on August 23, 1942, caused
by the undermining of a bridge pier by flood water.

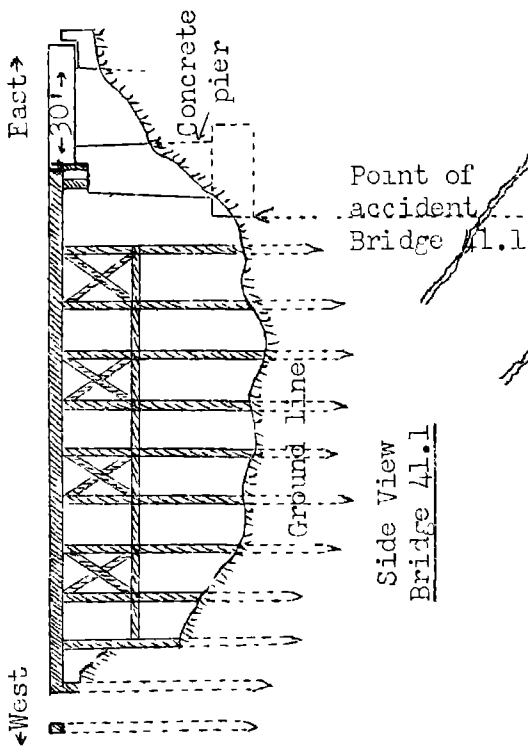
Inv. No. 2621
 Baltimore & Ohio Railroad
 Dorfee, W. Va.
 August 23, 1942

Location of Accident and Method of Operation

After the accident, the pier supporting the west end of the girder span leaned to the west at an angle of about 30 degrees and the west end of the girder was at the bottom of the east face of the pier. About 4 feet of the top of the pier was broken off. The piling and the decking of the bridge were destroyed, except the two most westerly bents. The front deck-casting and the engine-truck frame of the engine were demolished. The trucks of the 11 derailed cars were detached. The condition of the bridge and the positions of the engine and the equipment after the accident indicated that at the time the engine moved
