ACCIDENT ON THE  
BALTIMORE AND OHIO RAILROAD

HOPE, OHIO

DECEMBER 26, 1938

INVESTIGATION NO. 2319

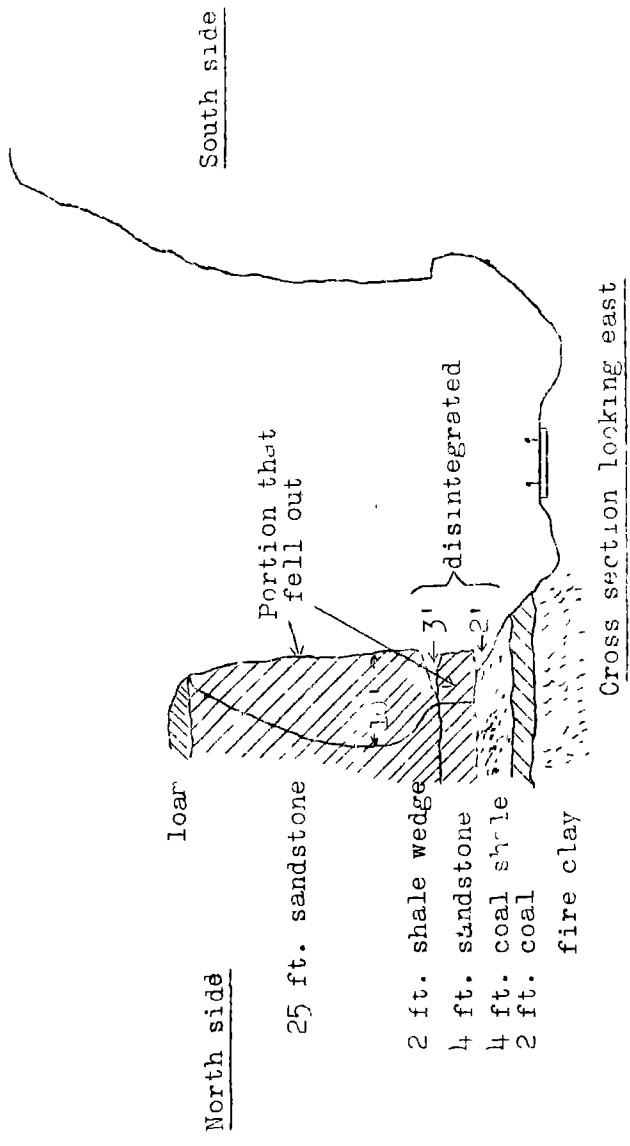
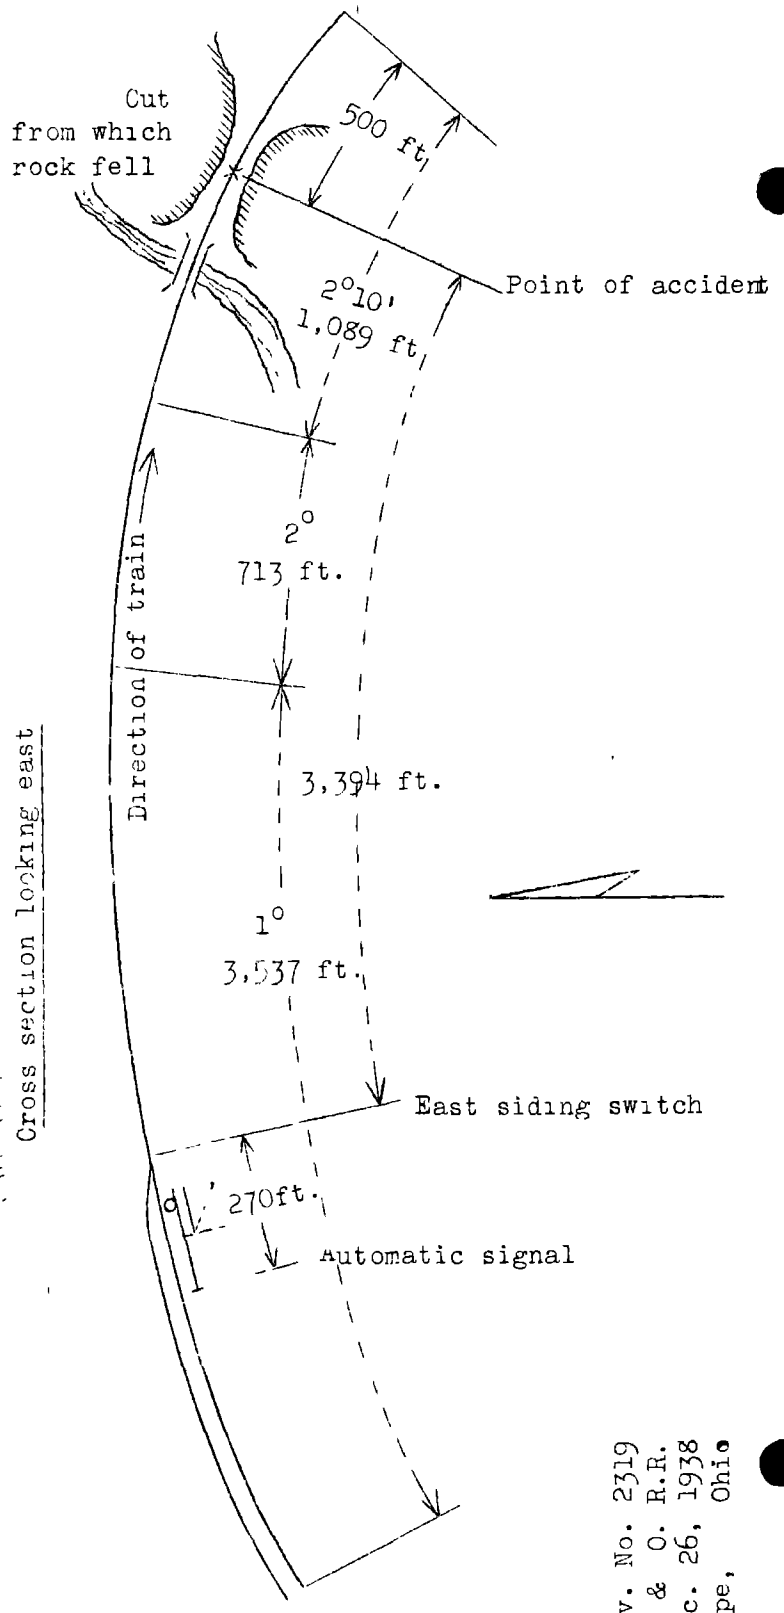
Inv. No. 2319  
 B. & O. R.R.  
 Dec. 26, 1938  
 Hope, Ohio

o Parkersburg, W.Va.  
 52.1 mi.  
 X Point of accident  
 o Hope  
 45.3 mi.  
 o Chillicothe, Ohio
