INVESTIGATION NO. 3031  
THE BALTIMORE AND OHIO RAILROAD COMPANY  
REPORT IN RE ACCIDENT  
AT LINCOLN PARK, N. Y., ON  
OCTOBER 26, 1946

Accident at Lincoln Park, N. Y., on October 26, 1946,  
caused by a switch being opened immediately in  
front of an approaching train.

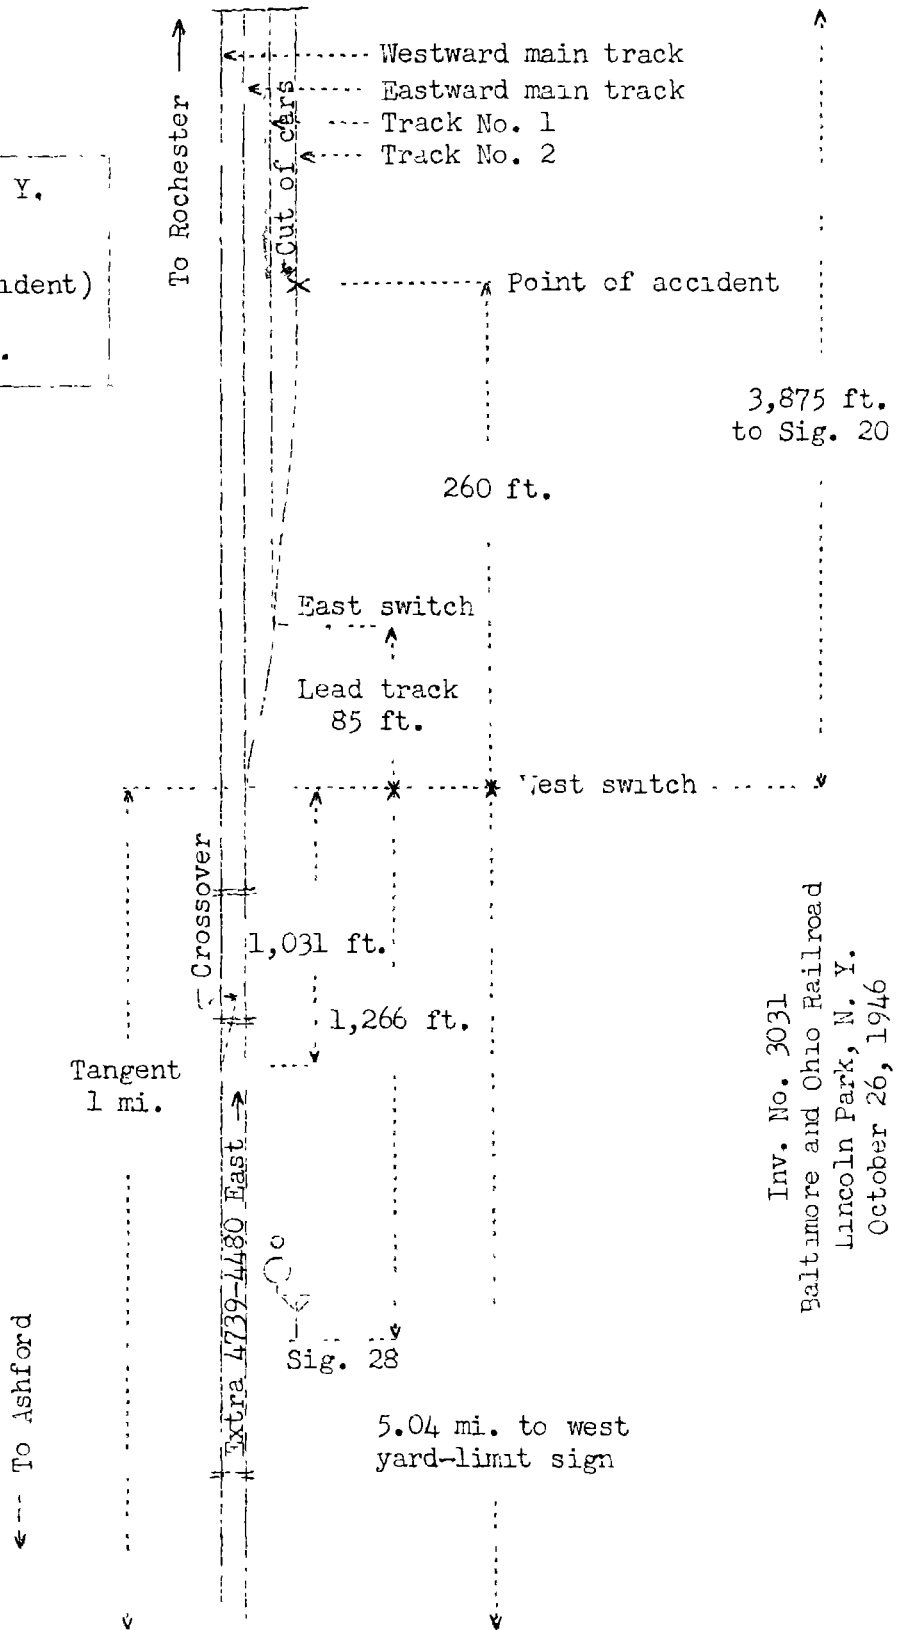
o Rochester, N. Y.  
 1.8 mi.  
 X Lincoln Park  
 (Point of accident)  
 91.8 mi.  
 o Ashford, N. Y.

3,875 ft.  
 to Sig. 20

260 ft.

East switch

Lead track  
 85 ft.

West switch

Crossover

The switchstands of the east and west lead-track switches are of the hand-throw low-stand type. The west switch is provided with an oil-burning lamp and two targets. The centers of the lenses and the targets are, respectively, 2 feet 6 inches and 1 foot 7 inches above the tops of the ties and 7 feet 2 inches south of the centerline of the eastward main track. When the switch is lined normally a green target, 1 foot 5 inches by 7-1/4 inches, and a green light are displayed at right angles to the track. When the switch is lined for entry to the lead track a red target, 1 foot 4 inches by 5-1/4 inches, and a red light are displayed at right angles to the track. No lamp or other illuminating device is provided on the switchstand of the east lead-track switch.
