INVESTIGATION NO. 3250
THE BALTIMORE AND OHIO RAILROAD COMPANY
REPORT IN RE ACCIDENT
AT NEWARK, OHIO, ON
APRIL 29, 1949

Date: April 29, 1949
Railroad: Baltimore and Ohio
Location: Newark, Ohio
Kind of accident: Derailment
Train involved: Passenger
Train number: 36
Engine number: 5237
Consist: 6 cars
Estimated speed: 10 m. p. h.
Operation: Hand signals
Tracks: Four; tangent; level
Weather: Clear
Time: 1:38 a. m.
Casualties: 7 injured
Cause: Insecure condition of track

Accident at Newark, Ohio, on April 29, 1949, caused
by an insecure condition of the track.

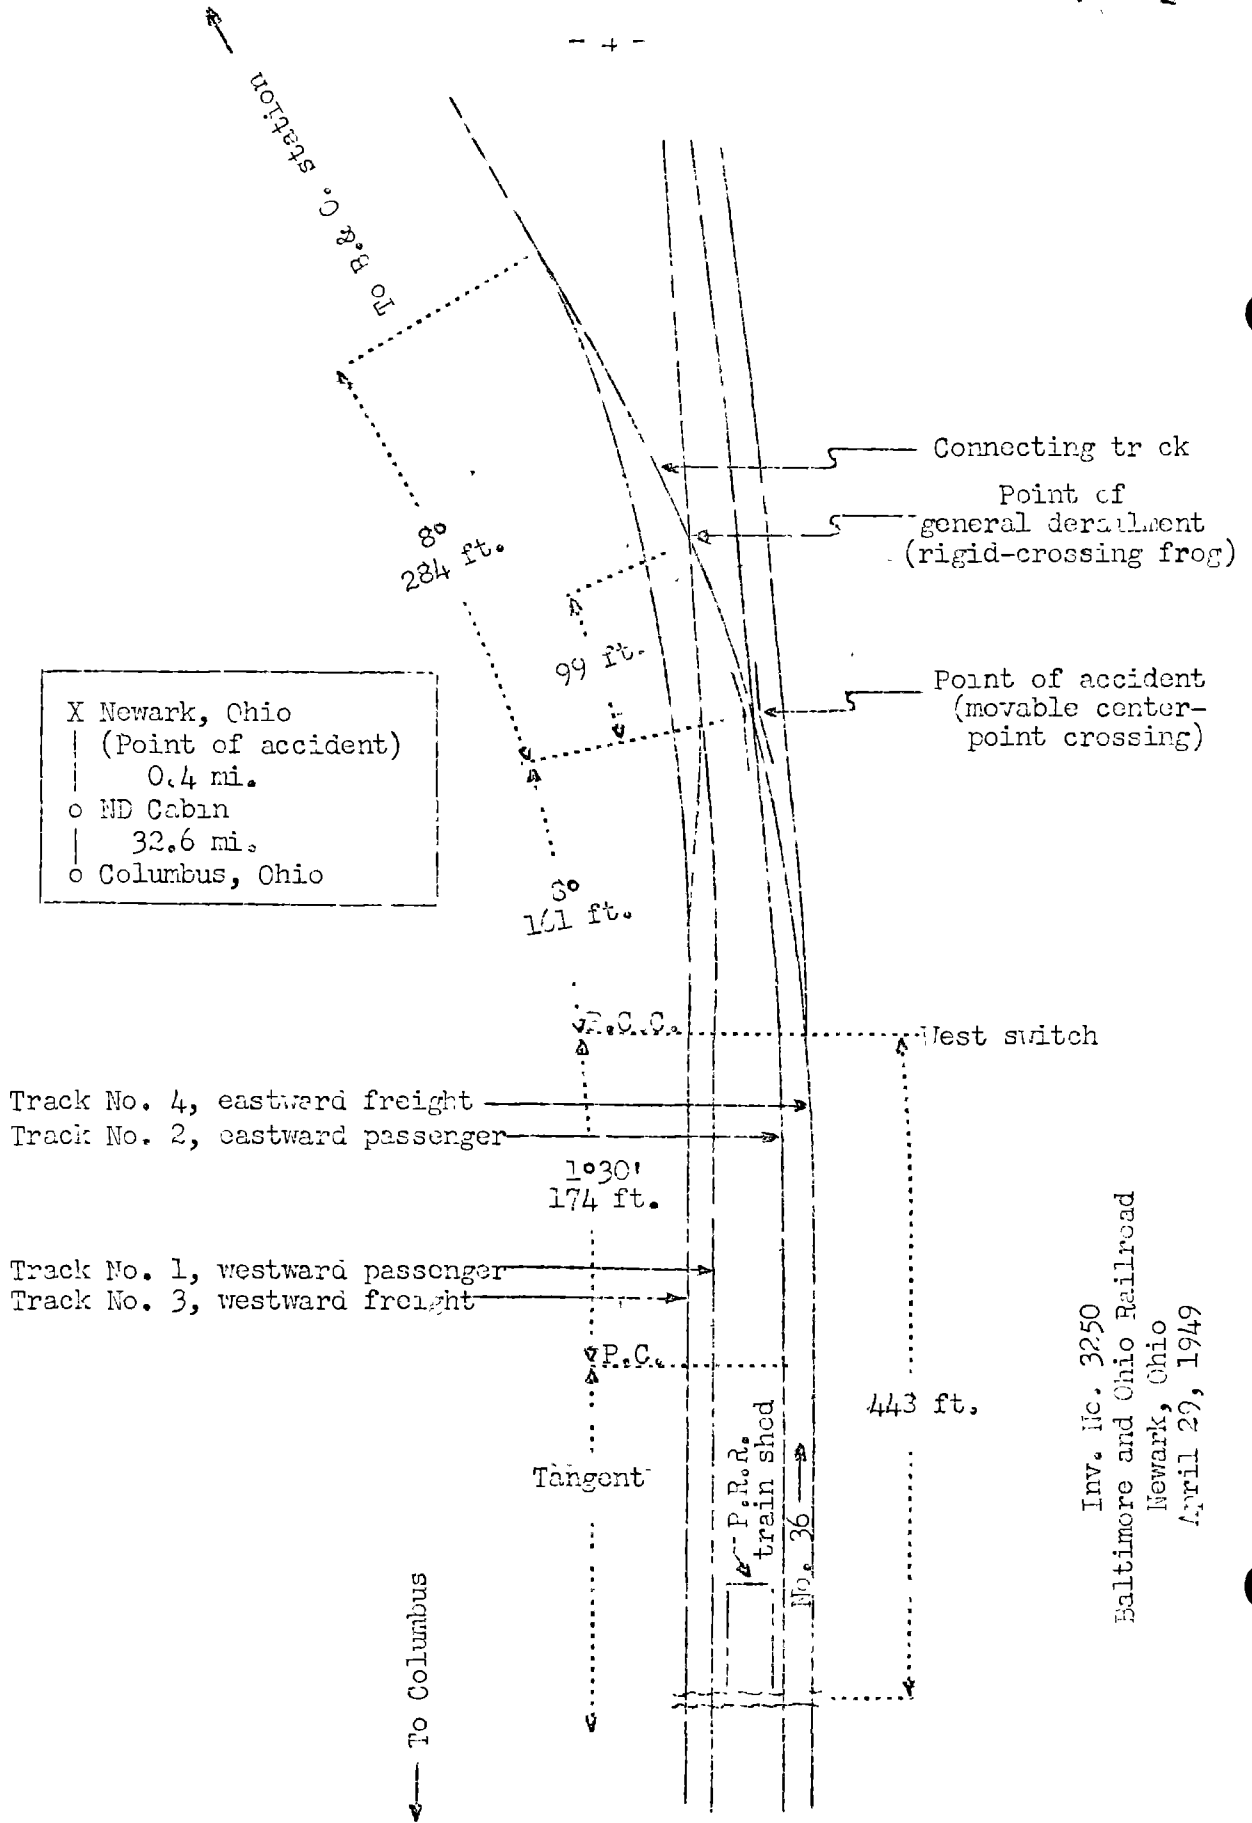
Inv. No. 3250
 Baltimore and Ohio Railroad
 Newark, Ohio
 April 29, 1949

X Newark, Ohio
 | (Point of accident)
 | 0.4 mi.
 o ND Cabin
 | 32.6 mi.
 o Columbus, Ohio

Location of Accident and Method of Operation

This accident occurred on that part of the Columbus and Newark Division extending between Columbus and Newark, Ohio, 32.93 miles. It is operated jointly by the Baltimore and Ohio Railroad and the Pennsylvania Railroad, and is a four-track line, over which P.R.R. trains moving with the current of traffic are operated by automatic-block and cab-signal indications, and B. & O. R.R. trains are operated by automatic block-signal indications. The main tracks are designated from south to north as No. 4, eastward freight; No. 2, eastward passenger, No. 1, westward passenger; and No. 3, westward freight. At Newark a connecting track extends between track No. 4 and track No. 3 and crosses tracks Nos. 2 and 1 at grade. The main tracks and the connecting track are maintained by the B. & O. R.R. The west switch of the connecting track is located in track No. 4 at a point 370 feet east of the P.R.R. station at Newark, and it is facing-point for east-bound trains. Track No. 2 is crossed by means of a movable center-point crossing located 161 feet east of the west switch, and track No. 1 is crossed by means of a rigid crossing located 99 feet east of the movable center-point crossing. Trains are operated over the connecting track by hand signals. The accident occurred on the connecting track at a point 8 feet 6 inches east of the movable center-point crossing. From the west there is a 1°30' curve to the left 174 feet to the west switch of the connecting track, and then an 8° curve to the left 161 feet to the point of accident and 284 feet eastward. The grade is level.
