INVESTIGATION NO. 2924
THE BALTIMORE AND OHIO RAILROAD COMPANY
REPORT IN RE ACCIDENT
AT PHILIPPI, W. VA., ON
AUGUST 17, 1945

Accident at Philippi, W. Va., on August 17, 1945, caused
by an inferior train occupying the main track on
the time of an opposing superior train.

Inv. No. 2924
 Baltimore and Ohio Railroad
 Philippi, W. Va.
 August 17, 1945

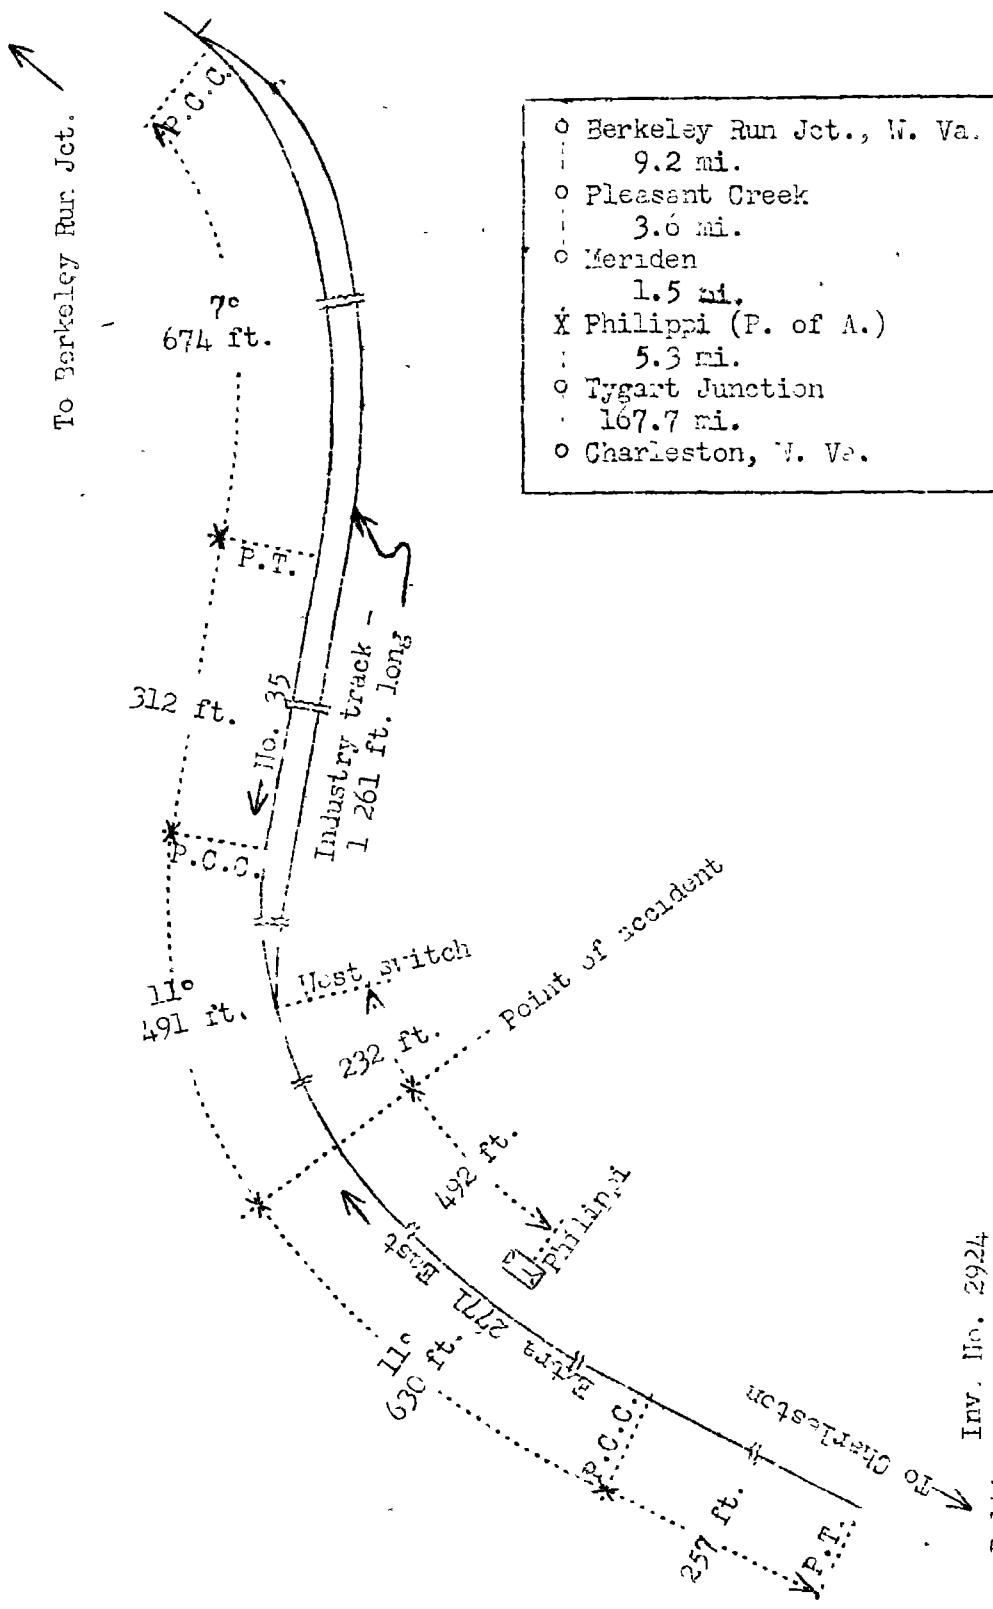
- o Berkeley Run Jct., W. Va. 9.2 mi.
- o Pleasant Creek 3.6 mi.
- o Meriden 1.5 mi.
- x Philippi (F. of A.) 5.3 mi.
- o Tygart Junction 167.7 mi.
- o Charleston, W. Va.

This accident occurred on the Grafton and Charleston Sub-Division, which extends between Berkeley Run Jct. and Charleston, W. Va., 187.3 miles, a single-track line in the vicinity of the point of accident, over which trains are operated by timetable and train orders, and a manual-block system for trains following passenger trains. At Philippi, 14.3 miles west of Berkeley Run Jct., an industry track 1,261 feet in length parallels the main track on the south. The west switch of this track is 724 feet east of the station. The accident occurred on the main track 232 feet west of the west switch of the industry track. From the east there are, in succession, a compound curve to the right 674 feet in length, the maximum curvature of which is 7°, a tangent 312 feet and a compound curve to the left, the maximum curvature of which is 11°, extending 491 feet to the point of accident and 630 feet westward. From the west there is a tangent 257 feet in length, which is followed by the curve on which the accident occurred. The grade is 0.35 percent descending westward.
