INVESTIGATION NO. 5173  
THE BALTIMORE AND OHIO RAILROAD COMPANY  
REPORT IN RE ACCIDENT  
NEAR RASSELAS, PA., ON  
MARCH 20, 1942

Accident near Rasselas, Pa., on March 20, 1948, caused  
by a broken rail.

Inv. No. 3173  
 Baltimore and Ohio Railroad  
 Rasselas, Pa.  
 March 20, 1948

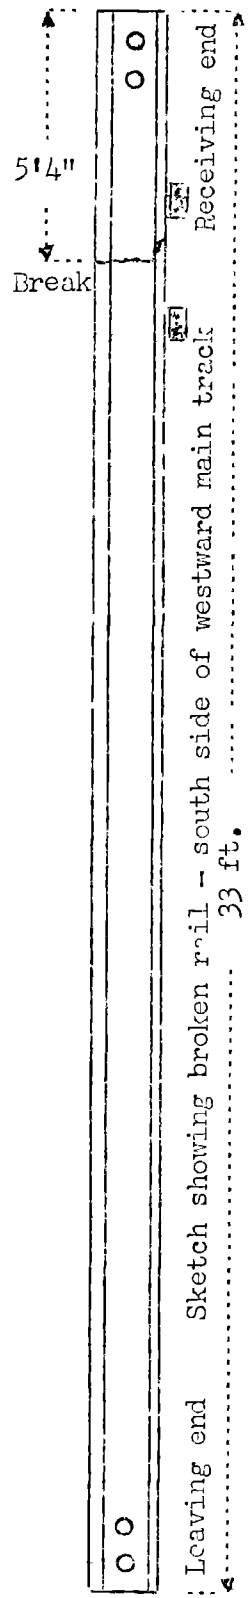
- o East Salamanca, N. Y. 39.60 mi.
- o J. & B. Junction, Pa. 11.40 mi.
- o Rasselas 1.57 mi.
- X Point of accident 44.23 mi.
- o Du Bois, Pa.

This accident occurred on that part of the Buffalo Division extending between East Salamanca, N. Y., and Du Bois, Pa., 96.8 miles. In the vicinity of the point of accident this is a double-track line, over which trains moving with the current of traffic are operated by timetable, train orders and an automatic block-signal system. The derailment occurred on the westward main track at a point 52.57 miles west of East Salamanca and 1.57 miles west of the station at Rasselas. From the east on the westward main track there are, in succession, a compound curve to the right, having a maximum curvature of  $7^{\circ}45'$ , 1,450 feet in length, a tangent 235 feet and an  $8^{\circ}$  curve to the left 1,375 feet to the point of accident and 195 feet westward. Throughout a distance of 7 miles immediately east of the point of accident the grade for west-bound trains varies between 0.07 and 1.09 percent descending to the point of accident, where it is 0.96 percent.
