REPORT NO. 3322
THE BALTIMORE AND OHIO RAILROAD COMPANY
IN RE ACCIDENT
NEAR RIKER, PA., ON
APRIL 22, 1950

Kind of accident: Head-end collision

Accident near Riker, Pa., on April 22, 1950, caused by a
train being admitted to a block occupied by an
opposing train.

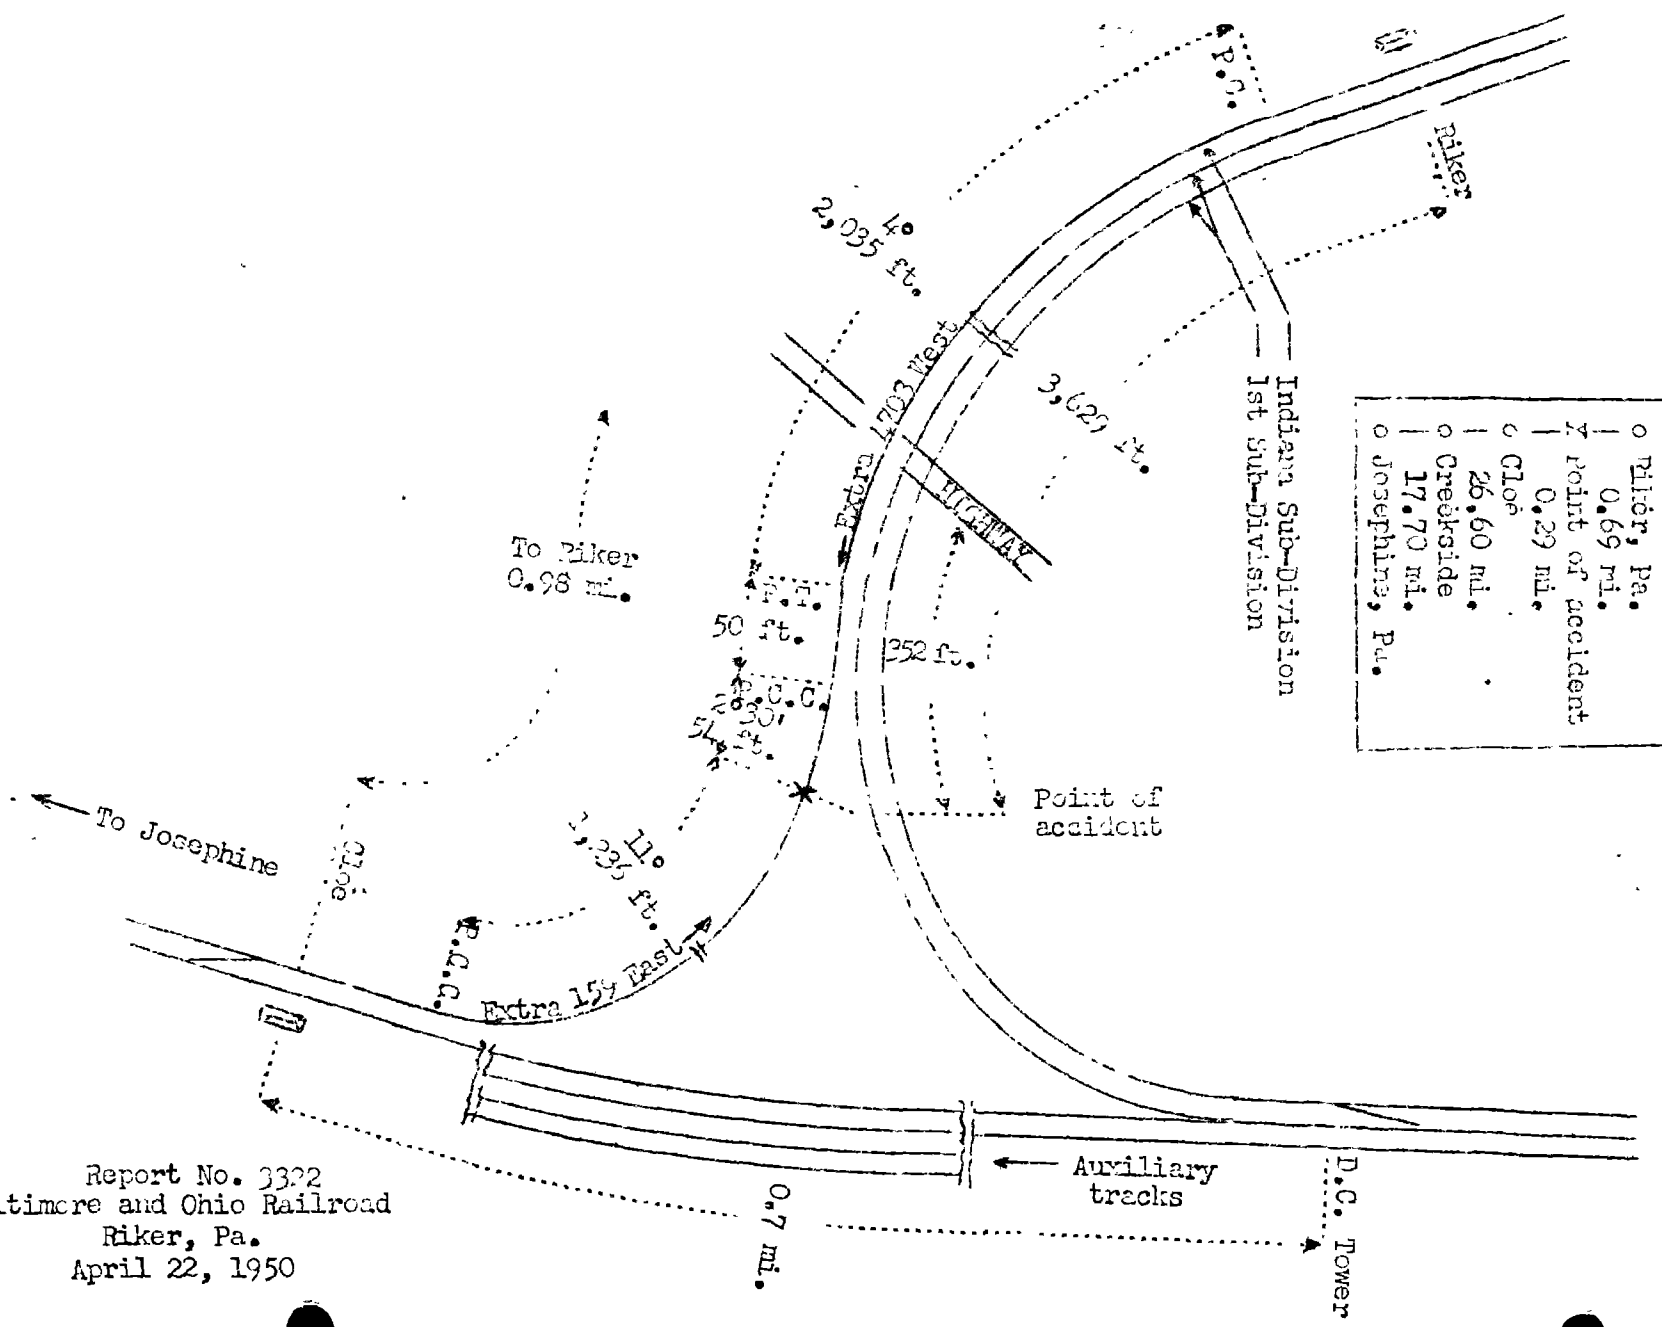
Report No. 3322
 Baltimore and Ohio Railroad
 Riker, Pa.
 April 22, 1950

o	Riker, Pa.
	0.69 mi.
X	Point of accident
	0.29 mi.
o	C106
	26.60 mi.
o	Creekside
	17.70 mi.
o	Josephine, Pa.
