REPORT NO. 3522  
THE BALTIMORE AND OHIO RAILROAD COMPANY  
IN RE ACCIDENT  
NEAR SMITHBURG, W. VA., ON  
APRIL 17, 1953

Accident near Smithburg, W. Va., on April 17, 1953, caused  
by the overturning of a rail.

Report No. 3522  
 Baltimore and Ohio Railroad Company  
 Smithburg, W. Va.  
 April 17, 1953

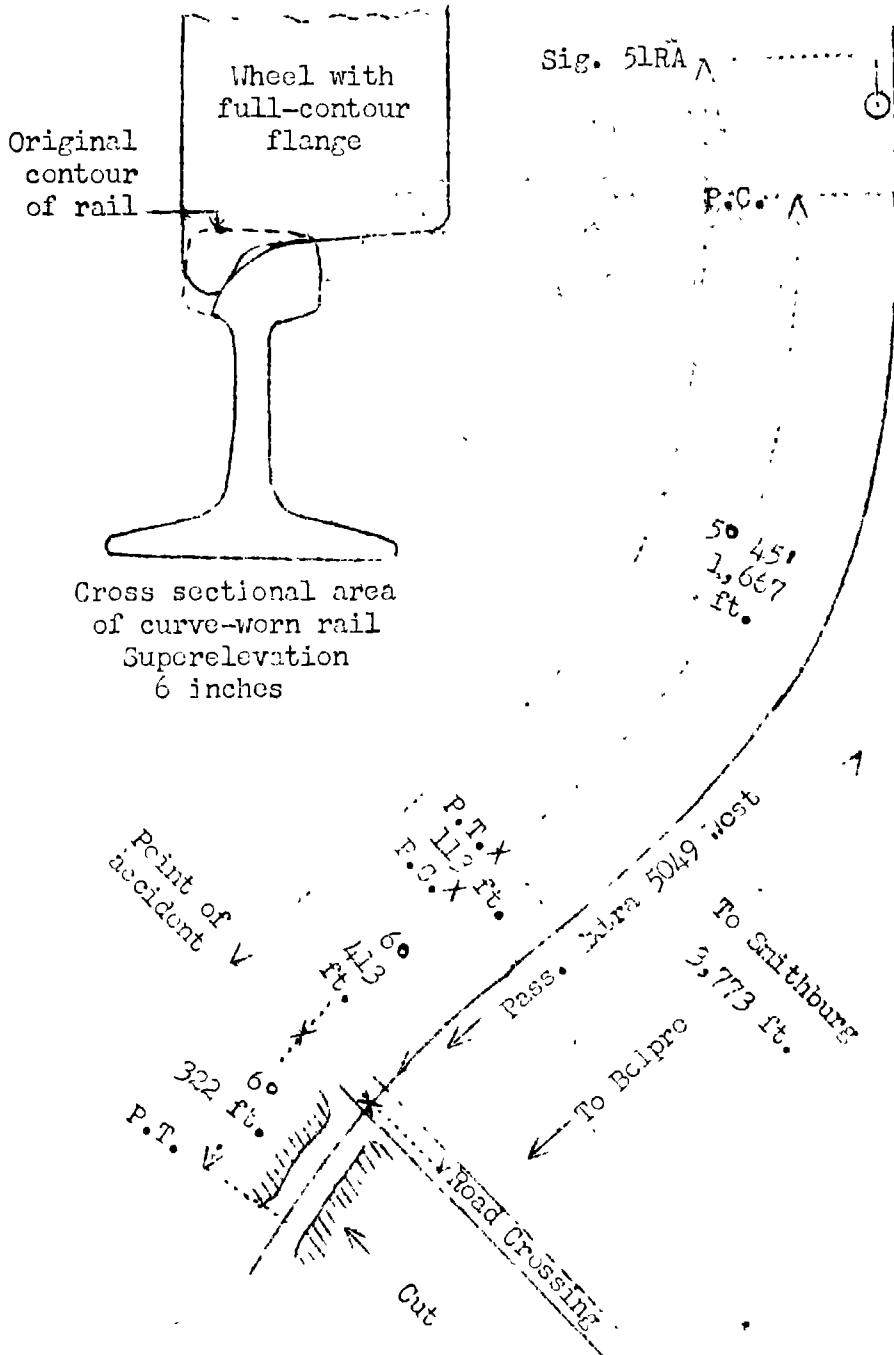
To East Grafton ↑

- East Grafton, W. Va. 2.2 mi.
- Grafton 46.8 mi.
- Smithburg, W. Va. 0.71 mi.
- X ( Point of accident ) 57.39 mi.
- Belpre, Ohio

Location of Accident and Method of Operation
