INVESTIGATION NO. 2485
THE BALTIMORE & OHIO RAILROAD COMPANY
REPORT IN RE ACCIDENT
AT TAKOMA PARK, D. C., ON
FEBRUARY 26, 1941.

Railroad: Baltimore & Ohio
Date: February 26, 1941
Location: Takoma Park, D. C.
Kind of accident: Rear-end collision
Trains involved: Freight : Freight
Train numbers: Extra 4804 : Extra 4444
Engine numbers: 4834 : 4444
Consist: 44 cars and : 53 cars and
caboose caboose
Speed: Standing : 5-10 m. p. h.
Operation: Automatic block-signal system
Track: Double; tangent; 0.78 percent
descending grade eastward
Weather: Clear
Time: About 2:55 p. m.
Casualties: 1 killed; 1 injured
Cause: Accident caused by failure to provide
adequate flag protection for preced-
ing train and by failure properly to
control speed of following train in
compliance with signal indications

Inv-2485
 B. & O. R. R.
 Takoma Park, D. C.
 February 26, 1941

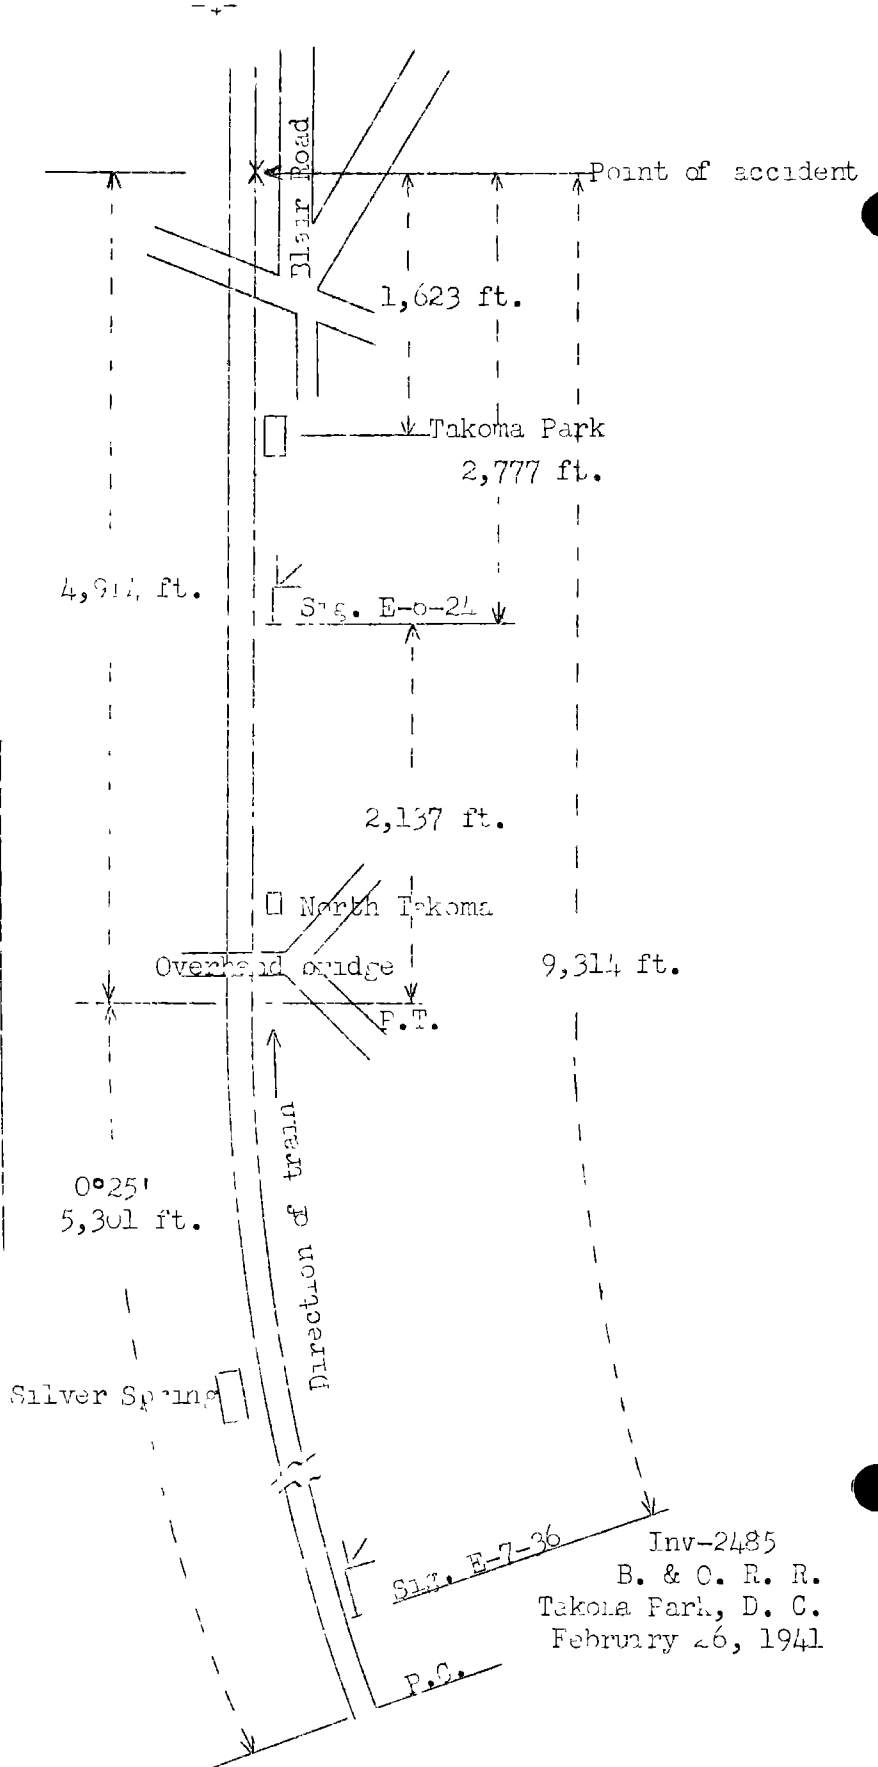
- o Washington, D. C. 0.2 mi.
- o Inwood 1,017 ft.
- X Point of accident 1,623 ft.
- o Takoma Park, D. C. 0.5 "
- o North Takoma, Md. 0.7 mi.
- o Silver Spring 31.3 mi.
- o Point of Decks 10.1 "
- o Overton, Md.

In the immediate vicinity of the point of accident the tracks are laid on a fill 20 feet in height. Blair Road parallels the tracks on the south at a distance of about 50 feet.
