ACCIDENT ON THE
BALTIMORE AND OHIO RAILROAD

TRENTON, OHIO

OCTOBER 31, 1938

INVESTIGATION NO. 2305

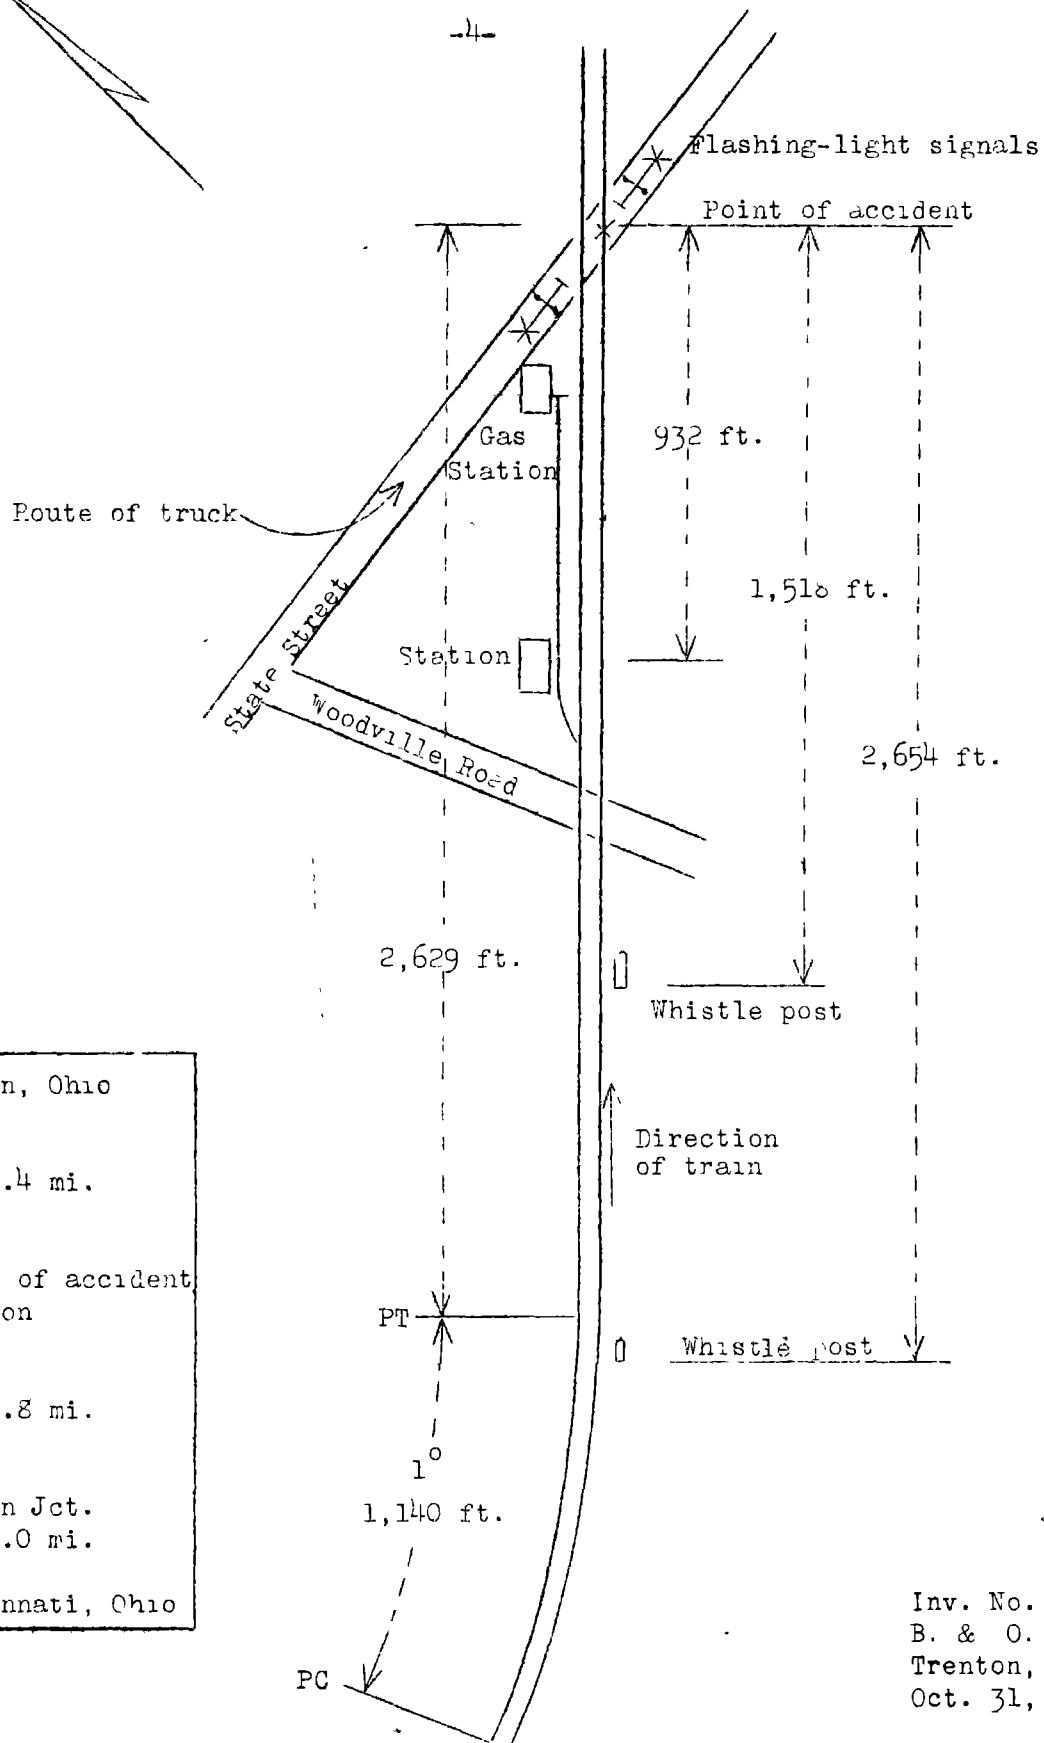
Inv. No. 2305
B. & O. R.R.
Trenton, Ohio
Oct. 31, 1938

o Dayton, Ohio	
	25.4 mi.
■ Point of accident	
o Trenton	
	26.8 mi.
o Winton Jct.	
	7.0 mi.
o Cincinnati, Ohio

The view of approaching north-bound trains had by the driver of an east-bound vehicle was obstructed by a building located 88 feet south of the center line of State Street and

32 feet west of the center line of the northward track. A greasing rack was located between the building and the tracks, and a telephone pole was located near the south curb 25 feet from the nearest rail; on clearing this pole, however, a clear view of the tracks southward could be had a distance of 3,330 feet; the range of vision then was gradually increased to a distance of 3,660 feet when a few feet from the southward track.
