REPORT NO. 3333

THE BALTIMORE AND OHIO RAILROAD COMPANY

NEAR WEST FARMINGTON, OHIO, ON

MAY 25, 1950

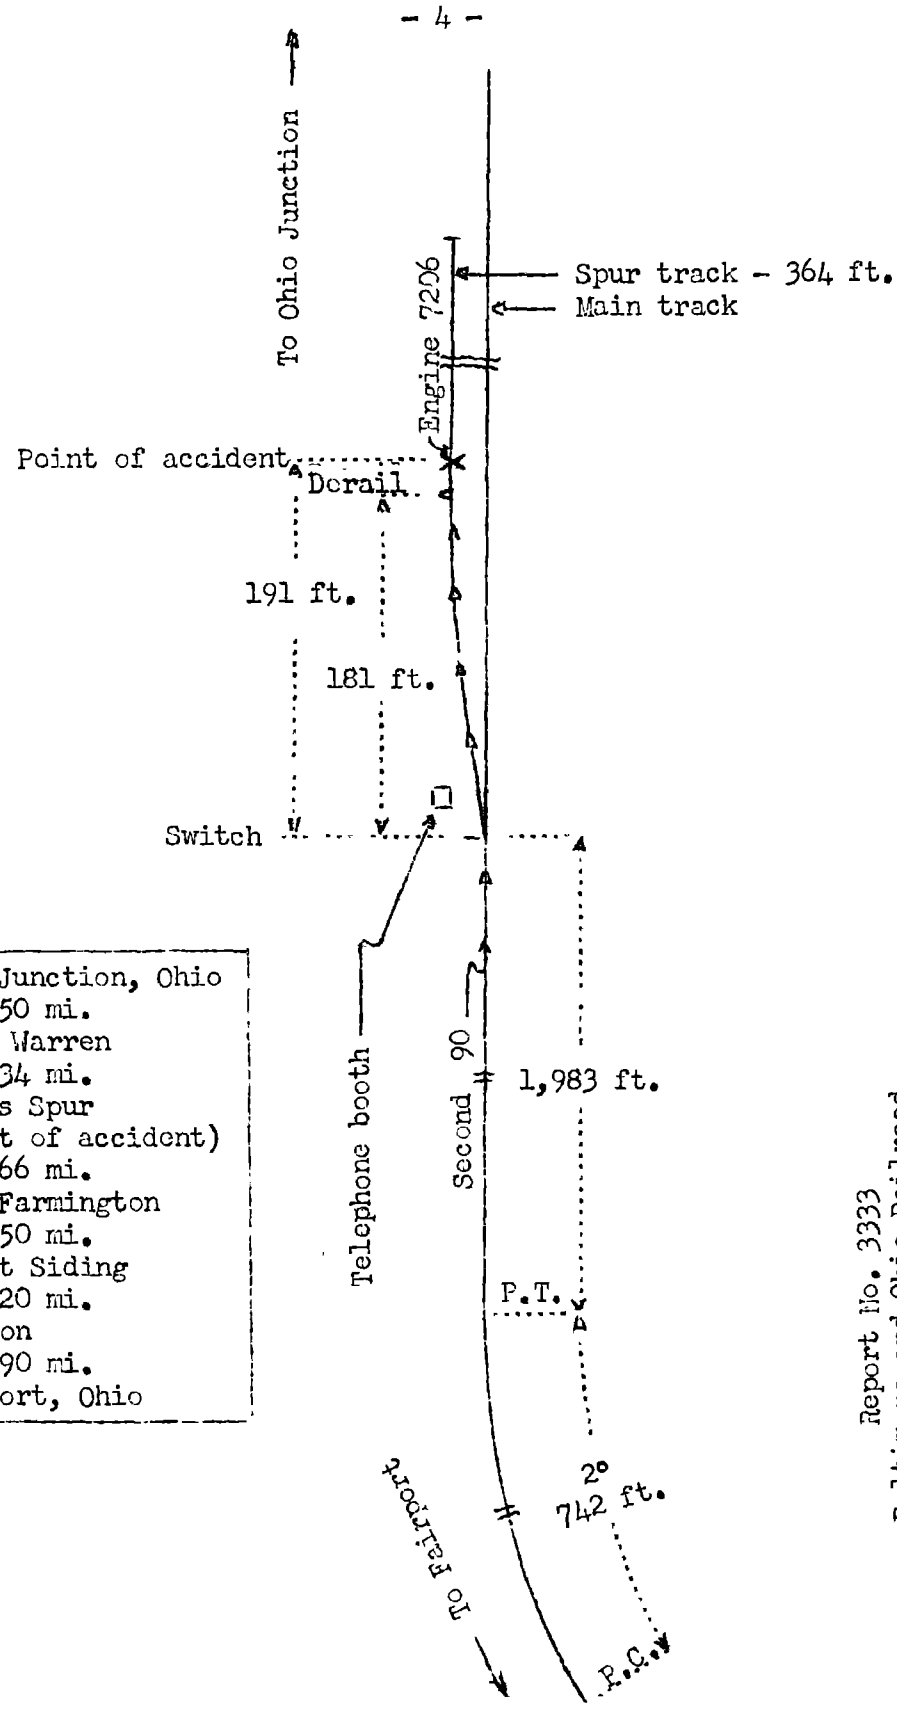
Report No. 3333  
 Baltimore and Ohio Railroad  
 West Farmington, Ohio  
 May 25, 1950

- o Ohio Junction, Ohio
- | 11.50 mi.
- o North Warren
- | 11.34 mi.
- X Failes Spur
- | (Point of accident)
- | 1.66 mi.
- o West Farmington
- | 6.50 mi.
- o Summit Siding
- | 14.20 mi.
- o Chardon
- | 13.90 mi.
- o Fairport, Ohio

Location of Accident and Method of Operation

This accident occurred on that part of the Akron Division extending between Fairport and Ohio Junction, Ohio, 59.1 miles. In the vicinity of the point of accident this is a single-track line, over which trains are operated by timetable and train orders, and a manual-block system for trains following passenger trains. At Failes Sour, 36.26 miles east of Fairport and 1.66 miles east of West Farmington, a spur track 364 feet in length parallels the main track on the north. The switch is facing-point for east-bound trains. The accident occurred on the spur track at a point 191 feet east of the switch. From the west on the main track there is a 2° curve to the right 742 feet in length, and then a tangent 1,983 feet to the spur-track switch and a considerable distance eastward. The grade is 0.15 percent descending eastward at the point of accident.
