INVESTIGATION NO. 2877  
BANGOR AND AROOSTOCK RAILROAD COMPANY  
REPORT IN RE ACCIDENT  
NEAR INGALLS, MAINE, ON  
MARCH 23, 1945

Accident near Ingalls, Maine, on March 23, 1945, caused  
by failure to obey a meet order.

Inv. No. 2877  
 Bangor and Aroostook Railroad  
 Ingalls, Maine  
 March 23, 1945

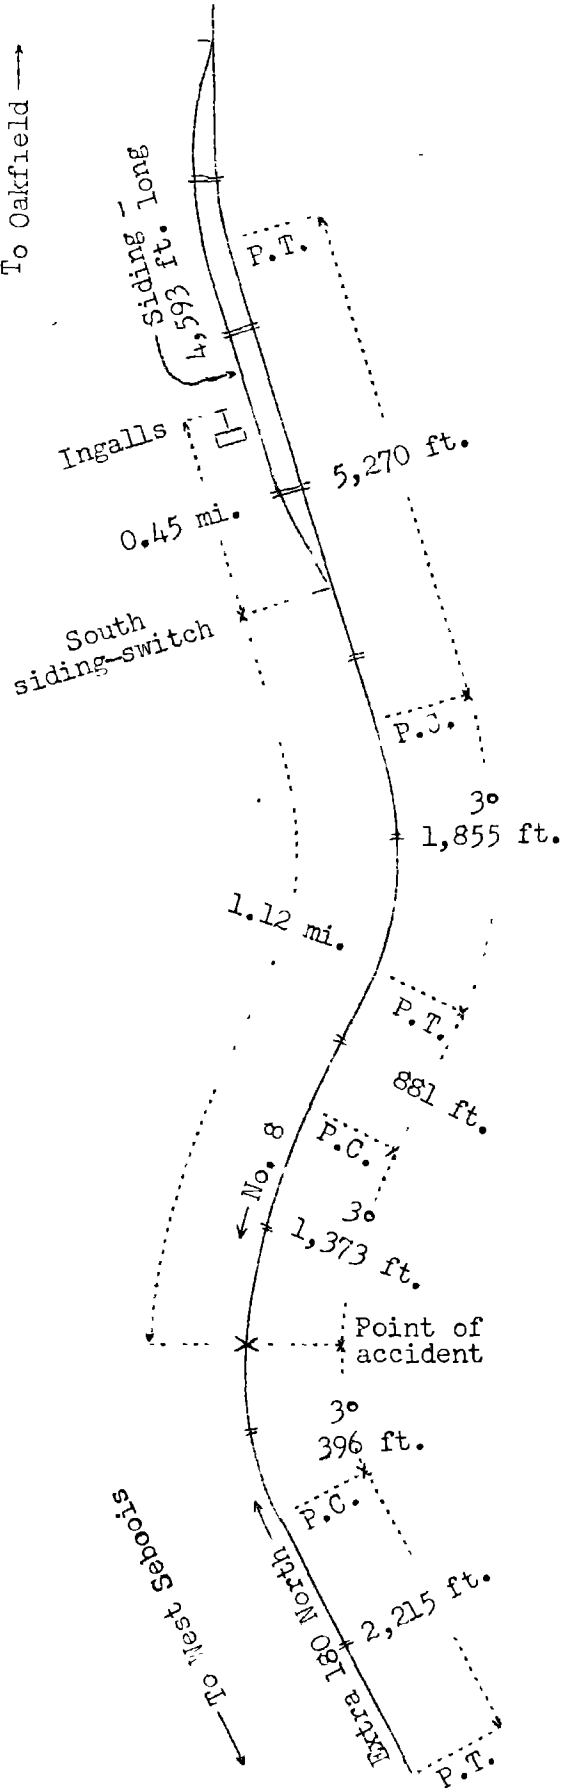
○	Oakfield, Maine
	18.60 mi.
○	Patten Jct.
	1.10 mi.
○	Sherman
	24.00 mi.
○	Millinocket
	9.00 mi.
○	Ingalls
	1.57 mi.
X	Point of accident
	3.53 mi.
○	West Sebois, Maine
