INTERSTATE COMMERCE COMMISSION

REPORT OF THE DIRECTOR OF THE BUREAU OF SAFETY CONCERNING AN
ACCIDENT ON THE BANGOR AND AROOSTOOK RAILROAD NEAR
STATE ROAD, ME., ON FEBRUARY 25, 1934.

April 28, 1934.

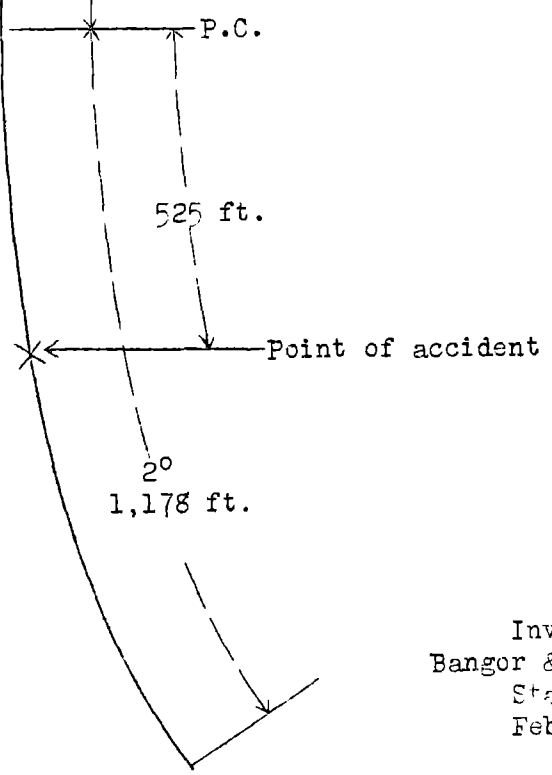
Inv. No. 1895
 Bangor & Aroostook R.R.
 State Road, Me.
 Feb. 25, 1934

●	Stockholm, Maine
	26.5 miles
●	State Road
	1.2 miles
×	Point of accident
	20.1 miles
●	Squa Pan, Maine

The snow plow was thrown to the left of the track, turned completely around, and stopped close to the east rail. The engine was partly overturned and stopped about 15 feet from and practically in line with the track, about three car lengths south of the plow; its left side was badly damaged. The tender remained coupled and at right angles to the engine with its rear truck on the roadbed. The first three cars and the front truck of the fourth car were derailed; these cars remained upright, having been driven into a high bank of snow on the west side of the track. The employee killed was the engineman and those injured were the two brakemen.
