REPORT OF THE DIRECTOR  
BUREAU OF SAFETY

ACCIDENT ON THE  
BOSTON AND MAINE RAILROAD

CHARLEMONT, MASS.

INVESTIGATION NO. 2307

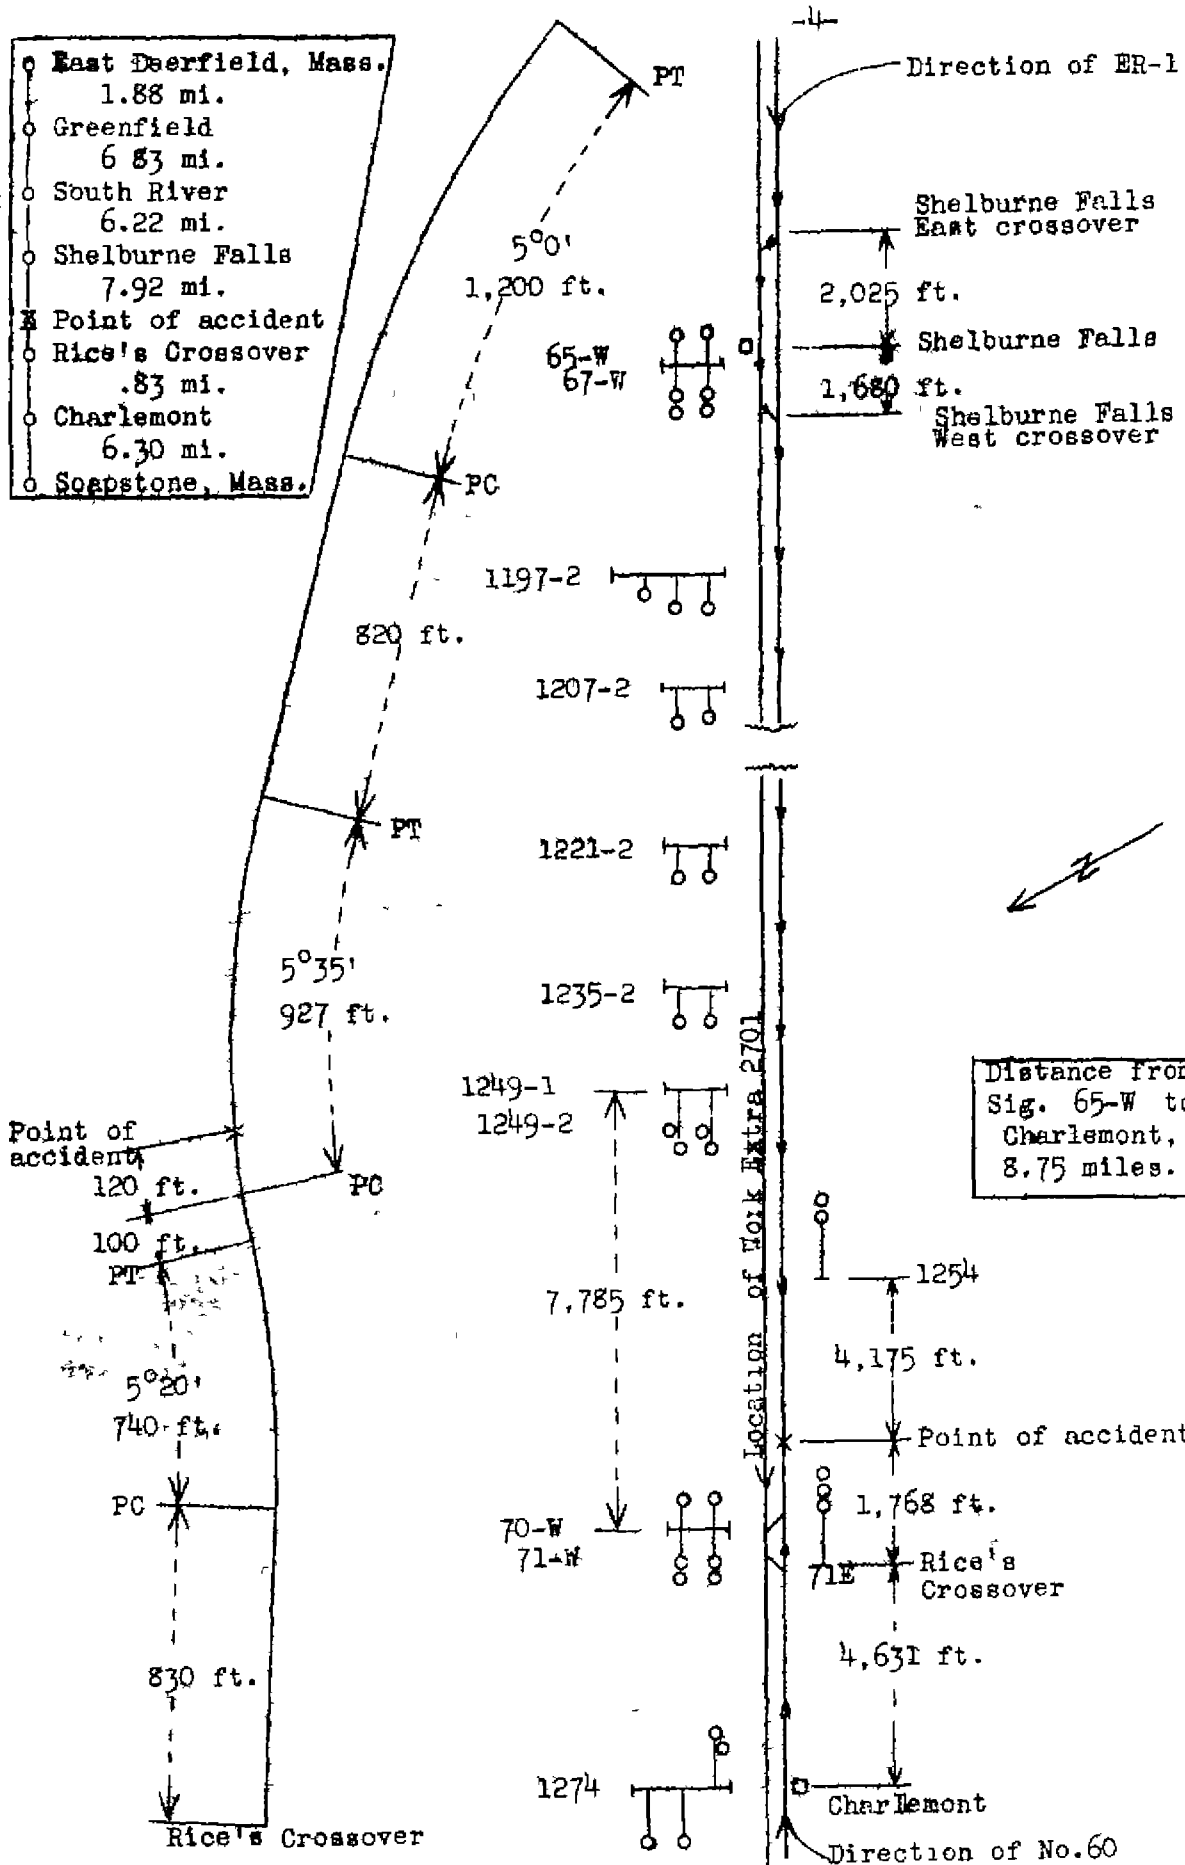
Inv. No. 2307  
 Boston & Maine R.R.  
 Charlemont, Mass.  
 November 7, 1938.

- East Deerfield, Mass. 1.88 mi.
- Greenfield 6.83 mi.
- South River 6.22 mi.
- Shelburne Falls 7.92 mi.
- ✕ Point of accident
- Rice's Crossover .83 mi.
- Charlemont 6.30 mi.
- Soapstone, Mass.

This accident occurred on that part of the Fitchburg Division which extends between Greenfield and Soapstone, Mass., a distance of approximately 29 miles. This is a double-track line over which trains are operated by a centralized-traffic-control system, in parts of this territory movements in either direction on both tracks being governed by signal indications. Shelburne Falls is located approximately 13 miles west of Greenfield. There is a trailing-point cross-over for westward trains, known as Shelburne Falls East, located 2,025 feet east of Shelburne Falls, and a facing-point cross-over for westward trains on the westward track, known as Shelburne Falls West, located 1,680 feet west of Shelburne Falls. At Rice's Crossover, 7.92 miles west of Shelburne Falls and 0.83 mile east of Charlemont, there are facing and trailing-point cross-overs.
