REPORT NO. 1942

Railroad: Boston & Maine
Date: November 5, 1934.
Location: Clinton, Mass.
Kind of accident: Side collision.
Trains involved: Light engine and freight train.
Casualties: 4 killed; 1 injured.
Cause of accident: Light engine fouled main track directly
in front of approaching freight train.

REPORT OF THE DIRECTOR OF THE BUREAU OF SAFETY CONCERNING
AN ACCIDENT ON THE BOSTON & MAINE RAILROAD AT CLINTON,
MASS., ON NOVEMBER 5, 1934.

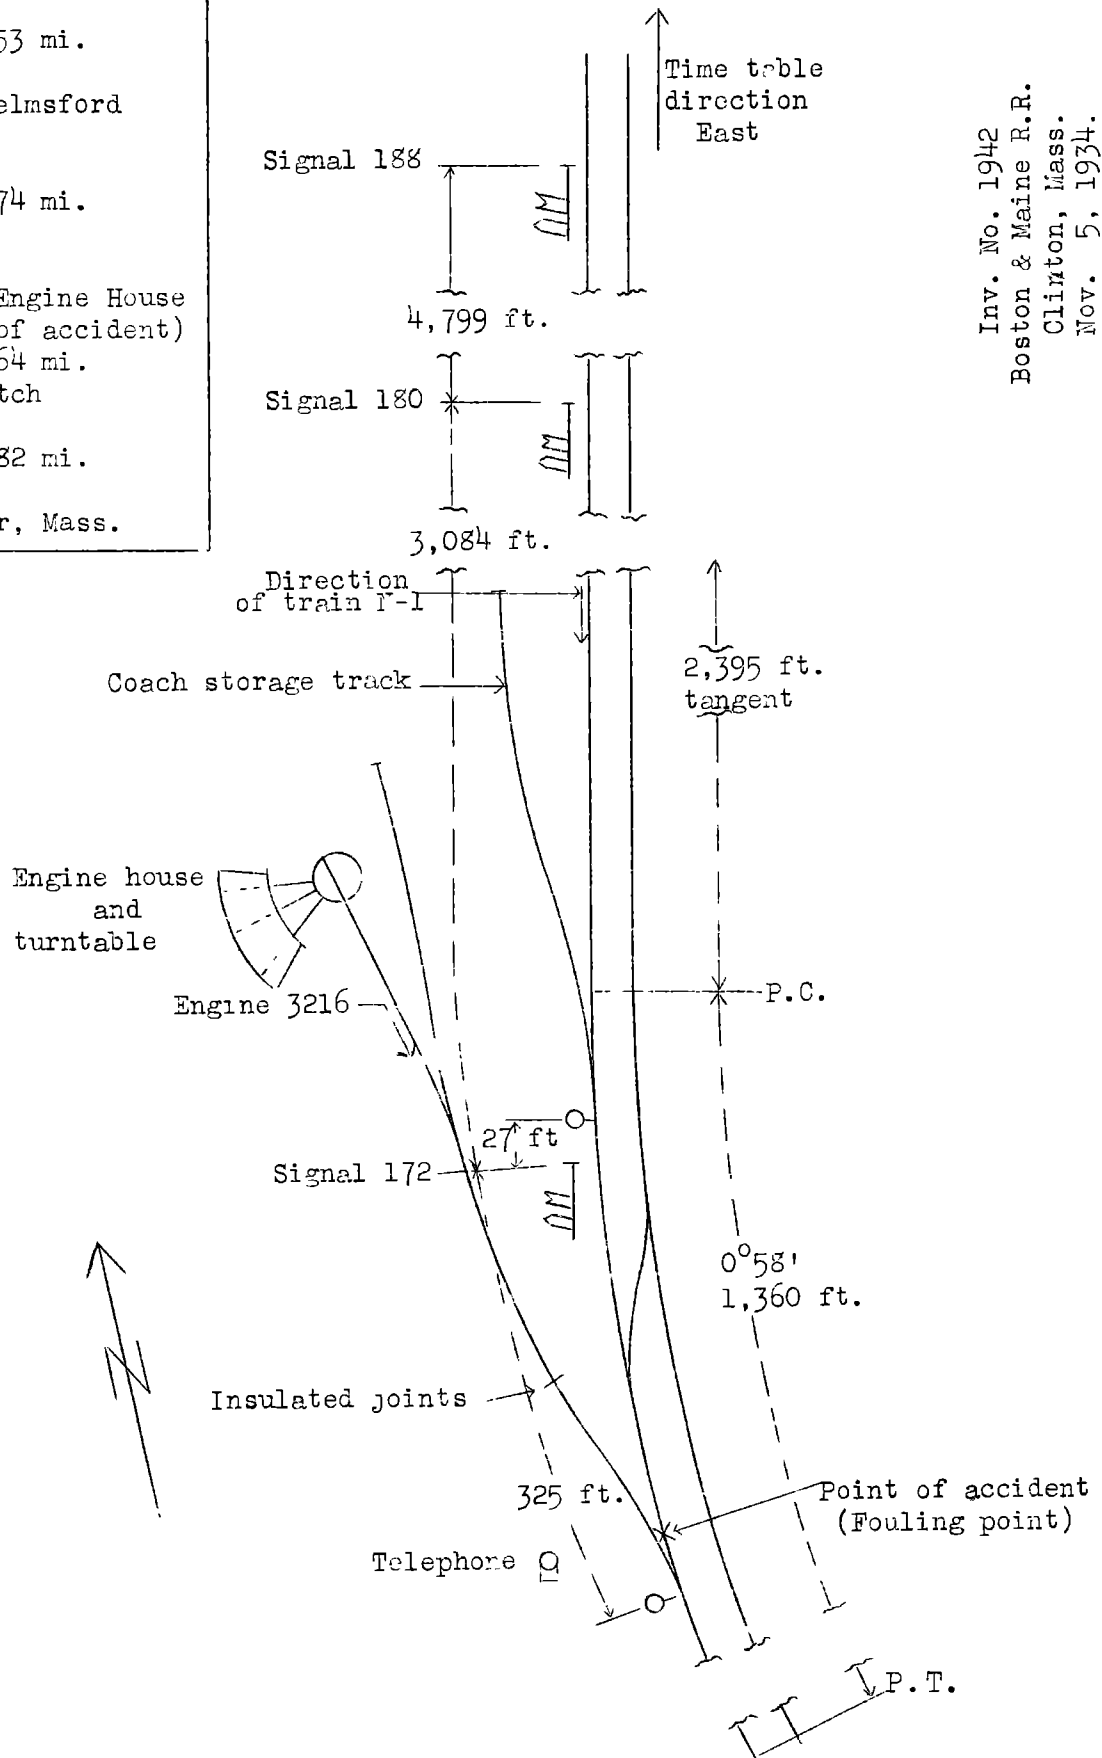
Inv. No. 1942
Boston & Maine R.R.
Clinton, Mass.
Nov. 5, 1934.

• Lowell Jct., Mass.
11.53 mi.
• North Chelmsford
23.74 mi.
✕ Clinton Engine House (Point of accident)
1.64 mi.
• East switch
15.82 mi.
• Worcester, Mass.

The signals involved are automatic block signals 172, 180, and 188, located 325 feet, 3,409 feet, and 8,203 feet, respectively, east of the engine-house track switch; these signals are of the 2-arm, 2-position, lower-quadrant, semaphore type. Signal 172 is situated between the engine-house track switch and the coach-storage track switch, 27 feet west of the latter switch, these switches being trailing-point switches for west-bound trains. The switch stands are of the Ramapo high type and are located on the engineman's side of a west-bound train; they are equipped with switch lamps, night indications being green when the switch is closed, and red when open. When the coach-storage track switch is opened it causes signal 180 to assume the stop position and signal 188 the caution position, and when an engine passes the insulated joints on the engine-house track, 176 feet from the switch points, it causes signal 172 to assume the stop position and signal 180 the caution position.
