REPORT NO. 3653
BOSTON AND MAINE RAILROAD
IN RE ACCIDENT
AT LOWELL, MASS., ON
AUGUST 23, 1955

Accident at Lowell, Mass., on August 23, 1955, caused by a broken tank-car underframe, and by the dislodged car body and a portion of the underframe obstructing an adjacent main track in front of an approaching train.

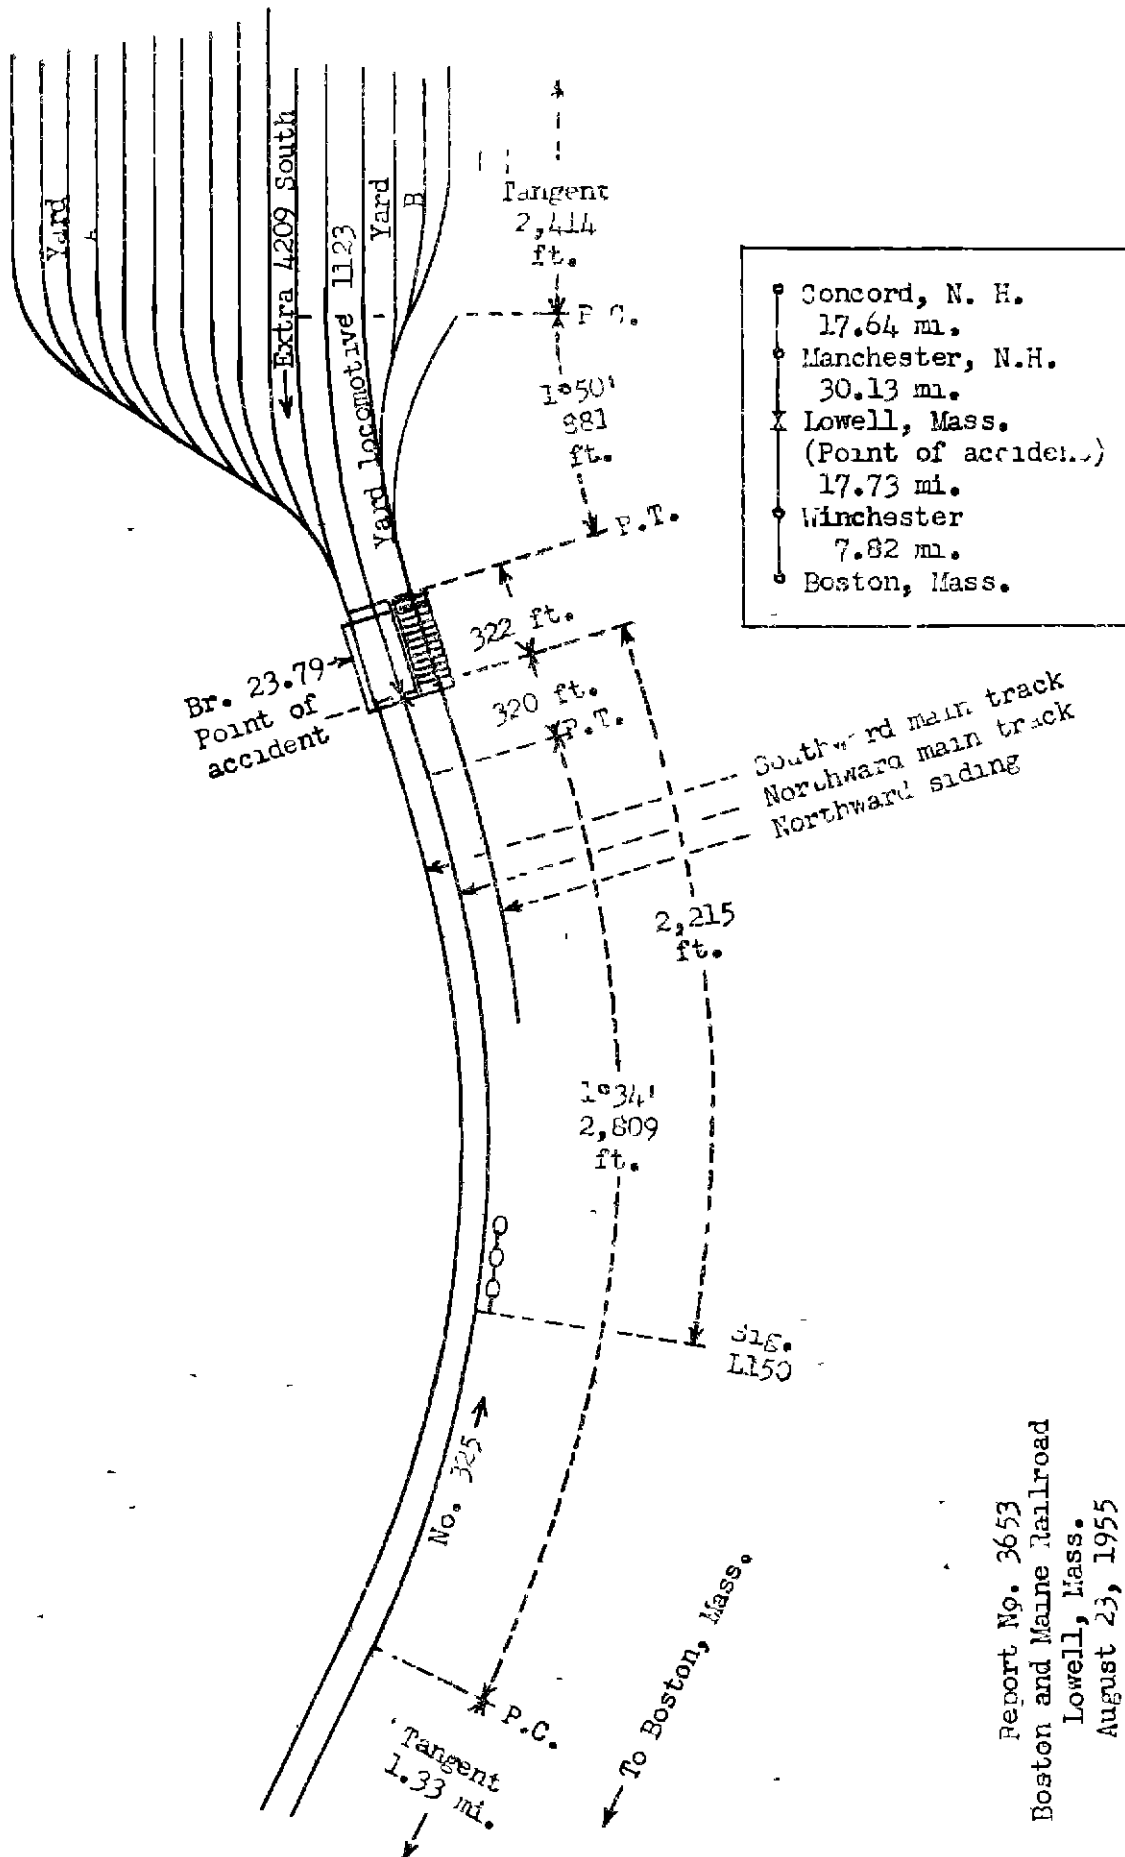
Report No. 3653
 Boston and Maine Railroad
 Lowell, Mass.
 August 23, 1955

Location of Accident and Method of Operation
