RAILROAD ACCIDENT INVESTIGATION

Report No 4025

CALIFORNIA WESTERN RAILROAD

CAMP THREE, CALIFORNIA

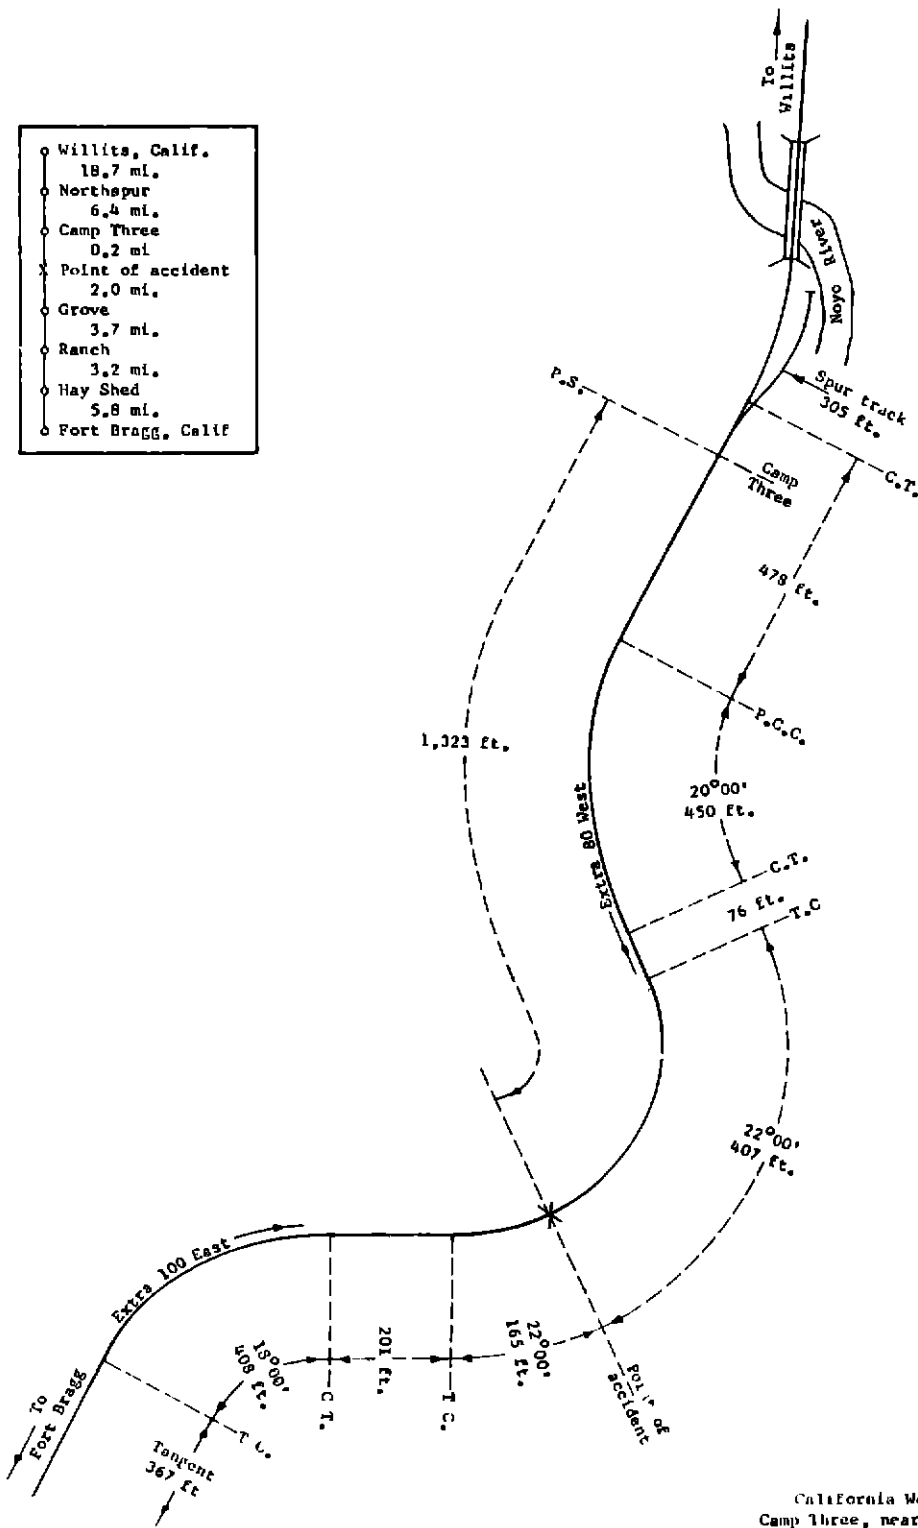
California Western Railroad
 Camp Three, near Fort Bragg, Calif.
 September 26, 1964

- Willits, Calif. 18.7 mi.
- Northspur 6.4 mi.
- Camp Three 0.2 mi
- ✕ Point of accident 2.0 mi.
- Grove 3.7 mi.
- Ranch 3.2 mi.
- Hay Shed 5.8 mi.
- Fort Bragg, Calif

The collision occurred on the main track 1,323 feet west of the spur-track switch at Camp Three.
