REPORT NO. 3439
THE CANADIAN NATIONAL RAILWAY COMPANY
IN RE ACCIDENT
AT SWIFT, MINN., ON
NOVEMBER 17, 1951

Accident at Swift, Minn., on November 17, 1951, caused by
failure to obey a meet order.

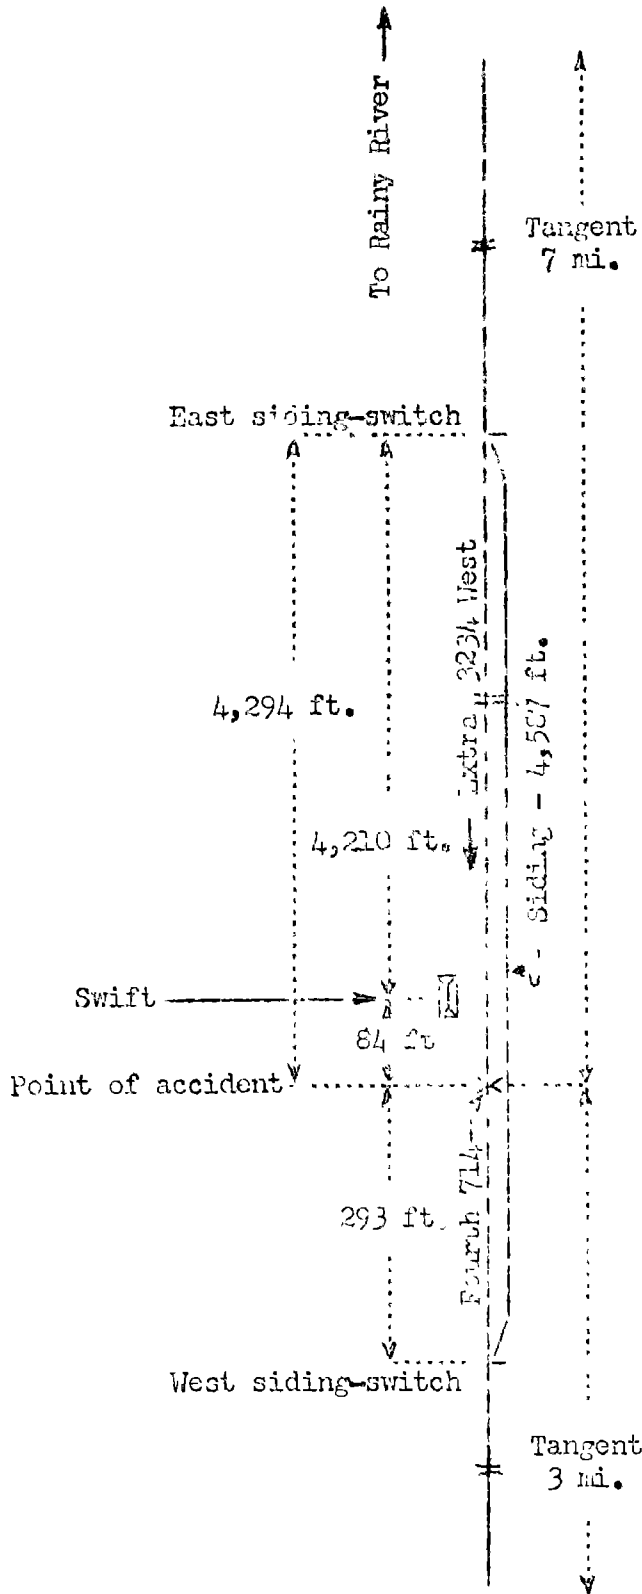
| o | Rainy River, | Ontario, Canada |
| | 1.6 mi. | |
| o | Baudette, Minn. | 30.4 mi. |
| X | (Point of accident) | |
| | Swift | 6.0 mi. |
| o | Warroad, Minn. | 19.6 mi. |
| o | Sprague, | Manitoba, Canada |
| | 90.3 mi. | |
| o | Paddington, | Manitoba, Canada |

Report No. 3439
 Canadian National Railway
 Swift, Minn.
 November 17, 1951
