INVESTIGATION NO. 3166
CAROLINA AND NORTHWESTERN RAILWAY COMPANY
REPORT IN RE ACCIDENT
NEAR HUDSON, N. C., ON
FEBRUARY 17, 1943

Accident near Hudson, N. C., on February 17, 1948,
caused by a broken rail.

Inv. No. 3166
 Carolina and Northwestern Railway
 Hudson, N. C.
 February 17, 1948

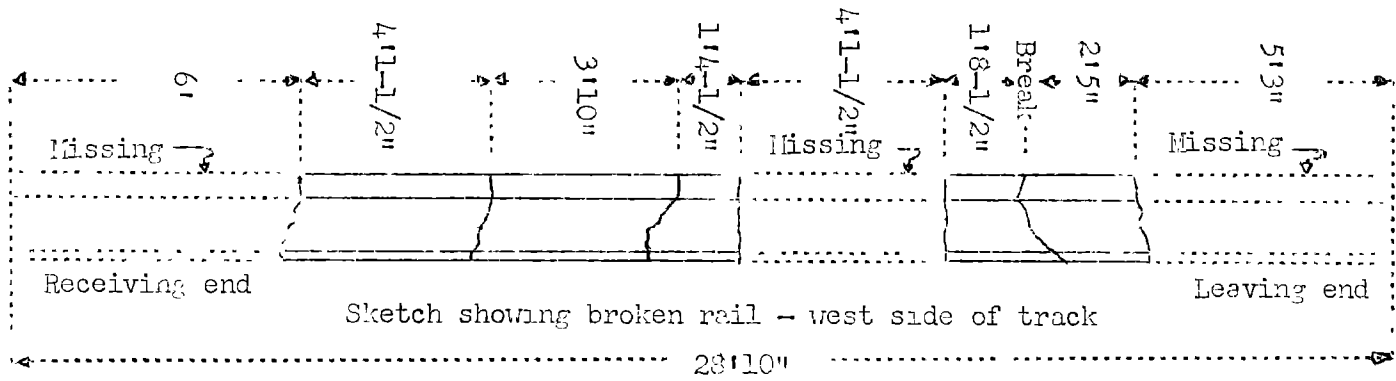
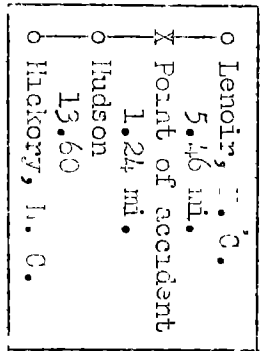
Location of Accident and Method of Operation

After the accident five pieces of a broken rail were recovered from the debris of the wreckage and the collapsed bridge. The total length of these pieces was 13 feet 5-1/2 inches. The remaining 15 feet 4-1/8 inches of this rail was not recovered. The breaks were new, and there was no indication of defective metal at the location of these breaks. There were heavy batter marks at the receiving ends of two of the breaks, but none on the leaving end of either break. Marks on the left front engine-truck wheel of the second engine of Extra 440-546 North indicate that it had been in contact with the end of a broken rail and that this wheel was the first to become derailed. Evidently, the first break occurred in that portion of the rail that was not recovered. Apparently, the failure of the rail at the first break occurred some time prior to the derailment, but the broken piece remained in normal alignment until the left rear tender-truck wheel of the first engine passed over it, then the second break occurred and this piece of rail became displaced and the derailment of the second engine followed. The remainder of the breaks in the rail occurred immediately after the first wheel became derailed. Marks on the bridge ties, on the west girder of the 26-foot span at the north end of the bridge, on the pilot of the second engine and on the strap bolts at the back end of the left main rod of this engine indicate that when the left engine-truck wheel was derailed bridge ties were shoved forward by the engine pilot, then the left 26-foot girder was displaced outwardly and the collapse of the bridge occurred as the engine overturned.
