ACCIDENT ON THE  
CENTRAL OF GEORGIA RAILWAY

OGELECHEE, GA.

JULY 23, 1936

INVESTIGATION NO. 2086

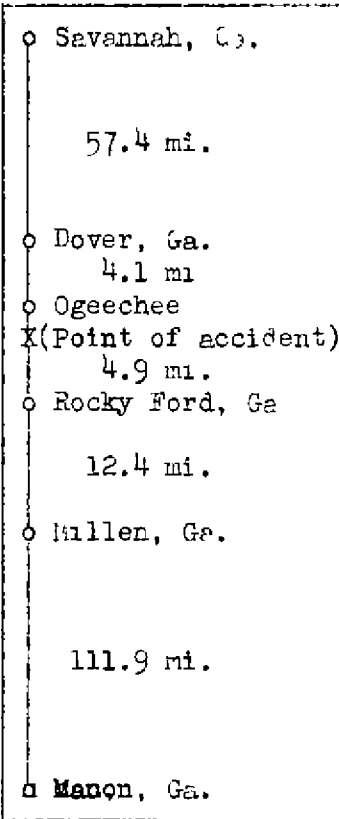
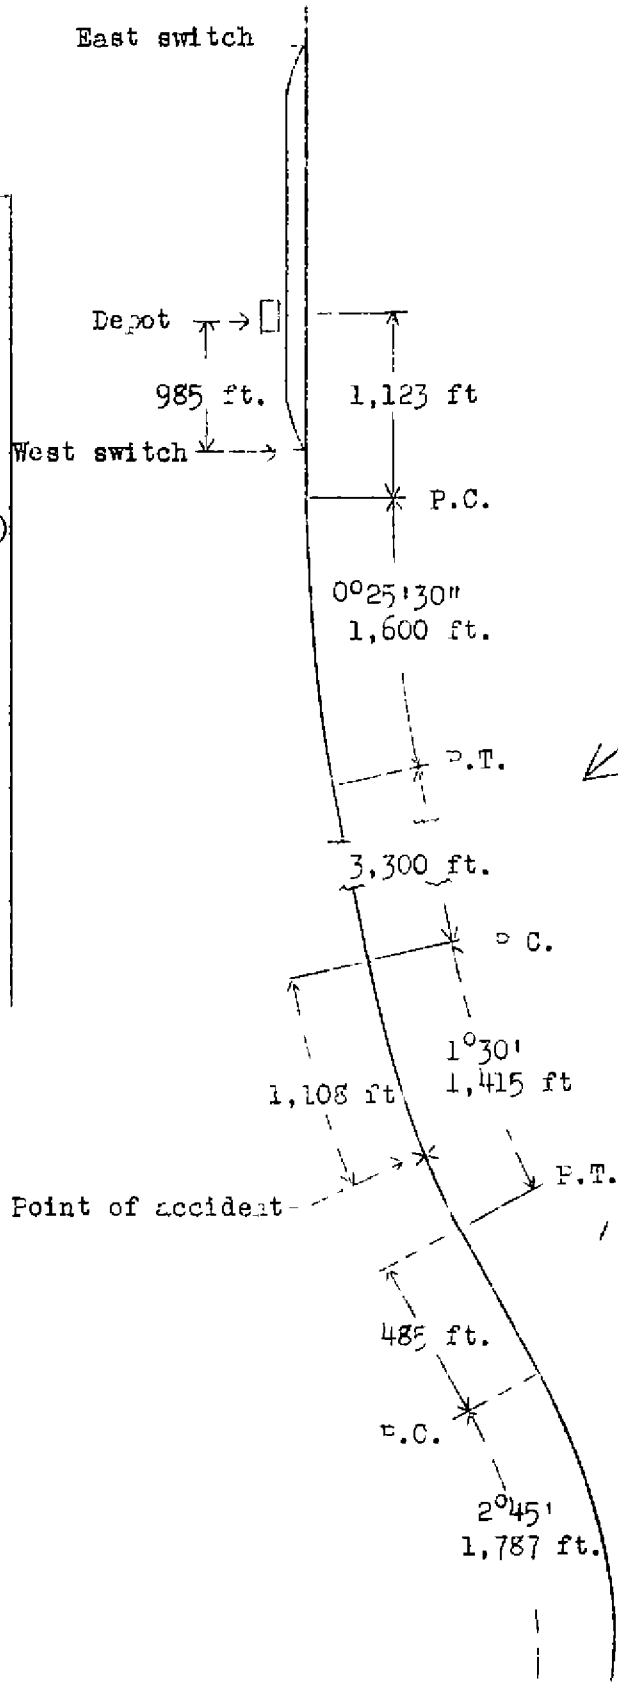
Inv. No. 2086  
Central of Georgia Ry.,  
Ogeechee, Ga.  
July 23, 1936

Owing to the track curvature and trees along the right-of-way, the view of the point of accident is restricted to about 500 feet from the fireman's side of a west-bound engine, and to about the same distance from the engineman's side of an east-bound engine.

This accident occurred on the Savannah District of the Savannah Division, extending between Savannah and Macon, Ga., a distance of 190.7 miles, in the vicinity of the point of accident this is a single-track line over which trains are operated by timetable and train orders, no block-signal system being in use. The accident occurred at a point approximately 1.35 miles west of the depot at Ogeechee, approaching this point from the east, beginning at the depot, the track is tangent for a distance of 1,123 feet, then there is a  $0^{\circ}25'30''$  curve to the left 1,600 feet in length, 3,300 feet of tangent, followed by a  $1^{\circ}30'$  curve to the left 1,415 feet in length, the accident occurring on this last mentioned curve at a point 1,108 feet from its eastern end. Approaching from the west there is a  $2^{\circ}45'$  curve to the left 1,787 feet in length and then 485 feet of tangent, followed by the curve on which the accident occurred. The grade in this vicinity is ascending for west-bound trains, being 0.56 percent at the point of accident, at which point the track is on a fill between two cuts, the fill is about 250 feet in length and has a maximum depth of about 11 feet, while the cut west of the fill is about 600 feet in length with a maximum depth of about 6 feet, and the cut east of the fill is about 350 feet in length with a maximum depth of about 7 feet.
