REPORT OF THE DIRECTOR
BUREAU OF SAFETY

ACCIDENT ON THE
CENTRAL OF GEORGIA RAILWAY

SARGENT, GA.

INVESTIGATION NO. 2328

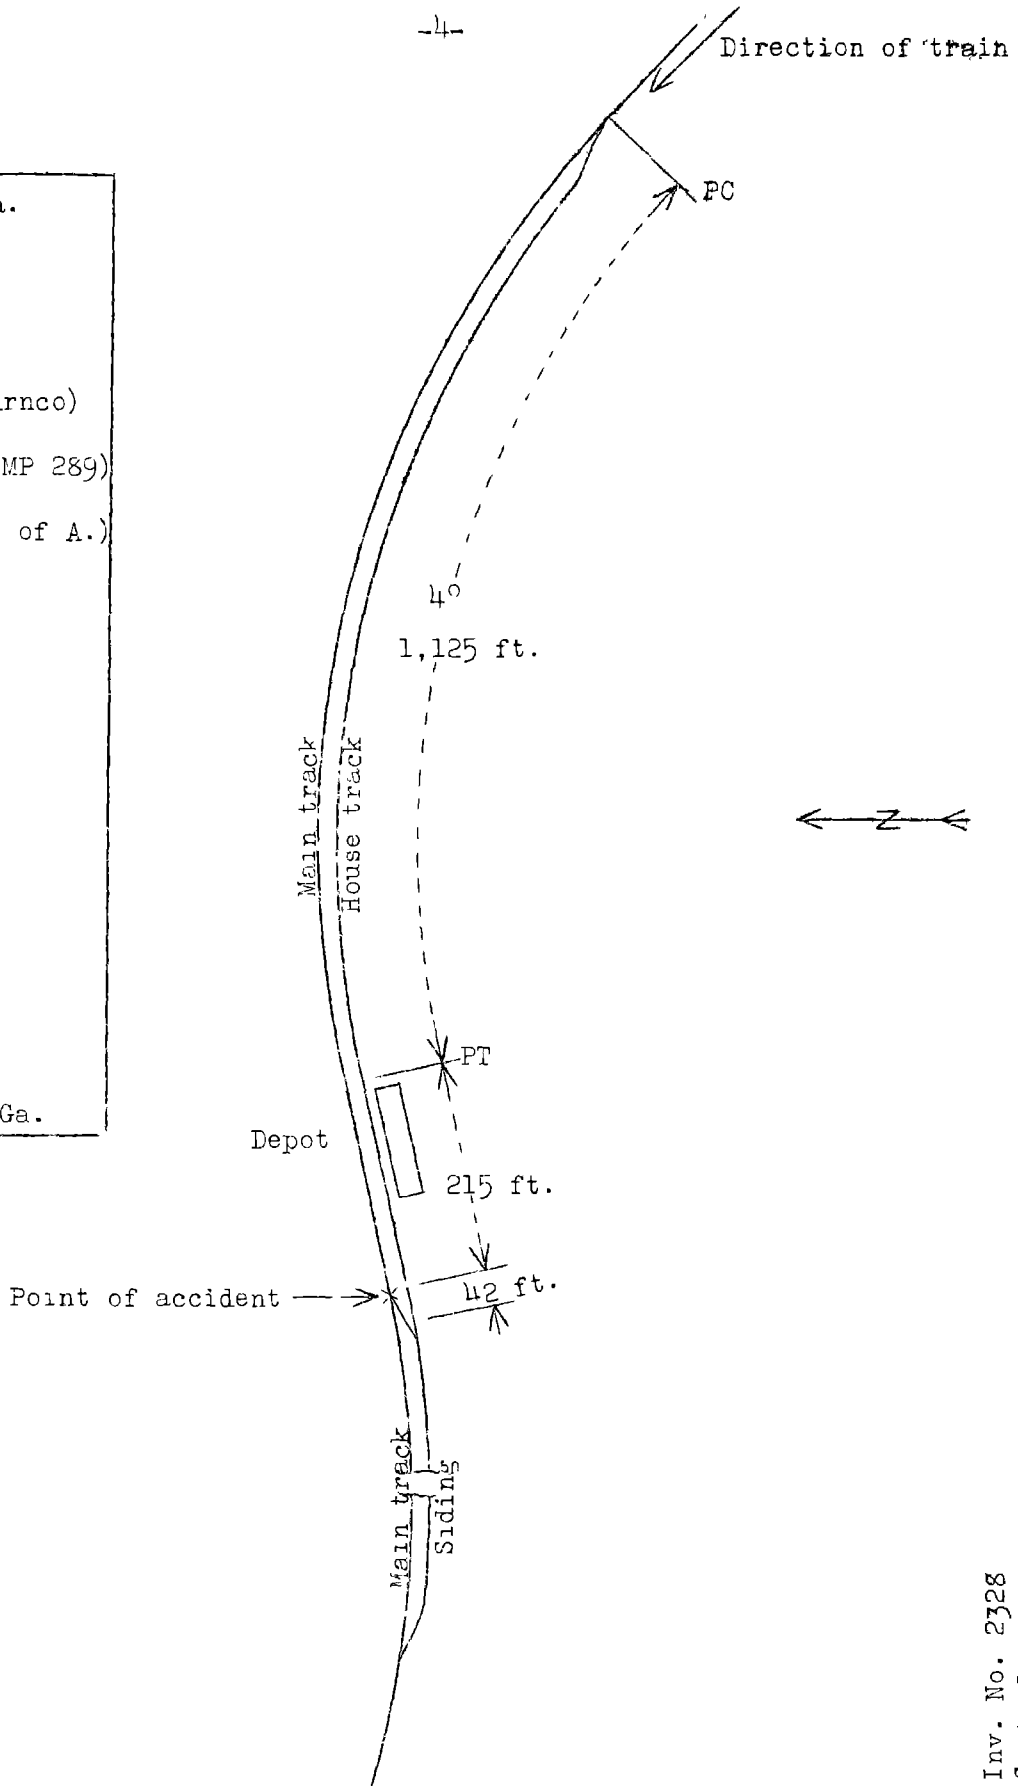
Inv. No. 2328
 Central of Georgia Ry.
 Sargent, Ga.
 February 7, 1939

○	Griffin, Ga.	29.4 mi.
○	Raymond	5.7 mi.
○	Newnan	1.5 mi.
○	W. Newnan (Arnco)	1.3 mi.
○	Gloverton (MP 289)	3.4 mi.
○	Sargent (P. of A.)	5.2 mi.
○	Whitesburg	7.2 mi.
○	Clem	5.6 mi.
○	Carrollton	8.3 mi.
○	Bowden Jct.	4.7 mi.
○	Bremen	7.8 mi.
○	Buchanan	6.0 mi.
○	Tallapoosa	3.6 mi.
○	Dugdown	11.4 mi.
○	Cedartown, Ga.

This accident occurred on that part of the Columbus Division designated as the Cedartown District which extends between Griffin and Cedartown, Ga., a distance of 101 miles. This is a single-track line over which trains are operated by timetable and train orders, no block-signal system being in use.
