REPORT OF THE DIRECTOR
BUREAU OF SAFETY

ACCIDENT ON THE
CENTRAL OF GEORGIA RAILWAY

STURDIVANT, ALA.

MARCH 2, 1940

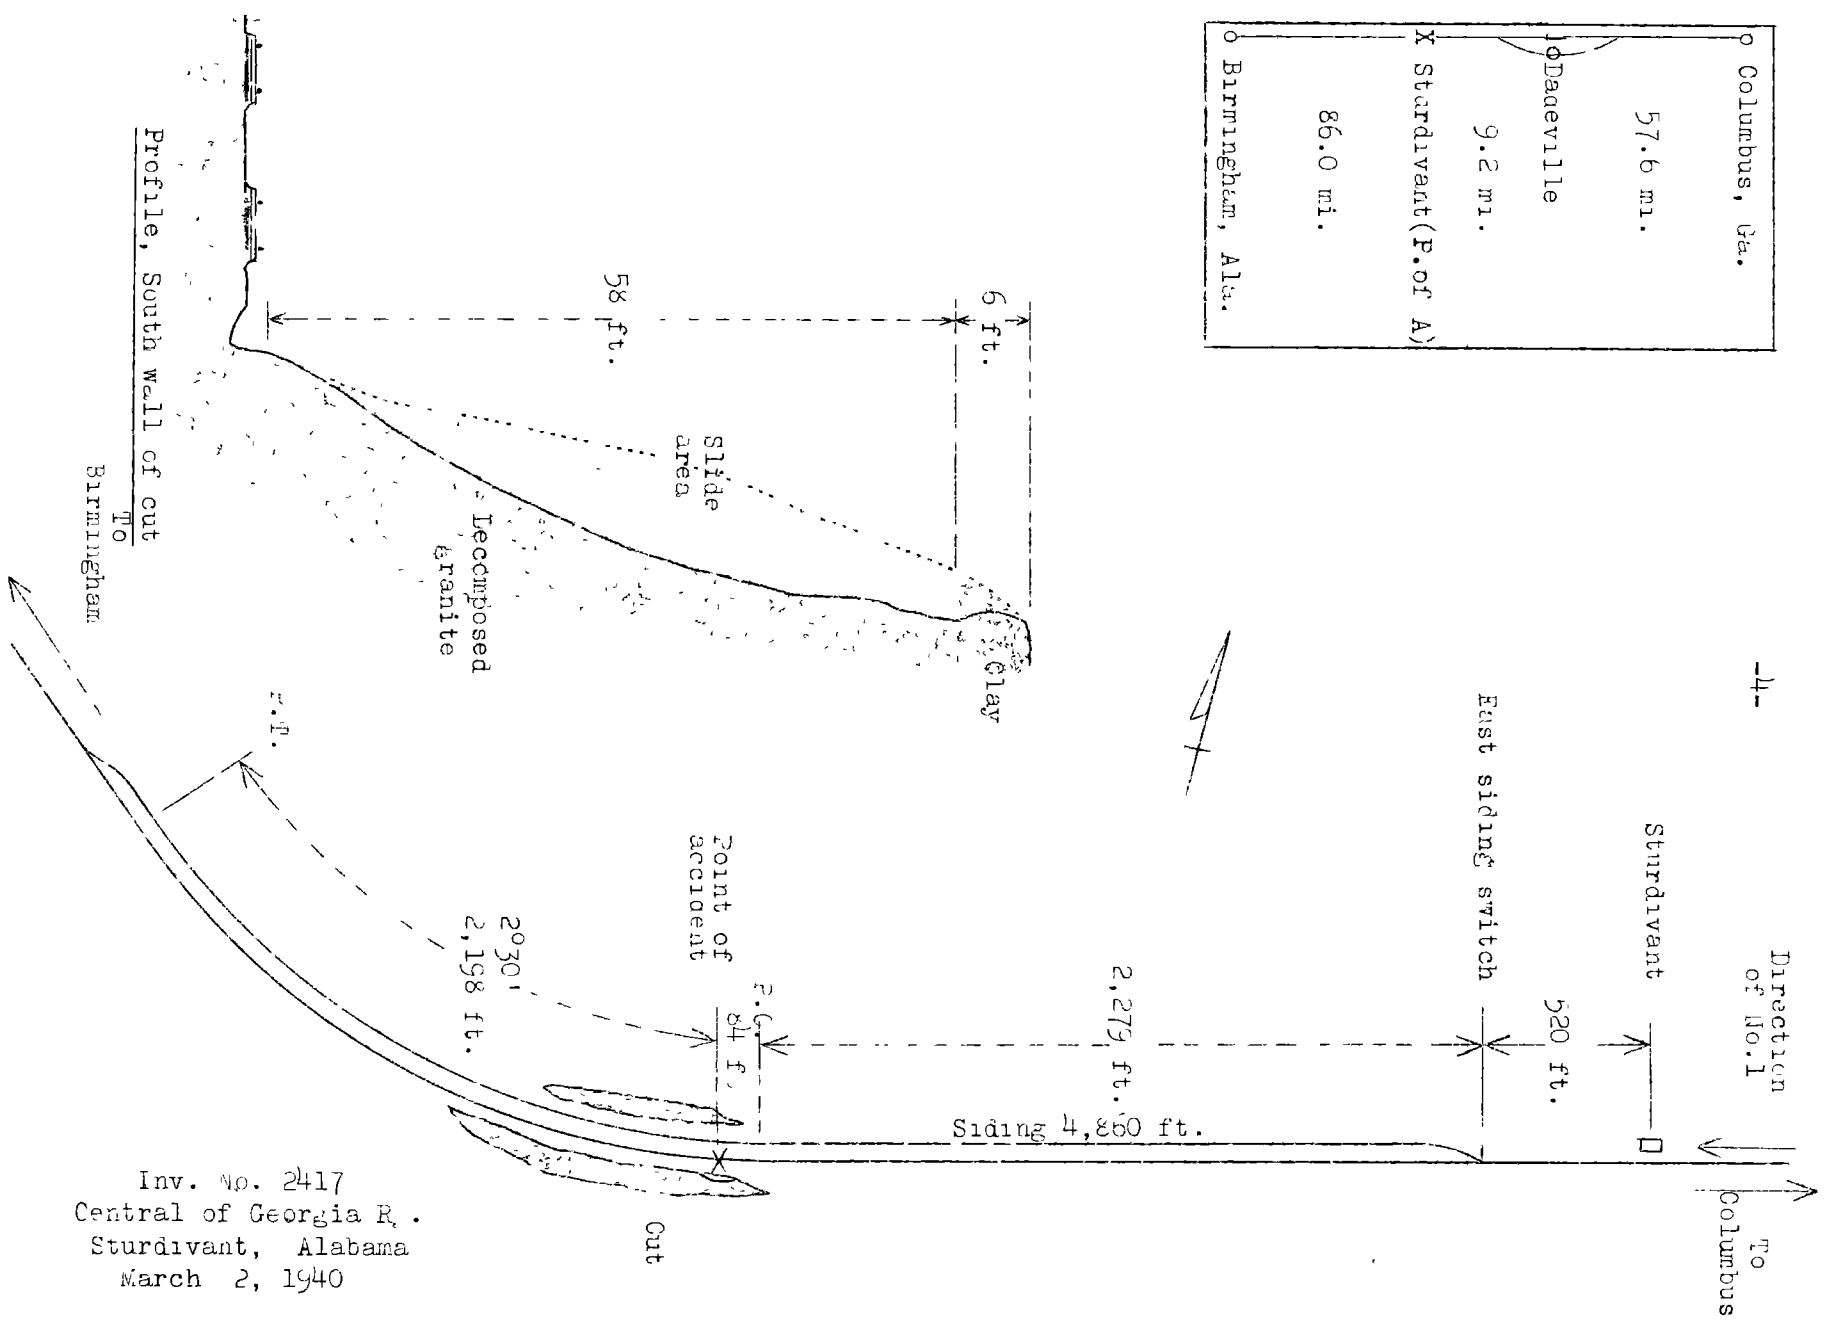
o Columbus, Ga.	57.6 mi.
o Daaverville	9.2 mi.
X Sturdivant (P. of A)	86.0 mi.
o Birmingham, Ala.
