INVESTIGATION NO. 2677
THE CENTRAL RAILROAD COMPANY OF NEW JERSEY
REPORT IN RE ACCIDENT
AT HIGH BRIDGE, N. J., ON
FEBRUARY 10, 1943

Accident at High Bridge, N. J., on February 16, 1943, caused
by a damaged switch as a result of dragging equipment
under a preceding train.

Inv-2677
 Central Railroad of New Jersey
 High Bridge, N. J.
 February 16, 1943

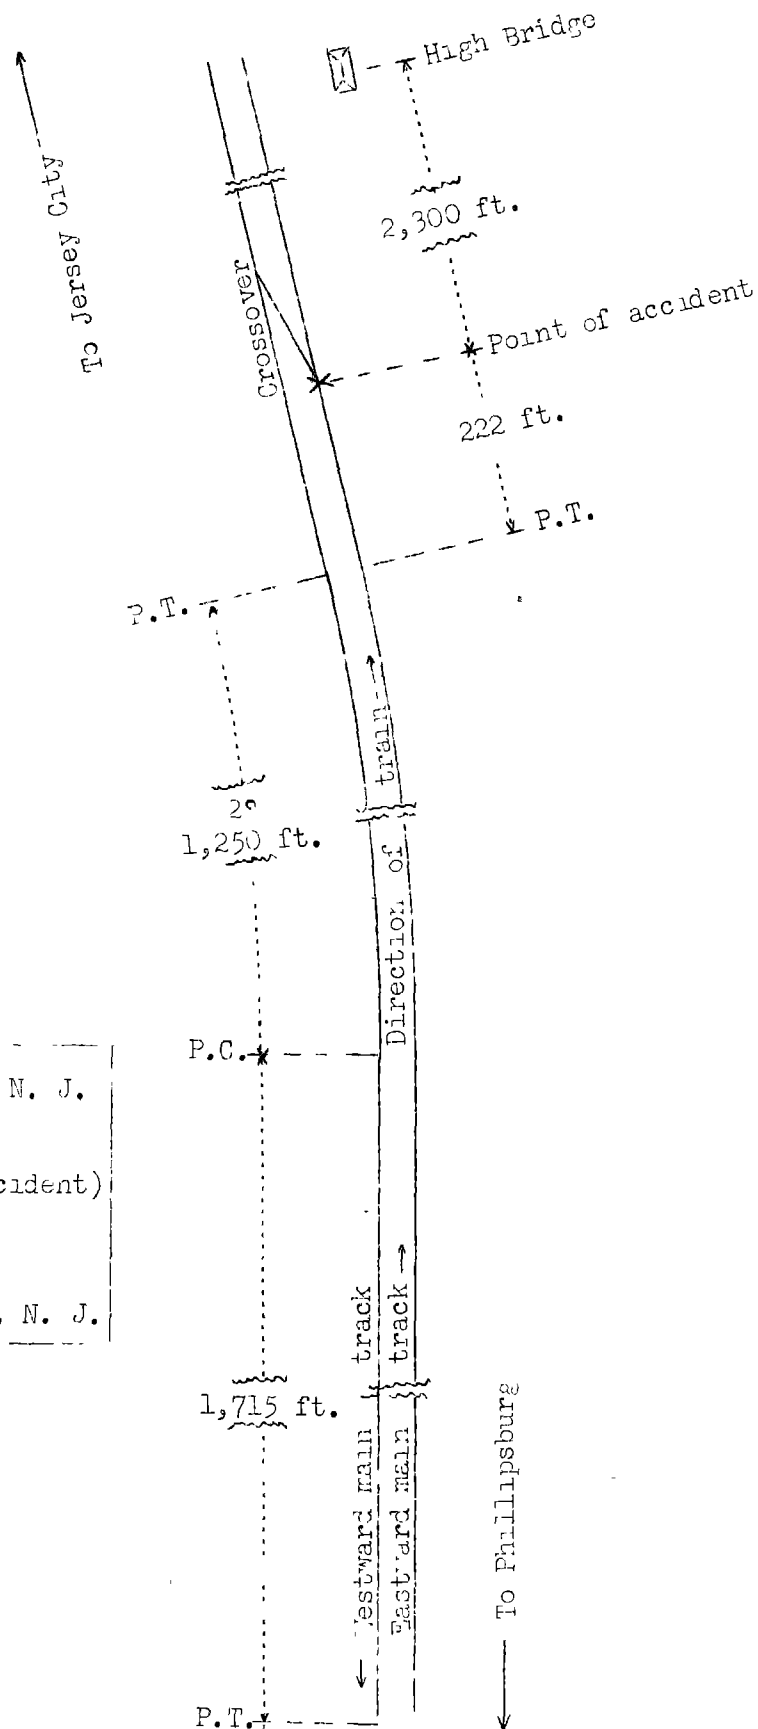
o	Jersey City, N. J.
	52.16 mi.
X	High Bridge
	(Point of accident)
	4.43 mi.
o	Hampton
	15.53 mi.
o	Phillipsburg, N. J.
