REPORT NO. 3338
CENTRAL RAILROAD COMPANY OF PENNSYLVANIA
IN RE ACCIDENT
NEAR MAUCH CHUNK, PA., ON
JULY 5, 1950

Kind of accident: Head-end collision

Accident near Mauch Chunk, Pa., on July 5, 1950, caused
by a track motor-car occupying the main track without
proper authority.

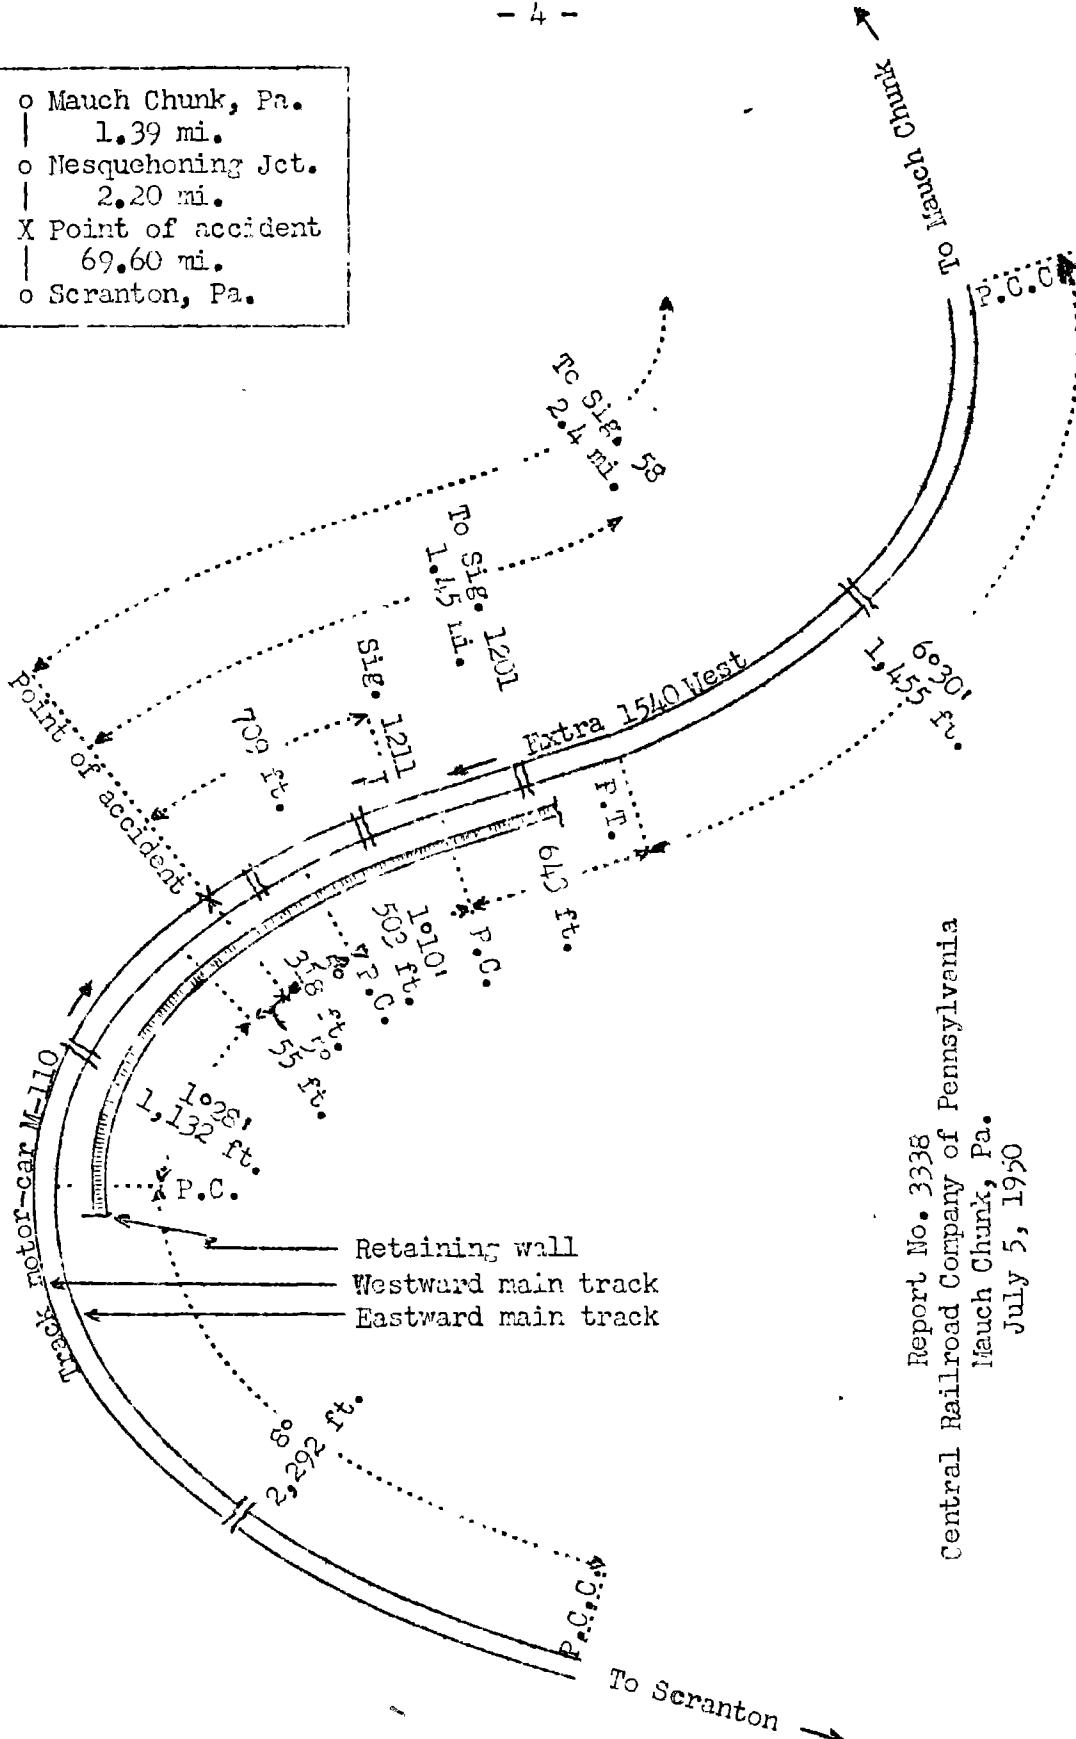
○ Mauch Chunk, Pa.
1.39 mi.
○ Nesquehoning Jct.
2.20 mi.
X Point of accident
69.60 mi.
○ Scranton, Pa.

This accident occurred on that part of the railroad extending between Mauch Chunk and Scranton, Pa., 73.19 miles. In the vicinity of the point of accident this is a double-track line, over which trains moving with the current of traffic are operated by timetable, train orders and an automatic block-signal system. The accident occurred on the westward main track at a point 3.59 miles west of Mauch Chunk and 2.2 miles west of the interlocking station at Nesquehoning Jct. From the east there are, in succession, a compound curve to the right, having a maximum curvature of $6^{\circ}30'$, 1,455 feet in length, a tangent 643 feet, a $1^{\circ}10'$ curve to the left 503 feet, and a 5° curve to the left 318 feet to the point of accident and 55 feet westward. From the west there are, in succession, a compound curve to the right, having a maximum curvature of 8° , 2,992 feet in length, a $1^{\circ}28'$ curve to the right 1,132 feet, and the curve on which the accident occurred. At the point of accident the grade is 0.65 percent ascending westward.
