INTERSTATE COMMERCE COMMISSION

REPORT OF THE DIRECTOR OF THE BUREAU OF SAFETY CONCERNING AN
ACCIDENT WHICH OCCURRED ON THE CENTRAL VERMONT RAILWAY
NEAR FITCHVILLE JUNCTION, CONN., ON JULY 6, 1932

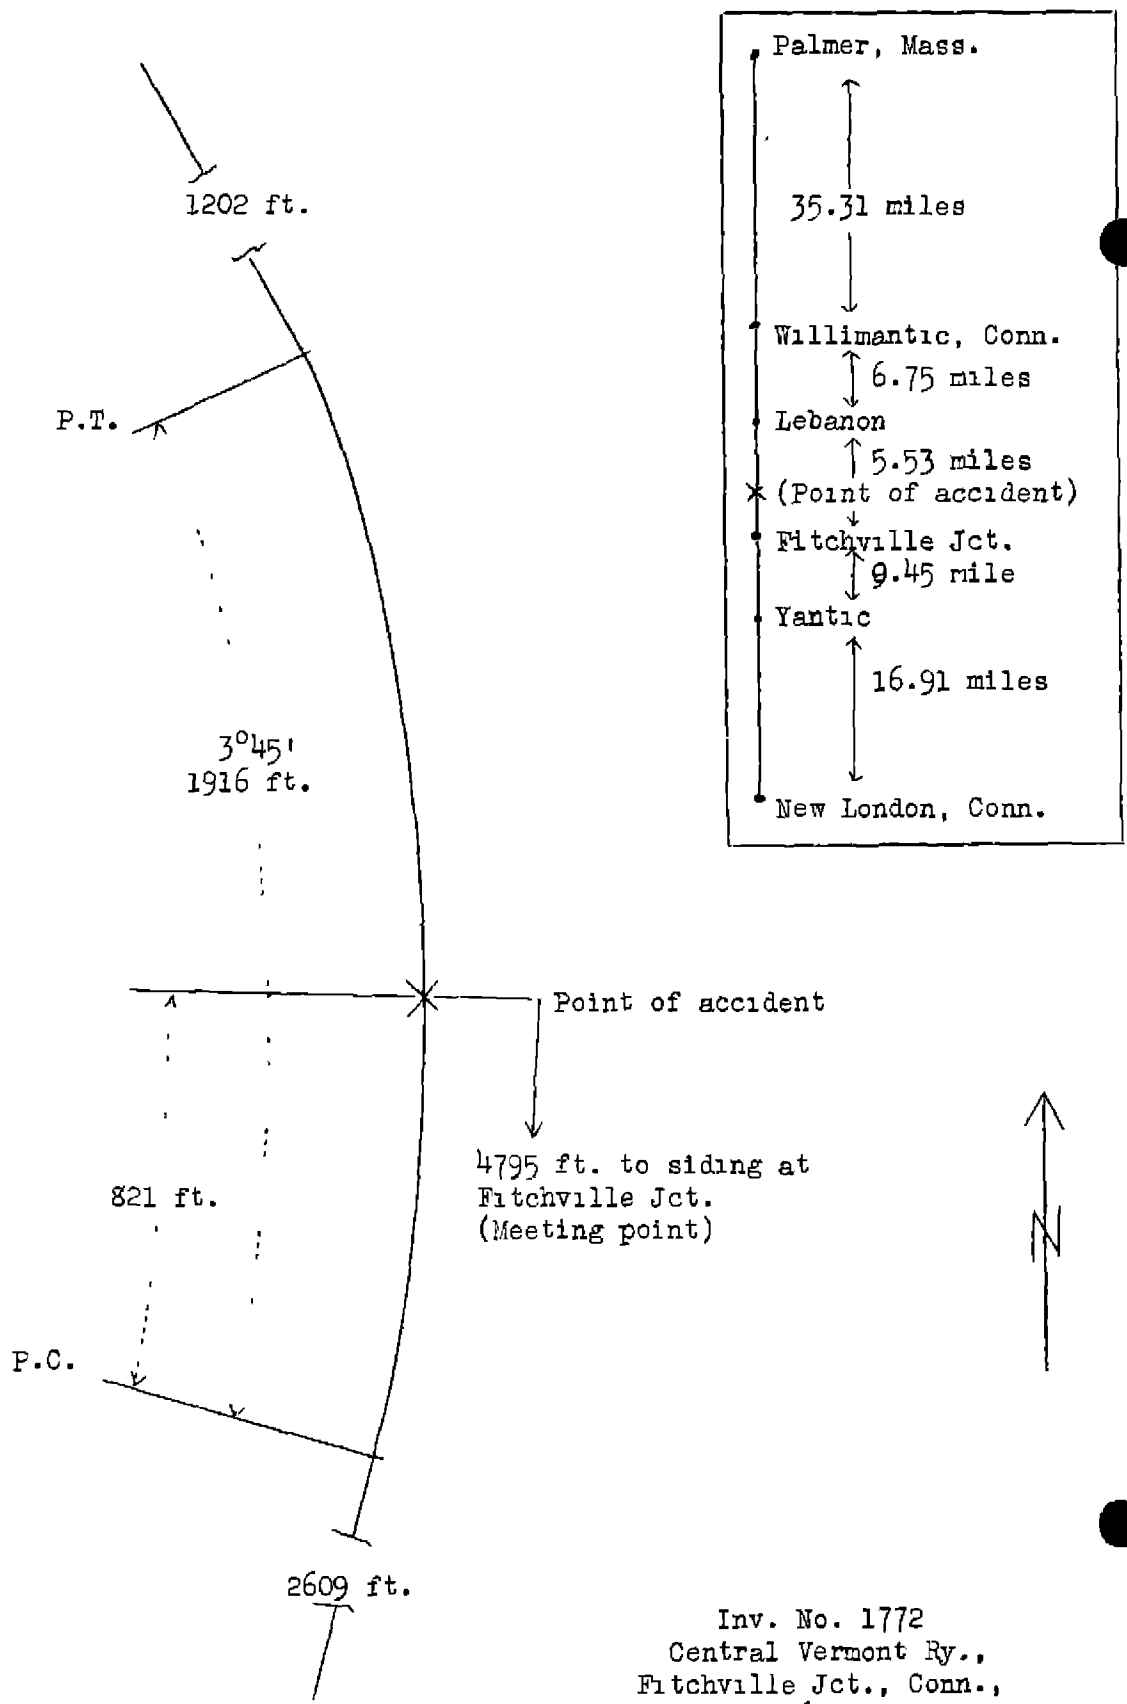
Inv. No. 1772
Central Vermont Ry.,
Fitchville Jct., Conn.,
July 6, 1932

NO. 1 ENG 144 MEET EXTRA 468 SOUTH AT
FITCHVILLE JCT. NO. 1 TAKE SIDING.

Southbound freight train extra 468 consisted of 24 cars and a caboose, hauled by engine 468, and was in charge of Conductor Farr and Engineman McNamara. At Willimantic, 12.28 miles north of Fitchville Junction the crew received a clearance card Form 350-A, together with a copy of train order No. 24, Form 19, reading as follows:

Train Dispatcher Emory stated that train order No. 24 was put out to train No. 1 at Yantic and to extra 468 at Willimantic at 3.43 p.m., it being first repeated by Station Agent Gibbs at Yantic at 3.44 p.m. The order then was made complete and delivered to extra 468 at Willimantic, that train departing from there at 3.53 p.m., 17 minutes prior to the time at which train No. 1 is scheduled to reach Yantic. Train Dispatcher Emory realized that the order was put out in violation of rule 215, which requires in part that where a train carrying passengers is concerned, "complete" must not be given to an order advancing an opposing inferior train until the signature of the conductor
