INTERSTATE COMMERCE COMMISSION
WASHINGTON

REPORT NO. 3656
THE CHESAPEAKE AND OHIO RAILWAY COMPANY
IN RE ACCIDENT
AT BREMO, VA., ON
SEPTEMBER 27, 1965

..
Accident at Bremo, Va., on September 27, 1955, caused by
a train being admitted to a block in which a preceding
train was authorized to make a reverse movement.

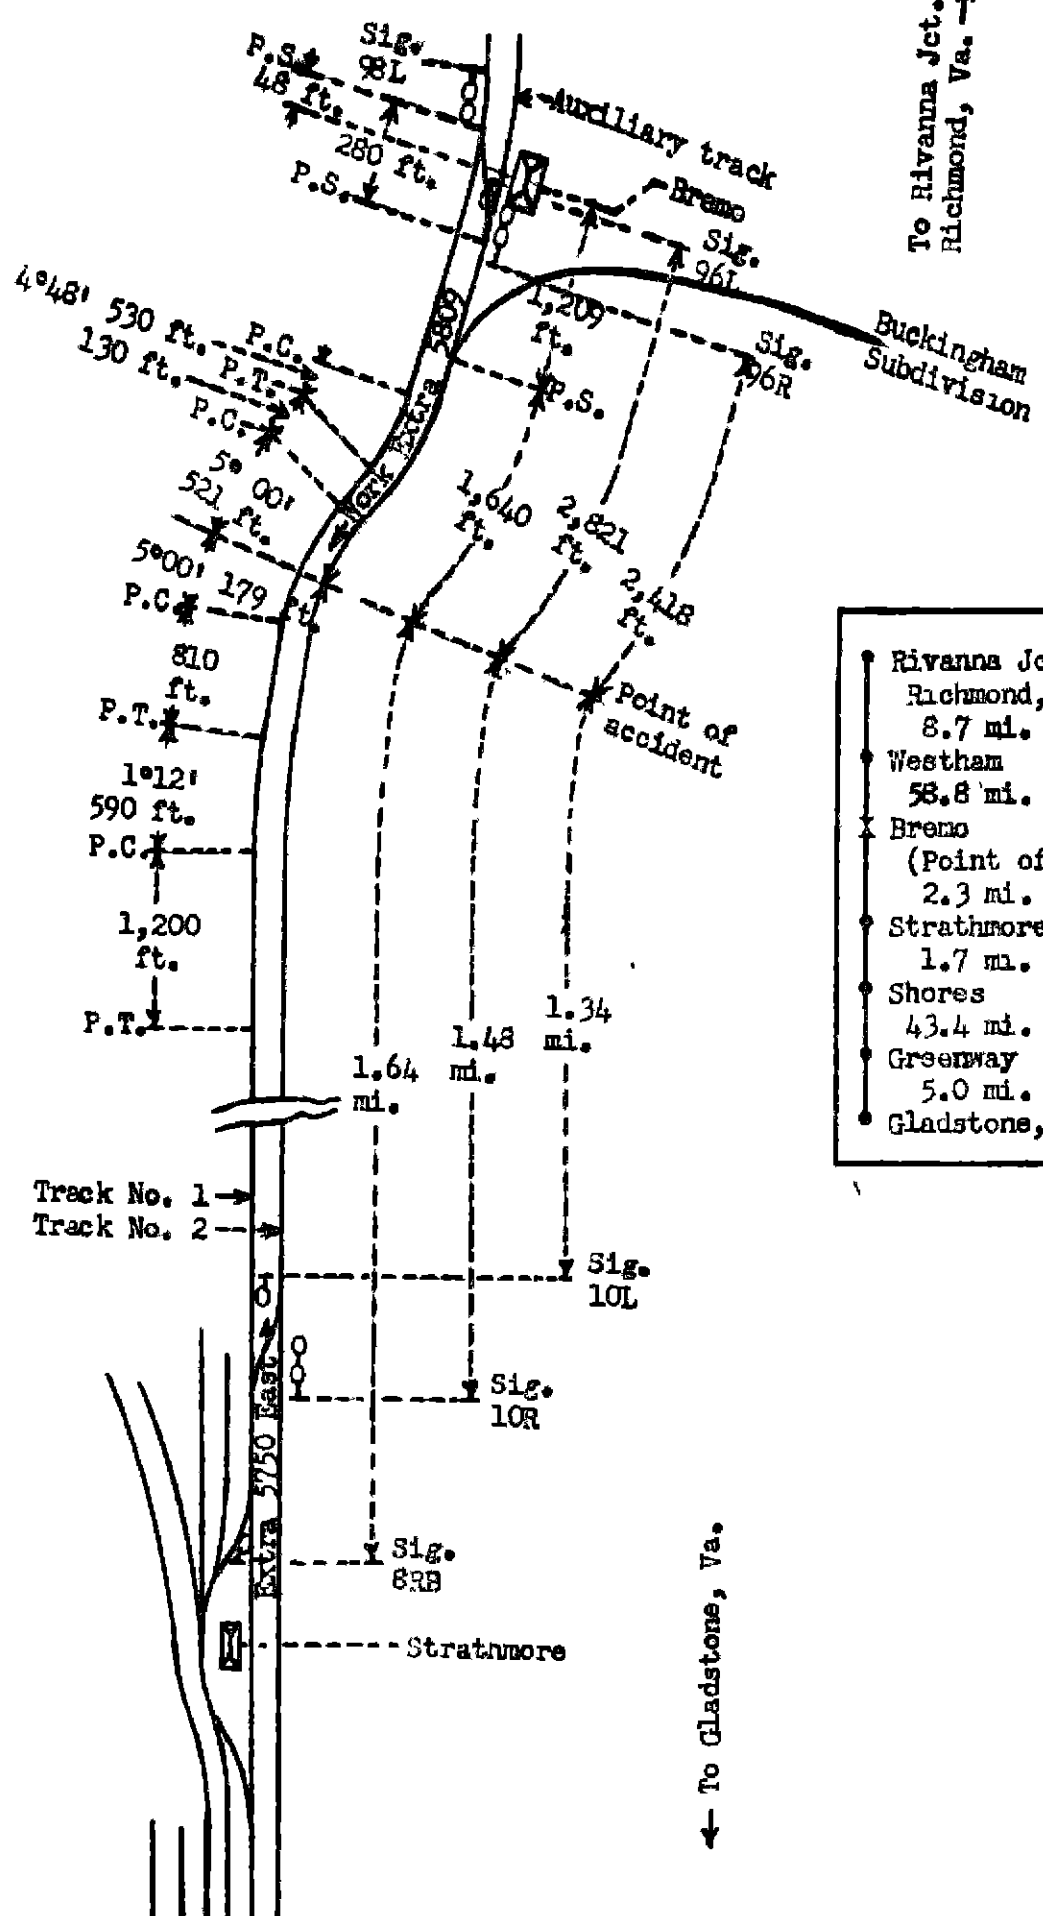
To Rivanna Jct.,
Richmond, Va. ↑

●	Rivanna Jct., Richmond, Va.	8.7 mi.
●	Westham	58.8 mi.
★	Bremo (Point of accident)	2.3 mi.
●	Strathmore	1.7 mi.
●	Shores	43.4 mi.
●	Greenway	5.0 mi.
●	Gladstone, Va.
