INTERSTATE COMMERCE COMMISSION

REPORT OF THE DIRECTOR OF THE BUREAU OF SAFETY CONCERNING
AN ACCIDENT ON THE CHESAPEAKE AND OHIO RAILWAY AT ELK
HILL, VA., ON NOVEMBER 24, 1932.

January 5, 1933.

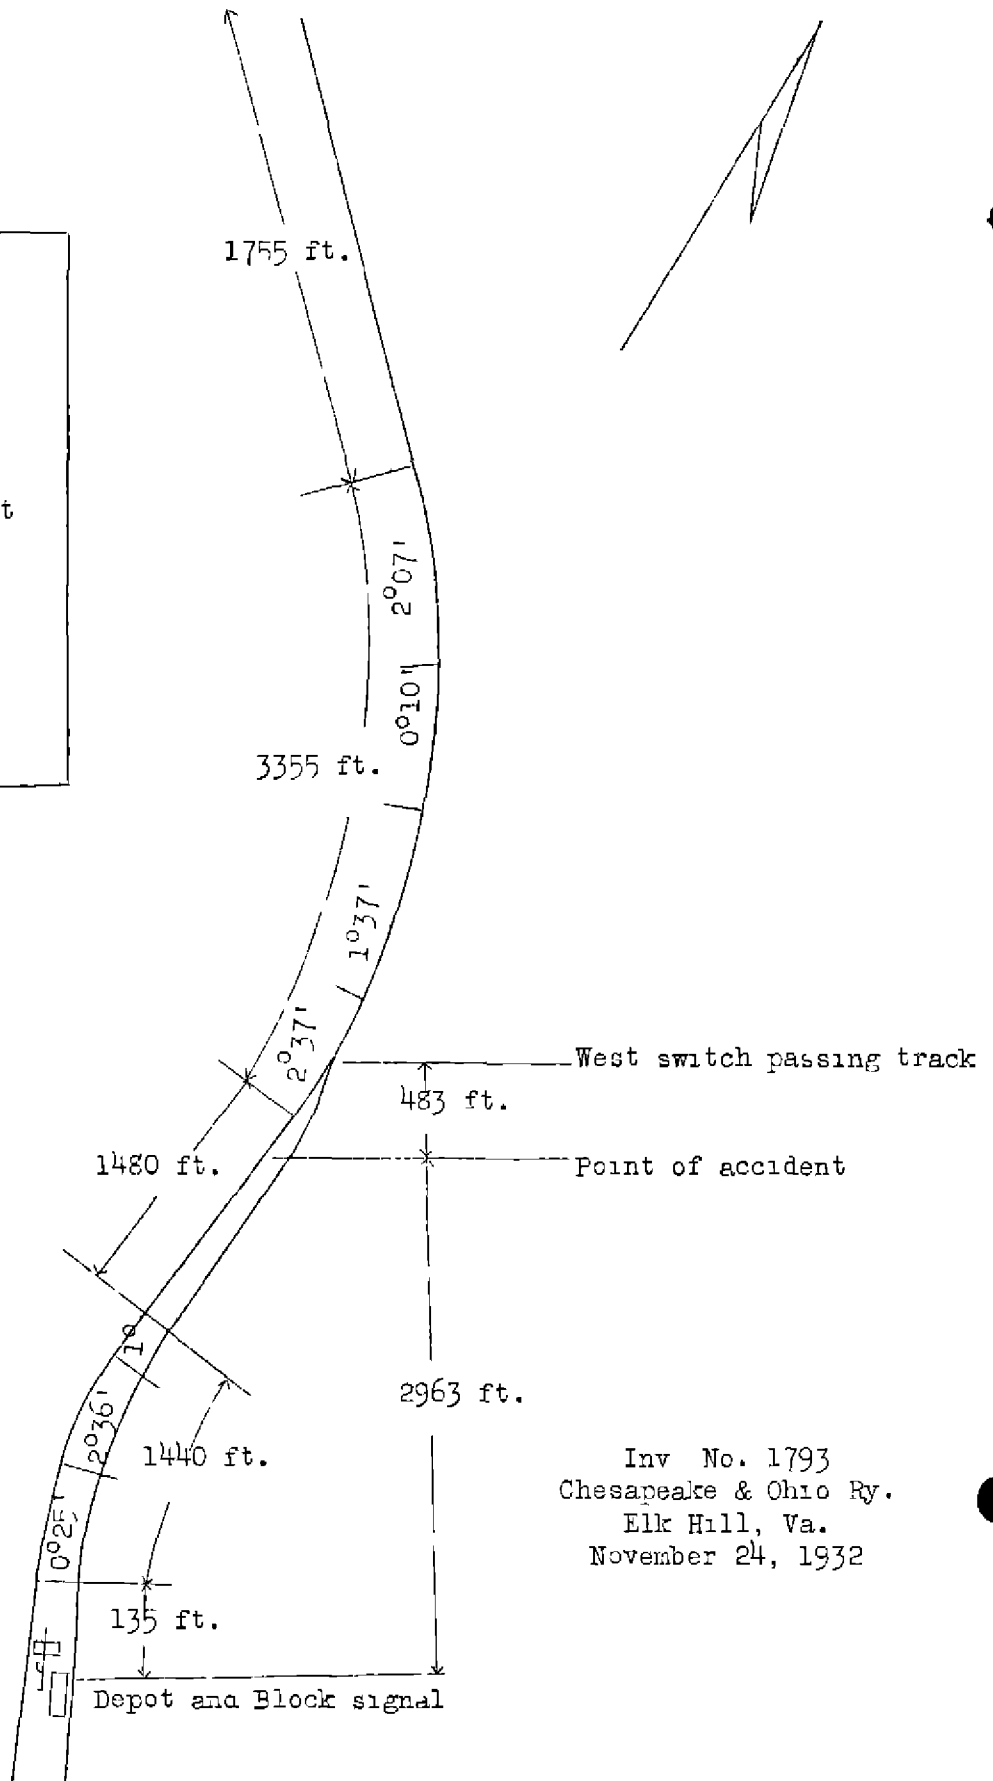
Inv No. 1793
 Chesapeake & Ohio Ry.
 Elk Hill, Va.
 November 24, 1932

A passing track 6,954 feet in length parallels the main track on the north, the west switch being located 3,446 feet west of the station. The block section within which this accident occurred extends between Elk Hill and Columbia, the latter station being 4.9 miles west of Elk Hill.

An engine at the point of accident can be seen from a point approximately 1 mile west thereof, but it can not be determined whether the engine is on the main track or siding until a point 844 feet west of it has been reached.
