INTERSTATE COMMERCE COMMISSION

REPORT OF THE DIRECTOR OF THE BUREAU OF SAFETY CONCERNING AN
ACCIDENT ON THE CHESAPEAKE AND OHIO RAILWAY AT SOUTH
RICHMOND, IND., ON OCTOBER 25, 1933.

Inv. No. 1862
 Chesapeake and Ohio Ry.
 South Richmond, Ind.
 October 25, 1933.

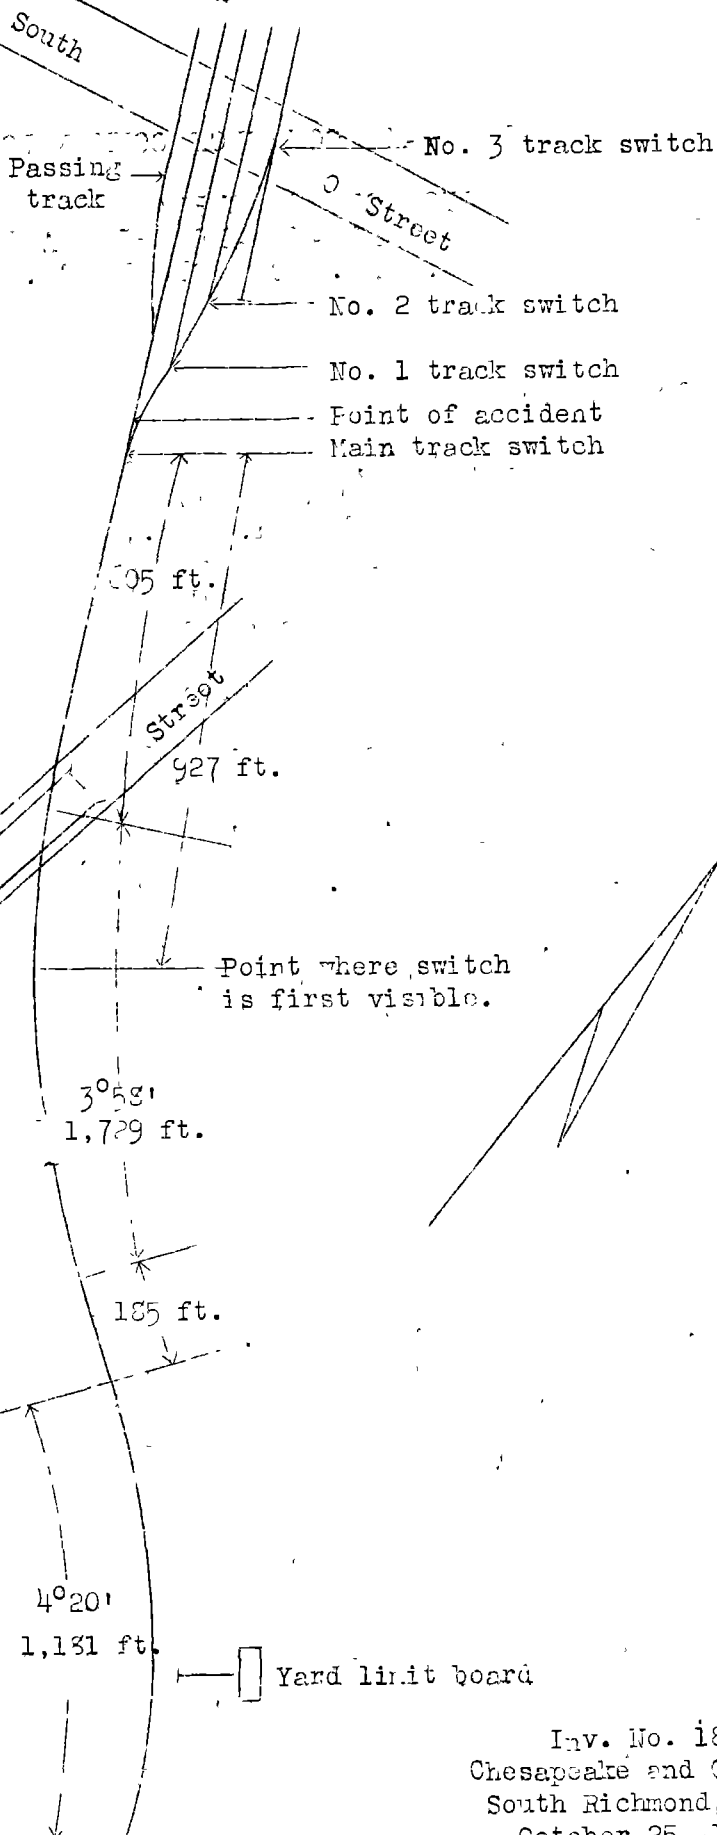
Overhead bridge

South 9th

East of the storage-track switch the track is laid in a cut

1,837 feet in length and there is an overhead bridge located about 605 feet east of the switch, or at the leaving end of the last curve. The embankment is about 15 feet in height and due to this embankment and supports of the overhead bridge, the switch can not be seen by the engineman of a west-bound train until he is within 927 feet of it. Beginning about 5 miles east of South Richmond, there are slow boards restricting speed to 20 and 25 miles per hour until the east yard-limit board is reached.
