INTERSTATE COMMERCE COMMISSION

REPORT OF THE DIRECTOR OF THE BUREAU OF SAFETY
CONCERNING AN ACCIDENT WHICH OCCURRED ON THE
CHESAPEAKE & OHIO RAILWAY AT UPPER SANDUSKY,
OHIO, ON MARCH 11, 1932.

Inv. No. 1758
Chesapeake & Ohio Railway
Upper Sandusky, Ohio
March 11, 1932.

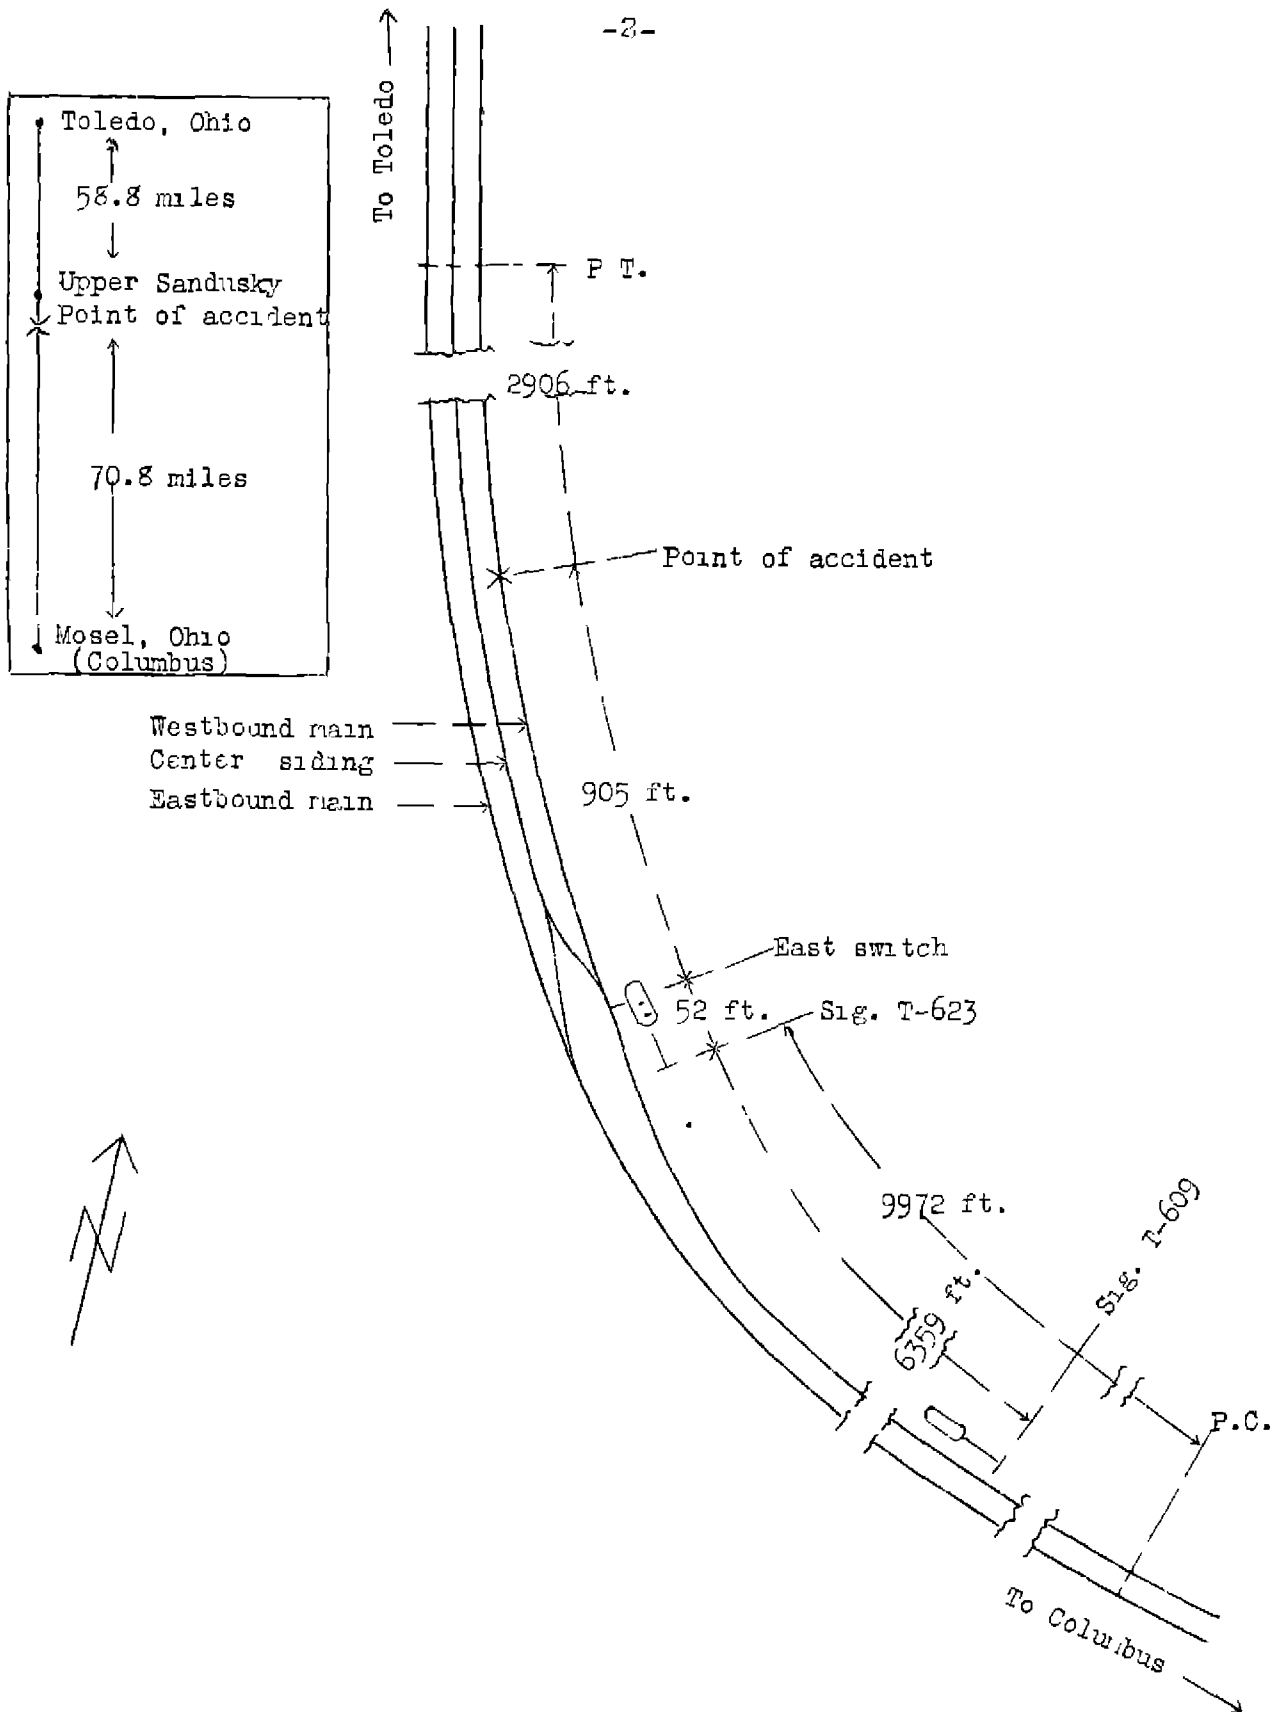
Signals T-623 and T-609 are located 957 feet and 7,316 feet, respectively, east of the point of accident; are of the three-indication, color-light type, displaying red, yellow, and green, for stop, approach, and proceed, respectively. The view is practically unobstructed.
