INVESTIGATION NO. 2822  
THE CHESAPEAKE AND OHIO RAILWAY COMPANY  
REPORT IN RE ACCIDENT  
NEAR WALBRIDGE, KY., ON  
AUGUST 30, 1944

Kind of accident: Head-end collision

Accident near Walbridge, Ky., on August 30, 1944, caused  
by failure of the railroad to provide adequate safe-  
guards for the movement of trains.

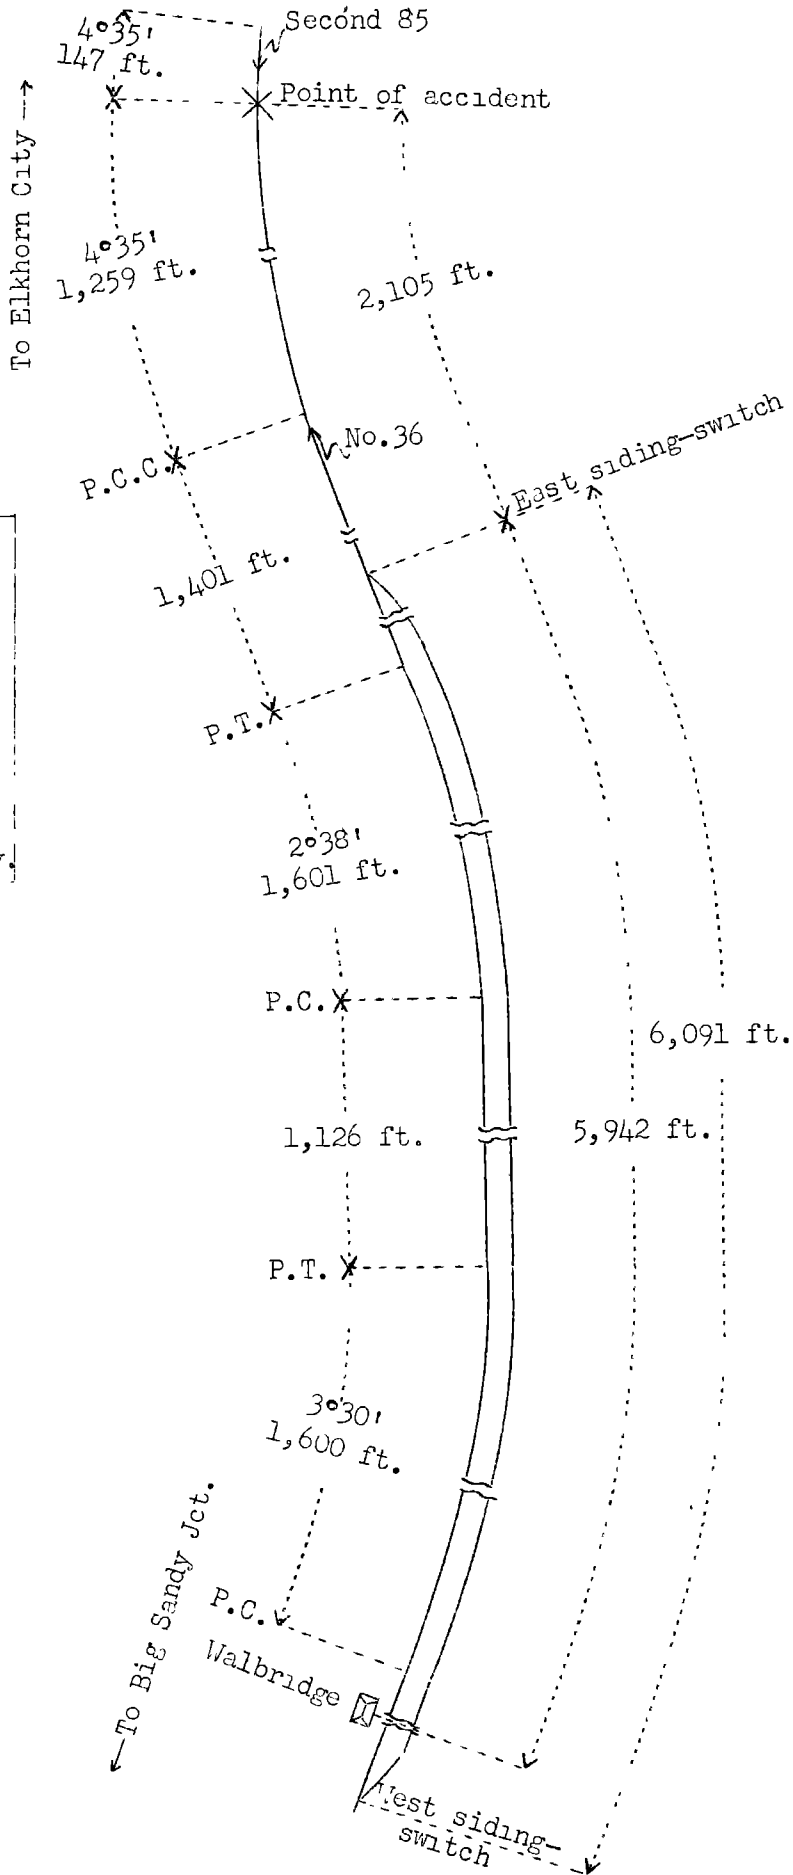
Inv. No. 2822  
 Chesapeake and Ohio Railway  
 Walbridge, Ky.  
 August 30, 1944

Location of Accident and Method of Operation
