INTERSTATE COMMERCE COMMISSION

REPORT OF THE DIRECTOR OF THE BUREAU OF SAFETY CONCERNING AN
ACCIDENT ON THE CHESAPEAKE AND OHIO RAILWAY AT WARREN,
VA. ON SEPTEMBER 10, 1935.

October 18, 1935.

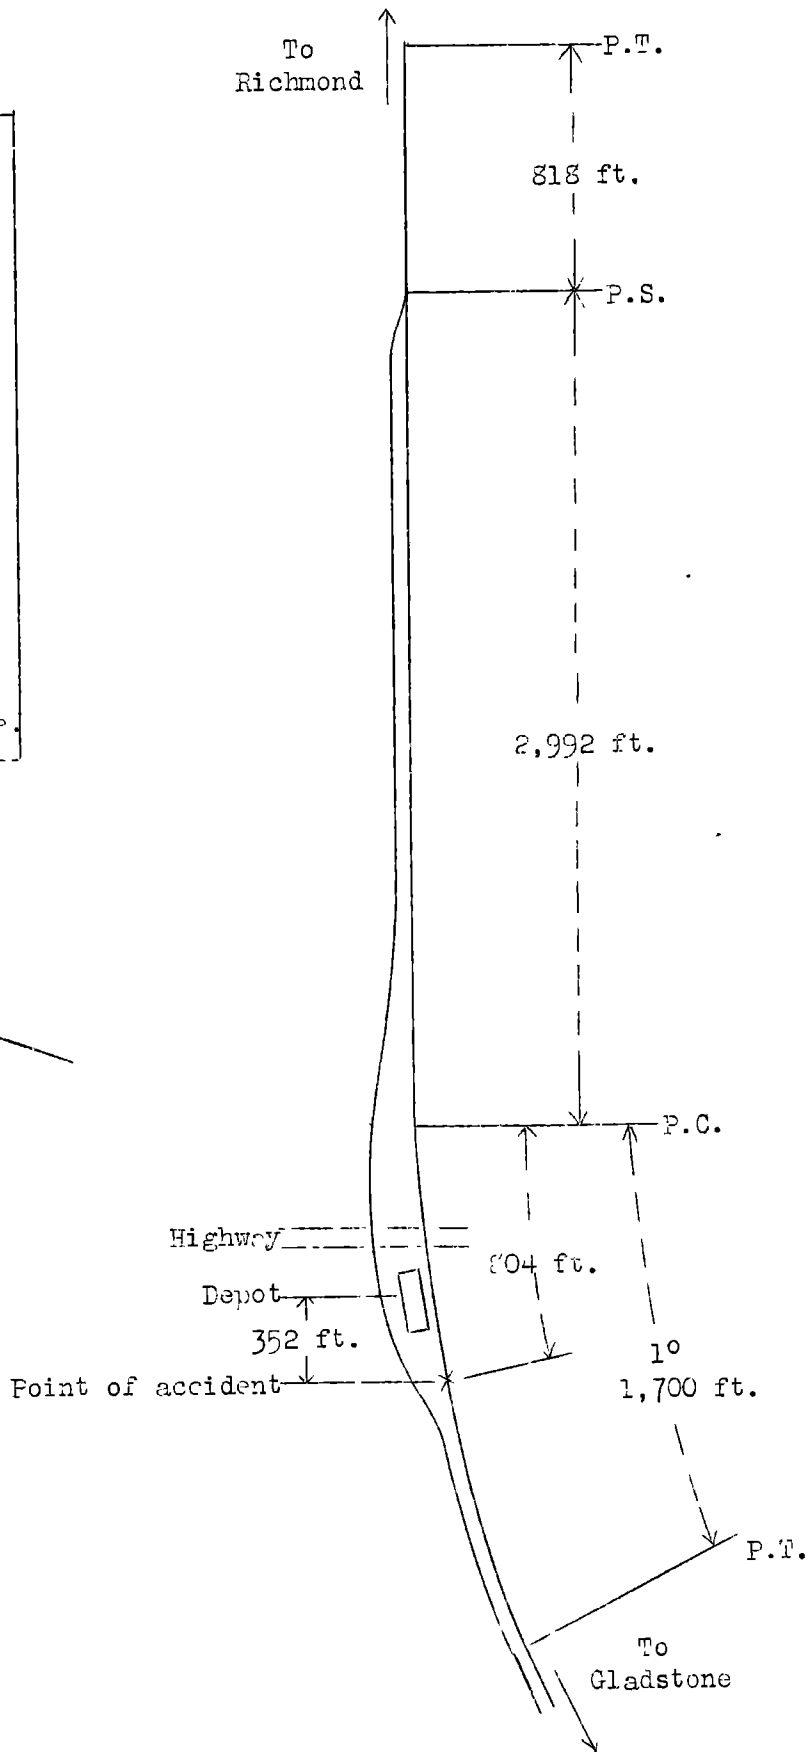
Inv. No. 2009
 Chesapeake & Ohio Ry.
 Warren, Va.
 September 10, 1935

To
Richmond

• Richmond (R Cabin)
70.6 mi.
• Strathmore
16.6 mi.
* Warren
13.7 mi.
• Warminster
19.8 mi.
• Gladstone, Va.

A passing siding 6,794 feet in length parallels the main track at the north, the east switch being located 3,444 feet east of the station or 3,796 feet east of the point of accident. The block section within which this accident occurred extends between Warren and Warminster, 13.7 miles west of Warren.

The track rests upon a low fill, formerly the tow path of a canal. Buildings and trees at the south side of the right-of-way restrict the distance that the point of accident may be seen from a west-bound locomotive approximately to 740 feet.
