INTERSTATE COMMERCE COMMISSION

REPORT OF THE DIRECTOR OF THE BUREAU OF SAFETY CONCERNING AN
ACCIDENT ON THE CHESTNUT RIDGE RAILWAY AT DELAWARE
AVENUE, PA., ON MARCH 23, 1934.

May 29, 1934.

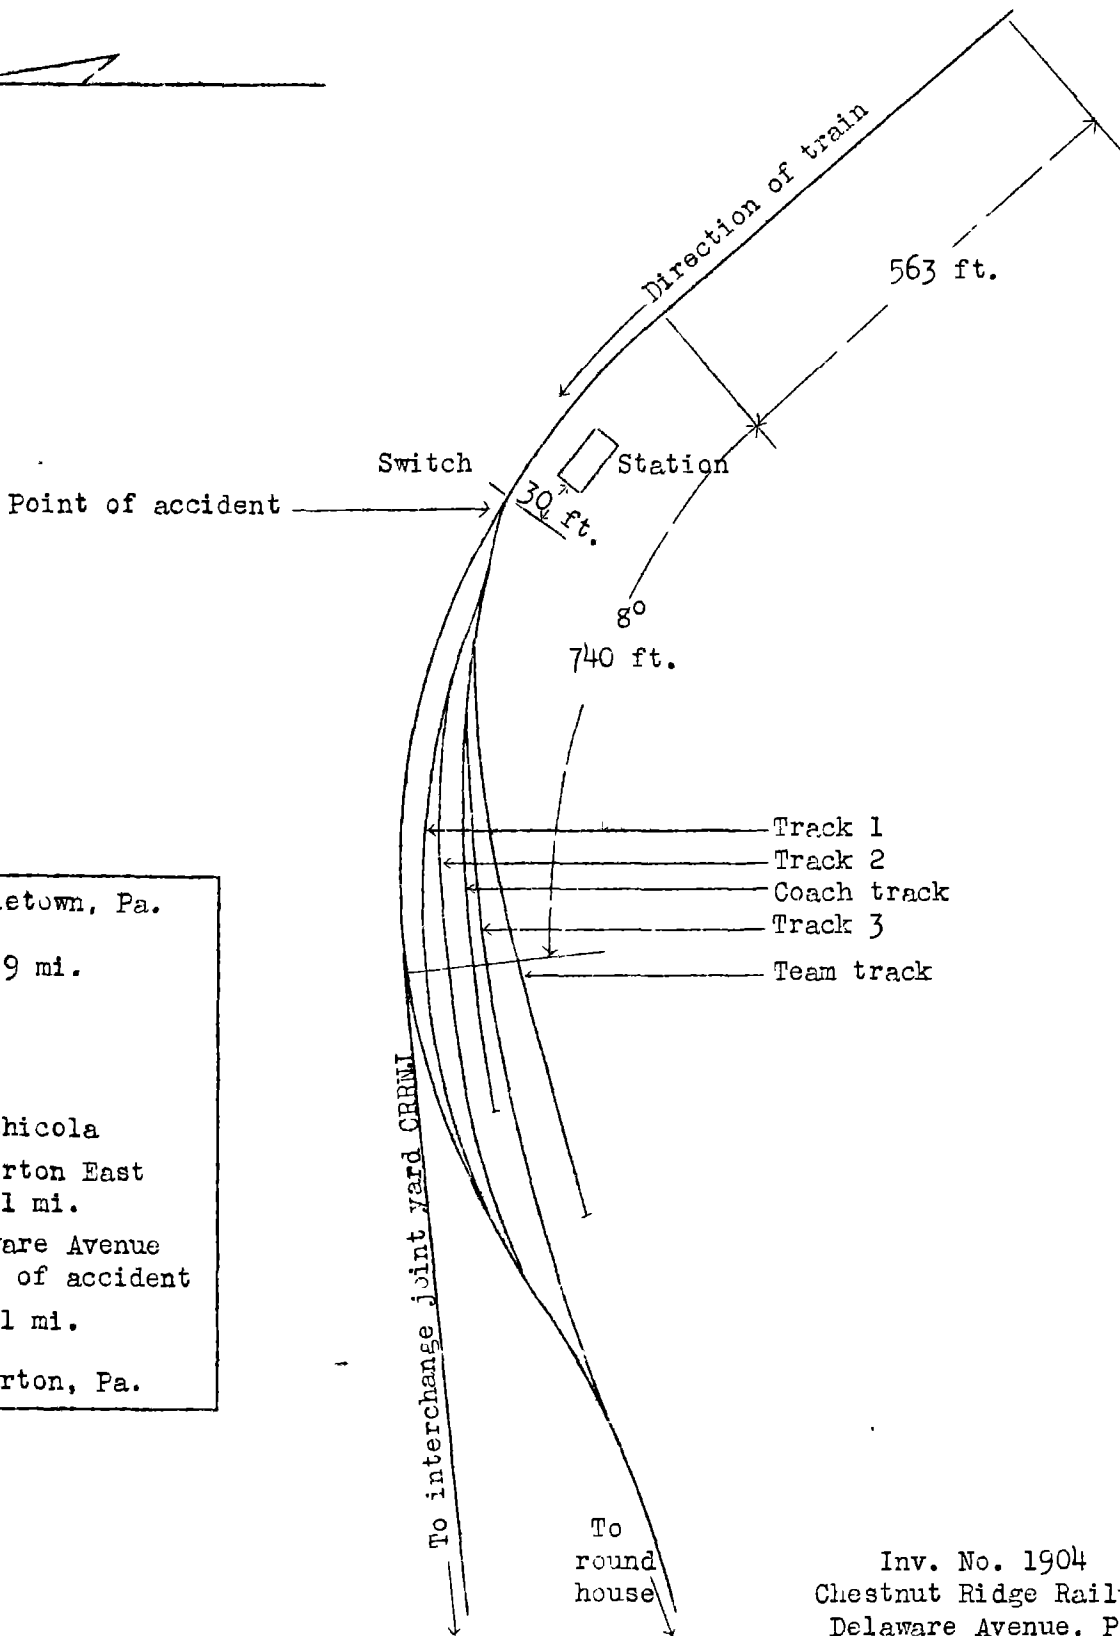
Inv. No. 1904
 Chestnut Ridge Railway
 Delaware Avenue, Pa.
 March 26, 1934

• Kunkletown, Pa.	
	9 mi.
• Aquashicola	
• Palmerton East	1 mi.
• Delaware Avenue	
• Point of accident	1 mi.
• Palmerton, Pa.
