INVESTIGATION NO. 5224
CHICAGO & EASTERN ILLINOIS RAILROAD COMPANY
REPORT IN RE ACCIDENT
AT OAKLAWN, ILL., ON
DECEMBER 31, 1948

Accident at Oaklawn, Ill., on December 31, 1948, caused
by failure properly to control the speed of Diesel-
electric units 1504B-1409A within yard limits.

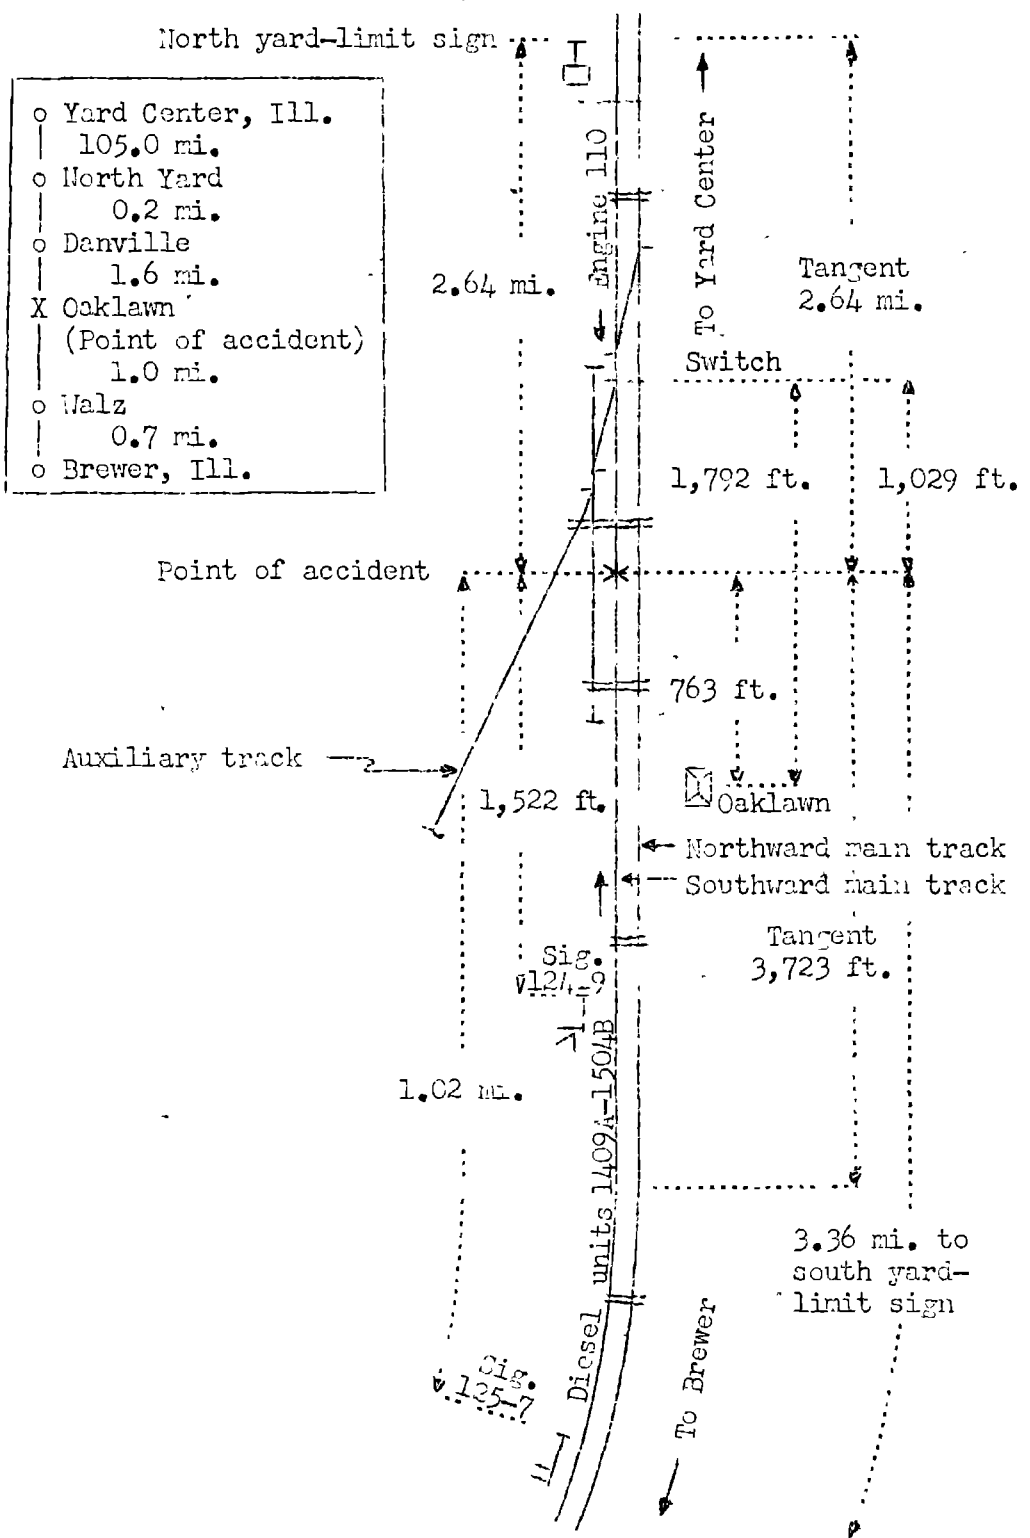
Inv. No. 3224
 Chicago & Eastern Illinois Railroad
 Oaklawn, Ill.
 December 31, 1948

- o Yard Center, Ill. 105.0 mi.
- o North Yard 0.2 mi.
- o Danville 1.6 mi.
- X Oaklawn (Point of accident) 1.0 mi.
- o Walz 0.7 mi.
- o Brewer, Ill.
