REPORT NO. 3648
CHICAGO & EASTERN ILLINOIS RAILROAD COMPANY
IN RE ACCIDENT
AT PAPINEAU, ILL., ON
JULY 1, 1958

Accident at Papineau, Ill., on July 1, 1955, caused
by a train entering a crossover at an excessive
rate of speed.

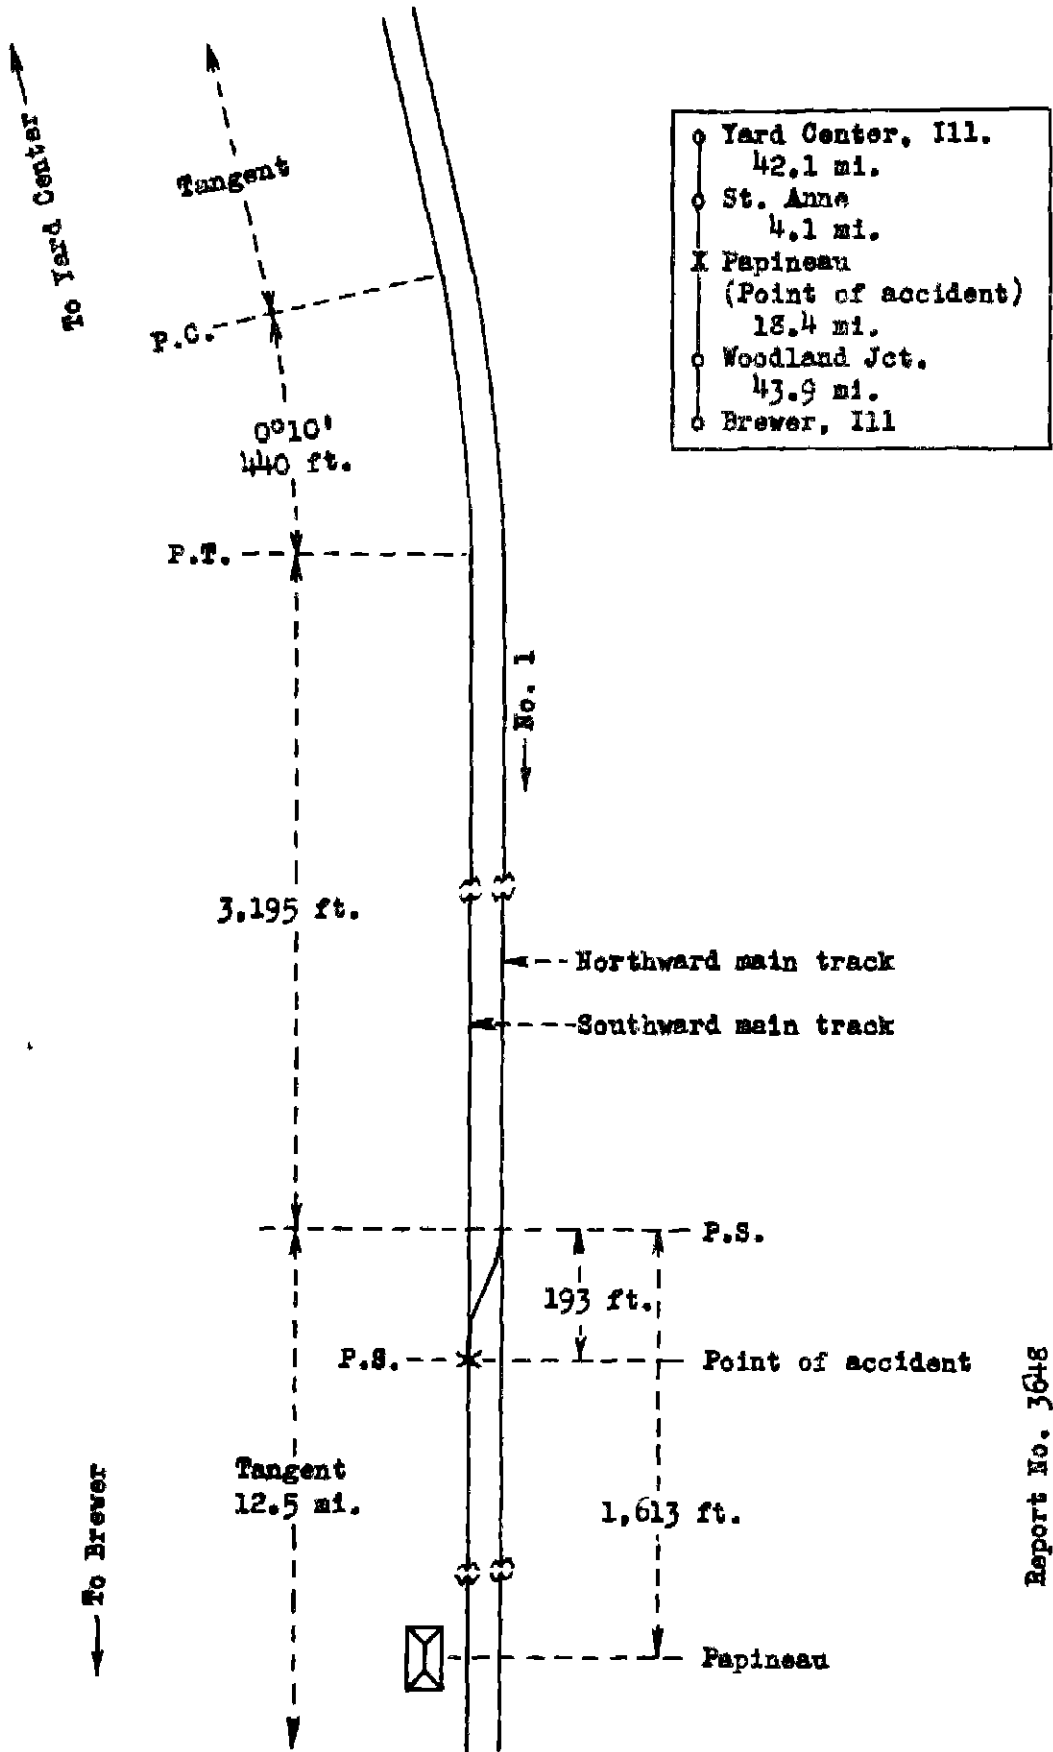
Report No. 3648
 Chicago & Eastern Illinois Railroad
 Papineau, Ill.
 July 1, 1955

- o Yard Center, Ill. 42.1 mi.
- o St. Anne 4.1 mi.
- X Papineau (Point of accident) 18.4 mi.
- o Woodland Jct. 43.9 mi.
- o Brewer, Ill

The switch stand of the north crossover-switch is of the ground-throw type and is located 7 feet 3 inches east of the center-line of the northward main track. It is equipped with an oil-burning switch lamp with 5-inch lenses.

There were no separations between the units of the train. The locomotive stopped on its right side with the front end 356 feet south of the south crossover-switch and 37 feet west of the southward main track. The cars stopped approximately in line with the locomotive. The first and second cars leaned to the west at angles of 45 degrees and 20 degrees, respectively. The locomotive and the first two cars were somewhat damaged, and the third car was slightly damaged.
