INVESTIGATION NO. 3089
CHICAGO & EASTERN ILLINOIS RAILROAD COMPANY
REPORT IN RE ACCIDENT
AT THORNTON, ILL., ON
MARCH 23, 1947

Accident at Thornton, Ill., on March 23, 1947, caused by
an automobile becoming stalled on a railroad-street
grade crossing.

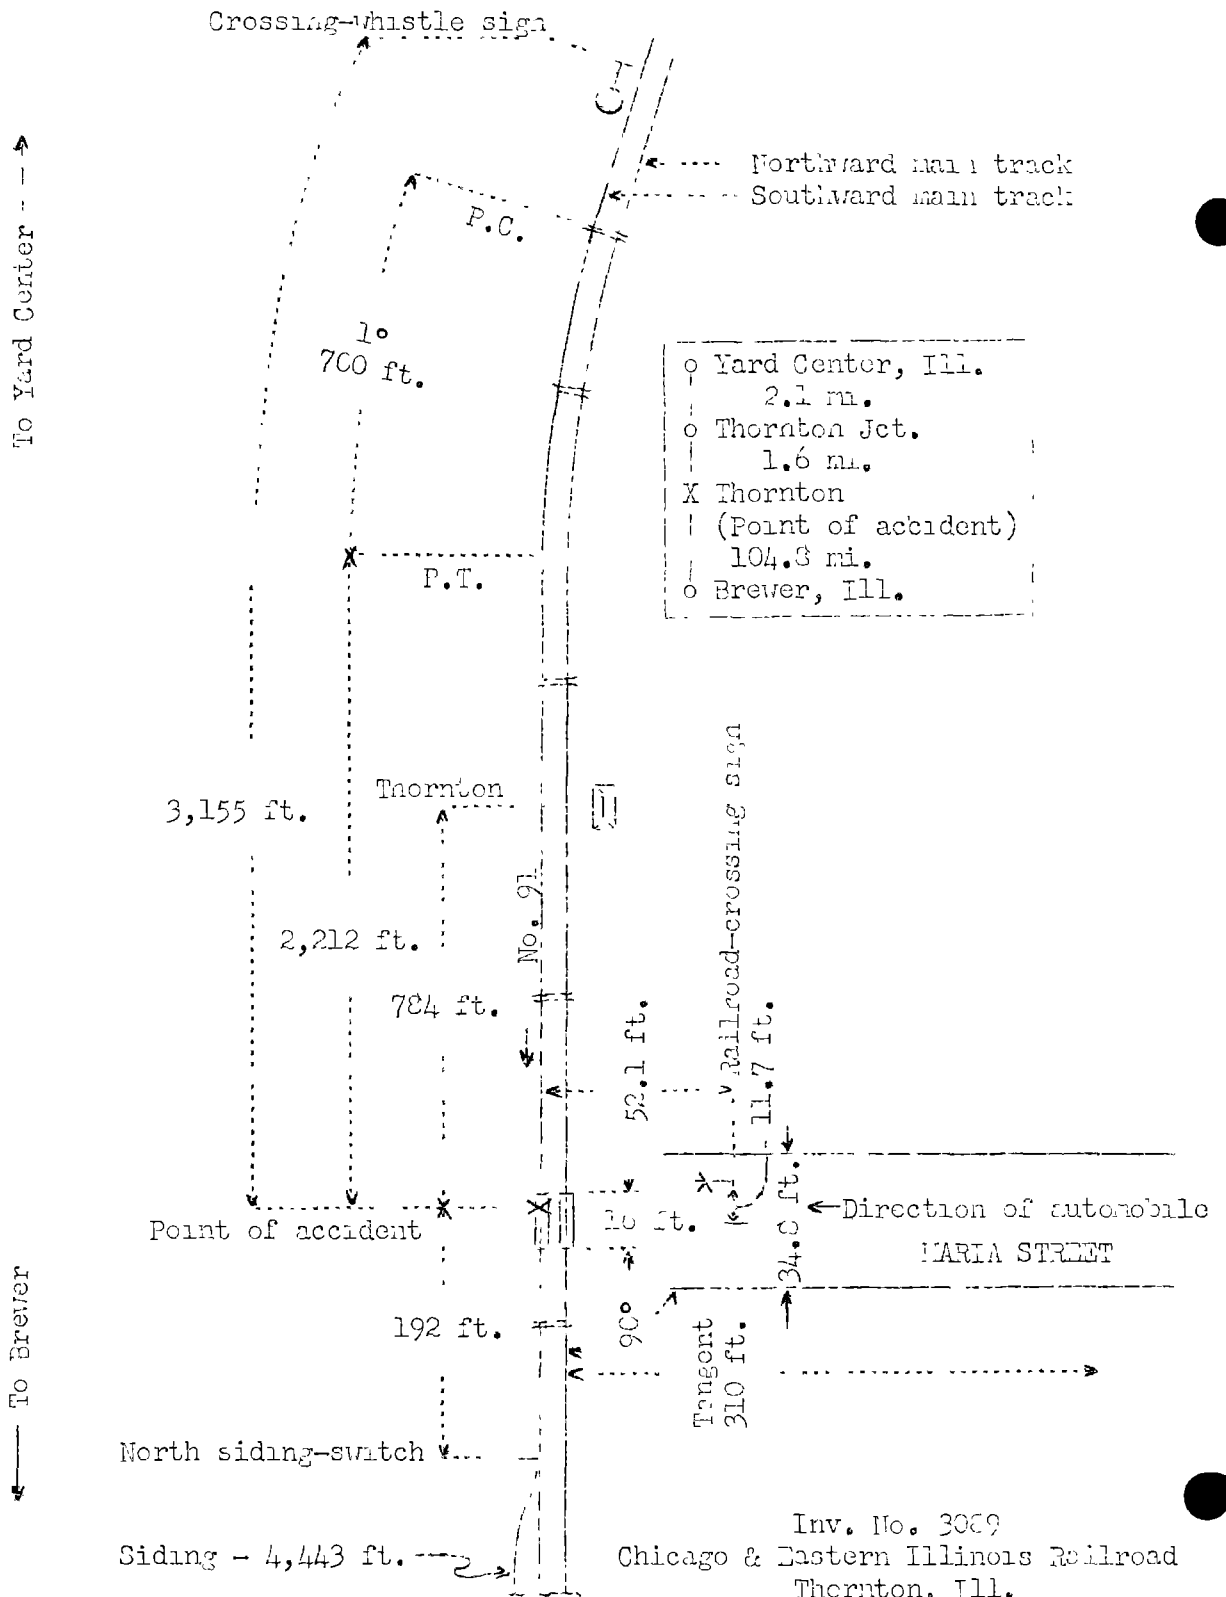
Inv. No. 3009
Chicago & Eastern Illinois Railroad
Thornton, Ill.
March 23, 1947

- o Yard Center, Ill.
2.1 mi.
- o Thornton Jct.
1.6 mi.
- X Thornton
(Point of accident)
104.3 mi.
- o Brewer, Ill.

This accident occurred on that part of the railroad extending between Yard Center and Brewer, Ill., 108.5 miles, a double-track line in the vicinity of the point of accident, over which trains moving with the current of traffic are operated by timetable, train orders and an automatic block-signal system and an automatic train-stop system. The accident occurred on the southward main track 3.7 miles south of Yard Center, at a point 784 feet south of the station at Thornton, where the railroad is crossed at grade by Maria Street. From the north on the railroad there is a 1° curve to the left 700 feet, then a tangent 2,212 feet to the crossing and a considerable distance southward. The grade is 0.02 percent ascending southward.

Immediately south of the crossing a siding 4,443 feet long parallels the southward main track on the west. The north switch of this siding is 192 feet south of the crossing.
