REPORT OF THE DIRECTOR  
BUREAU OF SAFETY

ACCIDENT ON THE  
CHICAGO & NORTH WESTERN RAILWAY

BESSEMER, MICH.

INVESTIGATION NO. 2432

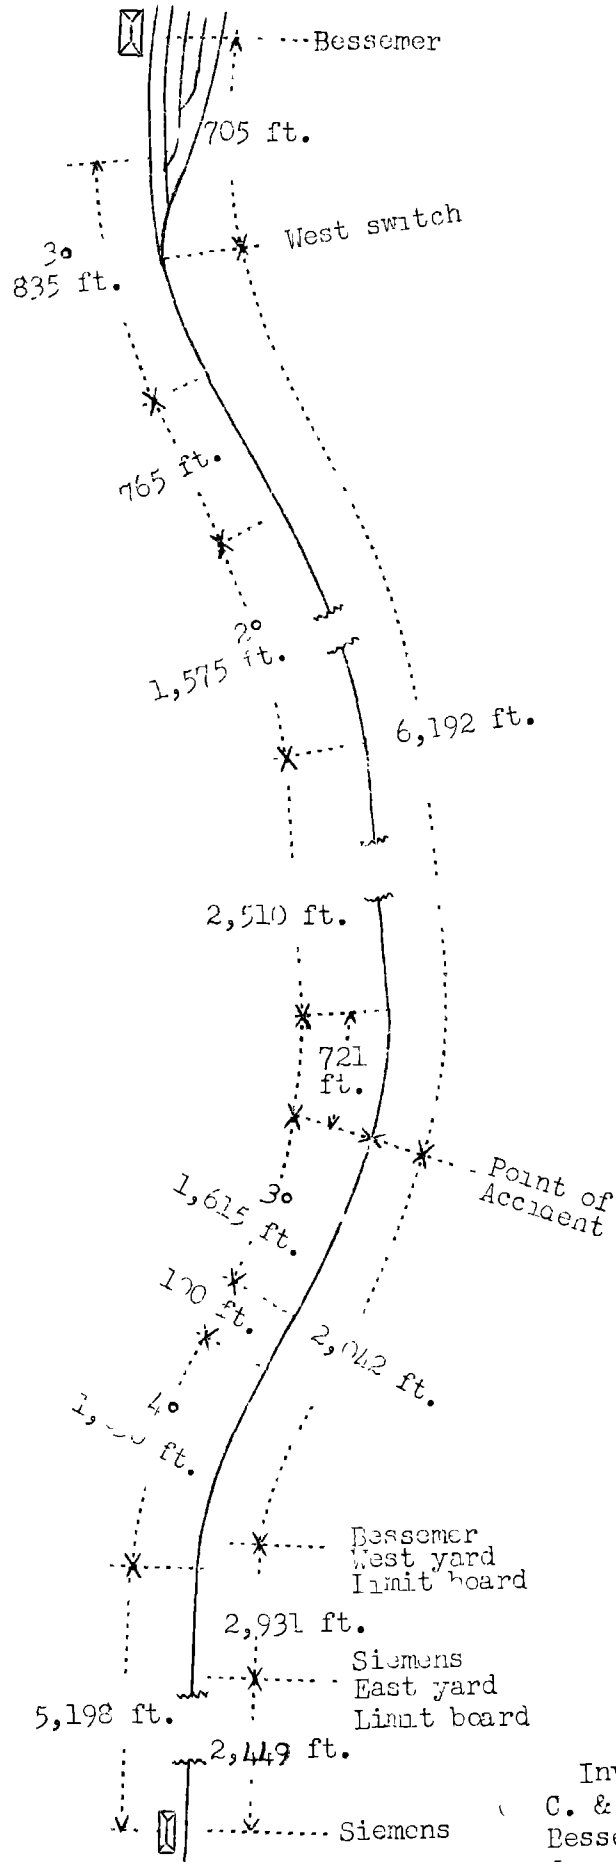
Inv-2432 -  
C. & N. W. Ry.  
Bessemer, Mich.  
June 12, 1940

- o Watersmeet, Mich.  
46.2 mi.
- o Wakefield  
5.7 mi.
- o Bessemer  
1.3 mi.
- X Point of accident  
1.2 mi.
- o Siemens  
3.8 mi.
- o Ironwood, Mich.  
40.1 mi.
- o Ashland, Wis.

This accident occurred on that part of the Ashland Division designated as Subdivision 5 which extends between Watersmeet, Mich., and Ashland, Wis., a distance of 98.3 miles. In the vicinity of the point of accident this is a single-track line over which at the time of the accident trains were operated by timetable and train orders; no block system was in use. The accident occurred on the main track within yard limits at a point 6,897 feet west of the station at Bessemer; the west yard-limit board is located 8,939 feet west of the station, and the west siding-switch is located 705 feet west of the station. As the point of accident is approached from the east there are, in succession, a  $3^{\circ}$  curve to the left, 835 feet in length; a tangent, 765 feet in length; a  $2^{\circ}$  curve to the right, 1,575 feet in length; a tangent, 2,510 feet in length; and a  $3^{\circ}$  curve to the right, 1,615 feet in length; the accident occurred on the last-mentioned curve at a point 721 feet west of its eastern end. As the point of accident is approached from the west there are, in succession, a tangent, 5,198 feet in length; a  $4^{\circ}$  curve to the right, 1,230 feet in length; a tangent, 100 feet in length; and the  $3^{\circ}$  curve on which the accident occurred. The grade for west-bound trains is level a distance of 2,000 feet, then varies between 0.16 and 1.43 percent ascending a distance of 1,748 feet to the point of accident, at which point it is 1.22 percent. The grade for east-bound trains varies between 0.05 and 1.50 percent descending a distance of 7,422 feet to the point of accident. At the point of accident the range of vision of the engine crew of either an east-bound or a west-bound train is restricted to a distance of about 325 feet because of track curvature, a cut about 12 feet in depth, and a thick growth of brush and small trees along the track.
