ACCIDENT ON THE
CHICAGO & NORTH WESTERN RY.

BOONE, IOWA

JANUARY 30, 1936

INVESTIGATION NO. 2037

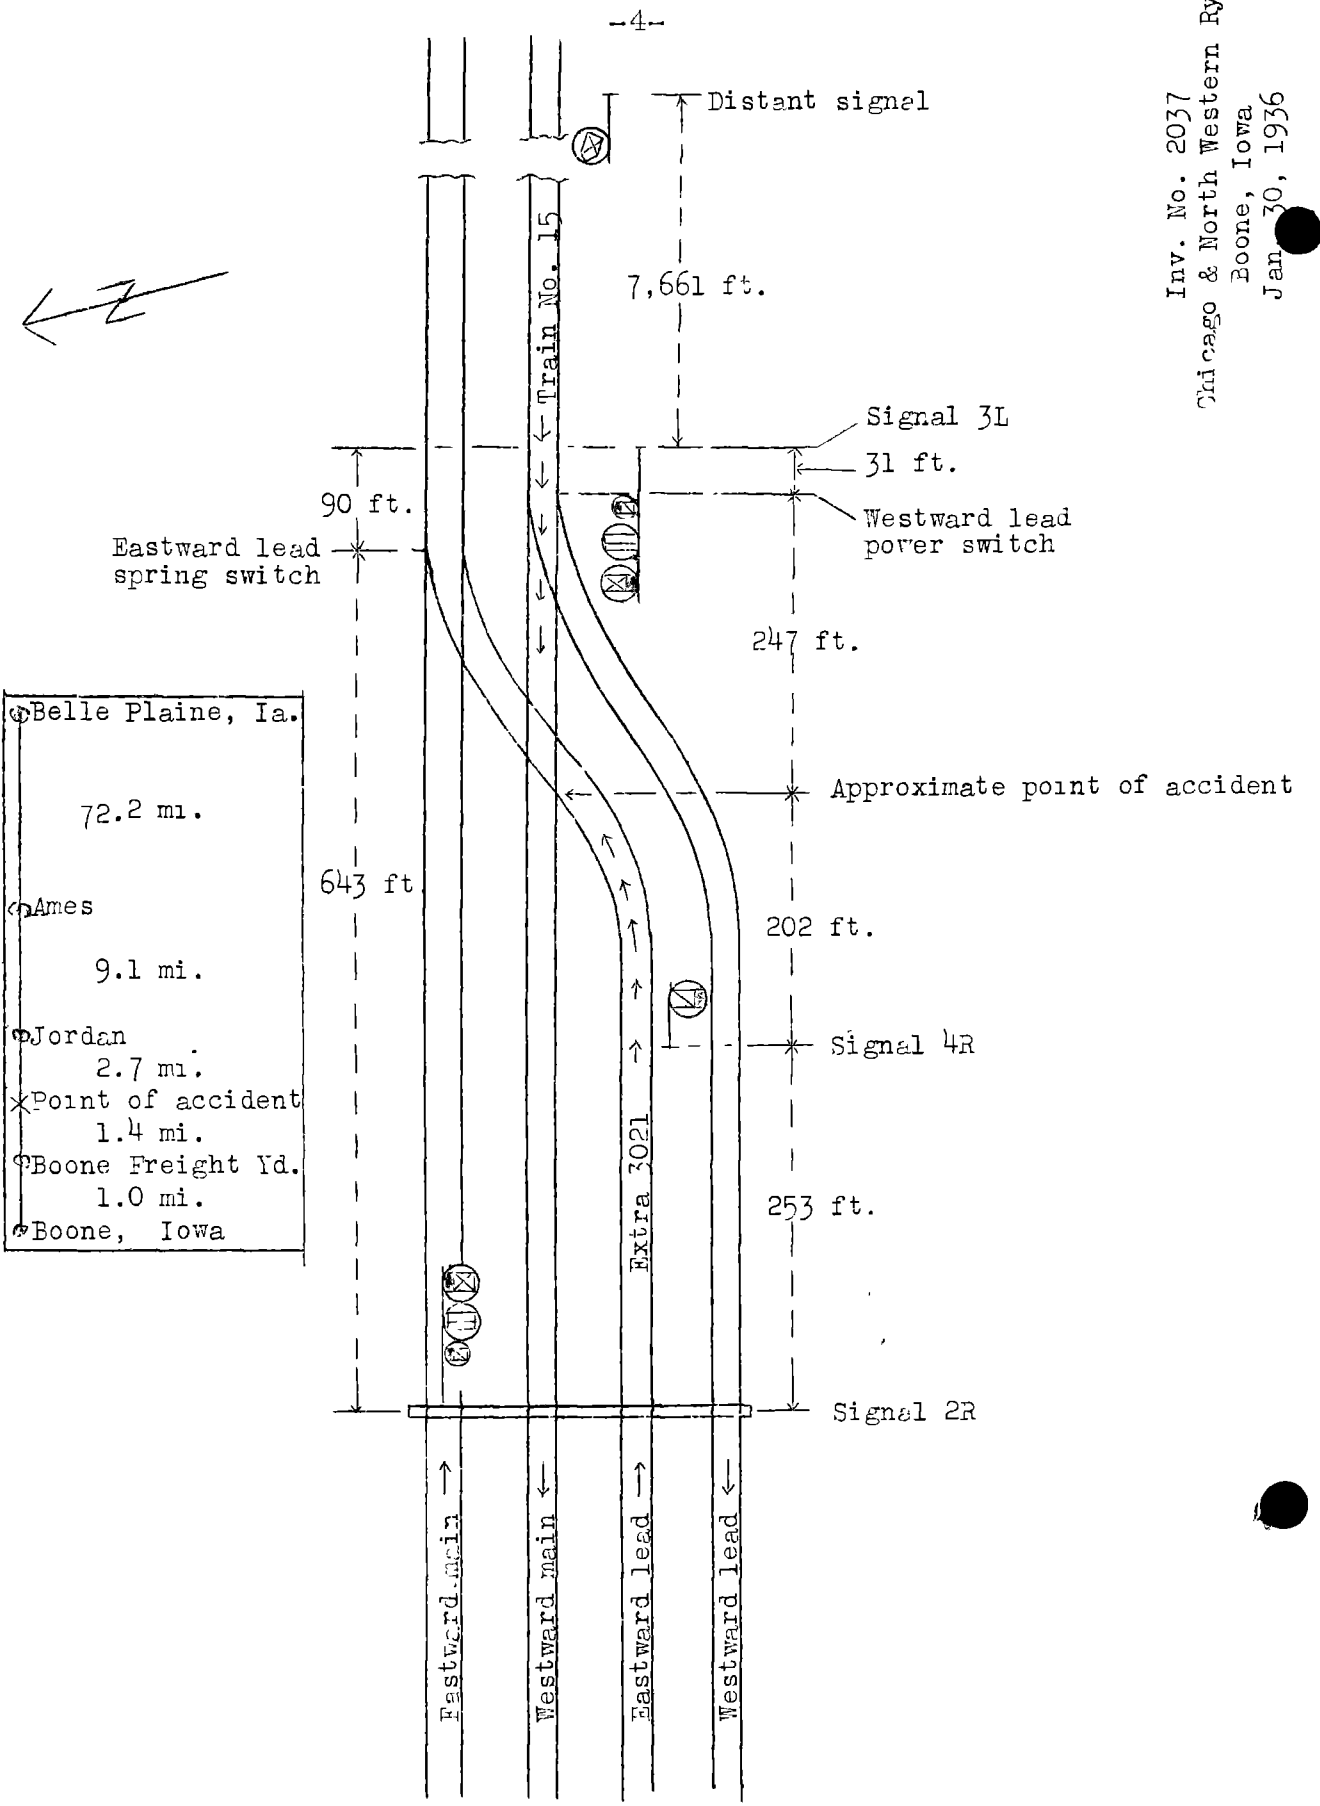
Inv. No. 2037
 Chicago & North Western Ry.
 Boone, Iowa
 Jan 30, 1936

○ Belle Plaine, Ia.	72.2 mi.
○ Ames	9.1 mi.
○ Jordan	2.7 mi.
× Point of accident	1.4 mi.
○ Boone Freight Yd.	1.0 mi.
○ Boone, Iowa

The interlocking tower at Eighth Street, and BU interlocking are located 3,035 and 12,524 feet, respectively, east of Boone. Through train movements and movements between the yard and main tracks are governed by color-light signals controlled from the tower. Movements on the eastward main, or to it from the yard, are made over a trailing-point spring switch; movements on the westward main, or from it to the yard, are made over a facing-point switch, electrically operated, controlled from the tower. Home signal 2R, which governs movements on the eastward main, is mounted on a signal bridge at a point 643 feet west of the spring switch and is a 3-unit signal; the top unit displays red, yellow, or green, for stop, approach, or proceed, respectively; the middle unit displays red at all times, and the bottom unit displays red or yellow for slow-speed movements with the block occupied. Home signal 3L, similar to signal 2R, governs

movements on the westward main and is mounted on a mast located 31 feet east of the power switch and 273 feet east of the point of accident. A 3-indication distant signal is located 7,661 feet east of signal 3L. Signal 4R governs movements from the eastward lead to the eastward main and is a 2-indication dwarf signal placed to the right of the eastward lead at a point 253 feet east of the signal bridge and 202 feet west of the point of accident; this signal displays a red light for a stop indication and a yellow light for proceed at restricted speed. Additional dwarf signals are installed to govern other movements. All signals and the power-operated switch are controlled by means of a 4-unit table interlocker, which is located in the tower, and equipped with green lever-lights to indicate the position of the appliances which are being controlled. The levers are not interlocked, but the circuits are so arranged that no signal can display a clear indication until the switch is in the correct position and the track conditions are proper for the movement intended to be made.
