INVESTIGATION NO. 2739
THE CHICAGO & NORTH WESTERN RAILWAY COMPANY
REPORT IN RE ACCIDENT
AT COBDEN, MINN., ON
NOVEMBER 10, 1943

Railroad: Chicago & North Western
Date: November 10, 1943
Location: Cobden, Minn.
Kind of accident: Head-end collision
Trains involved: Passenger : Passenger
Train numbers: First 504 : 503
Engine numbers: 1612 : 1577
Consist: 6 cars : 8 cars
Estimated speed: 2 m. p. h. : 15 m. p. h.
Operation: Timetable, train orders and
manual-block system
Track: Single; tangent; 0.18 percent
ascending grade westward
Weather: Cloudy
Time: About 2:50 a. m.
Casualties: 29 injured
Cause: Failure to obey meet order
Recommendation: That the Chicago & North Western
Railway Company establish an
adequate block system on the line
on which this accident occurred

Accident at Cobden, Minn., on November 10, 1943, caused
by failure to obey a meet order.

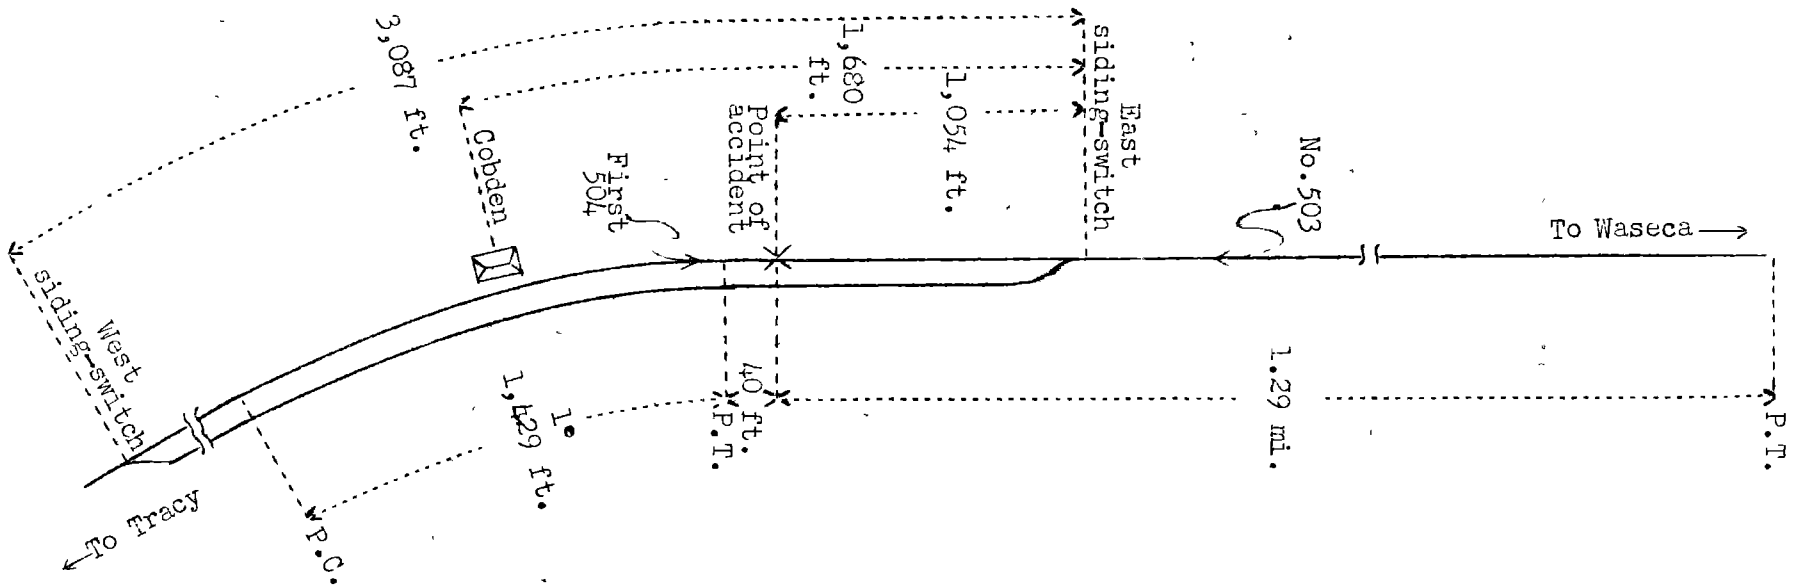
Inv. No. 2739
 Chicago & North Western Railway
 Cobden, Minn.
 November 10, 1943

○	Waseca, Minn.
○	29.1 mi.
○	Mankato
○	40.2 mi.
○	Sleepy Eye
○	6.2 mi.
✕	Cobden (P. of A.)
○	15.6 mi.
○	Sanborn
○	24.9 mi.
○	Tracy, Minn.

Location of Accident and Method of Operation

This accident occurred on that part of the Dakota Division designated as Subdivision 1 and extending between Waseca and Tracy, Minn., 116 miles. This was a single-track line over which trains were operated by timetable and train orders, and a manual-block system in effect between 7:30 a. m. and 5:30 p. m. At Cobden a siding 3,087 feet in length paralleled the main track on the south. The east switch of this siding was 1,630 feet east of the station. The accident occurred on the main track 1,054 feet west of the east siding-switch. From the east there was a tangent 1.29 miles to the point of accident. From the west there was a 1° curve to the right 1,429 feet, and a tangent 40 feet to this point. The grade for west-bound trains was 0.18 percent ascending.

First 504 stopped at the station at Cobden at 2:46 a. m. About 4 minutes later, after station work had been performed, this train was moving at an estimated speed of 2 miles per hour when it collided with No. 503 about 1,050 feet west of the east siding-switch. The engineer of First 504 said that soon after his train departed from the station he saw the reflection of the headlight of the approaching train, and he dimmed the headlight of his engine. Soon afterward he observed that No. 503 had passed the east siding-switch, and the accident occurred almost immediately.
