REPORT OF THE DIRECTOR
BUREAU OF SAFETY

ACCIDENT ON THE
CHICAGO & NORTH WESTERN RAILWAY

GREAT LAKES, ILL.

INVESTIGATION NO. 2394

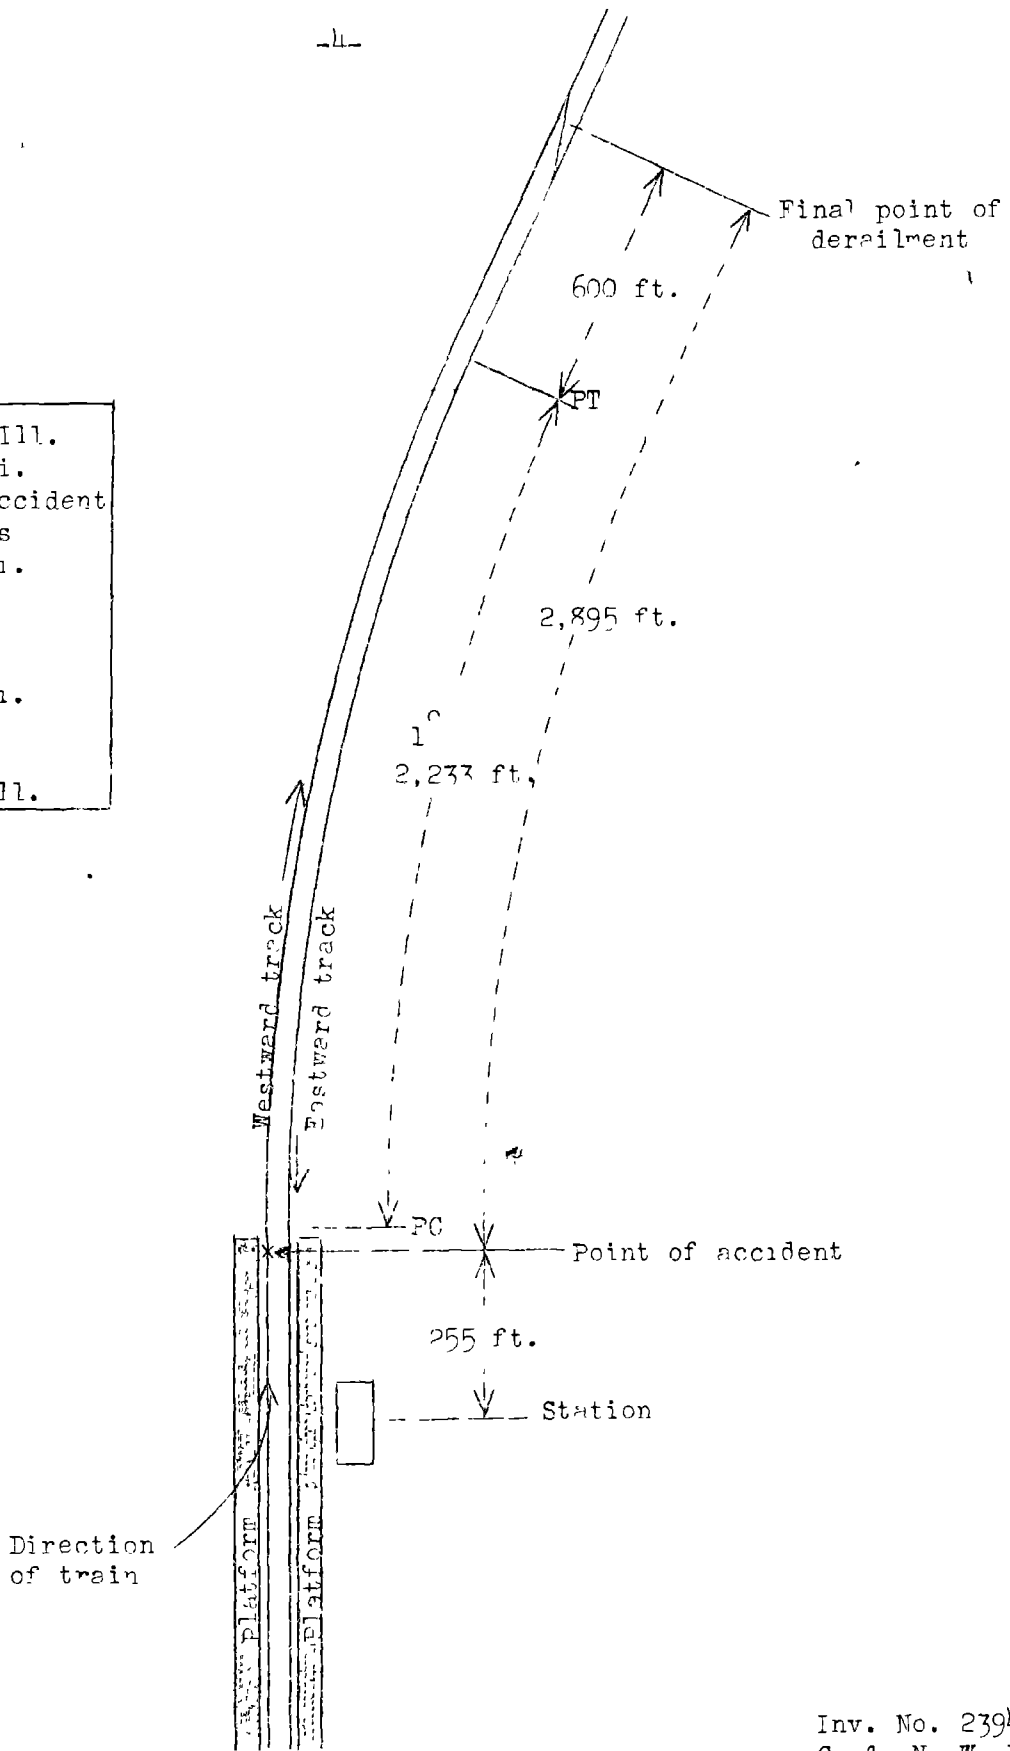
Inv. No. 2394
 C. & N. W. Ry.
 Great Lakes, Ill.
 Nov. 22, 1939

o	Waukegan, Ill.
	3.73 mi.
X	Point of accident
o	Great Lakes
	1.97 mi.
o	Leke Bluff
	30.24 mi.
o	Chicago, Ill.
