INVESTIGATION NO. 3185
CHICAGO AND NORTH WESTERN RAILWAY COMPANY
REPORT IN RE ACCIDENT
NEAR IRVINE, WYO., ON
MAY 28, 1948

Accident near Irvine, Wyo., on May 28, 1948, caused by
failure to obey a right-of-track order.

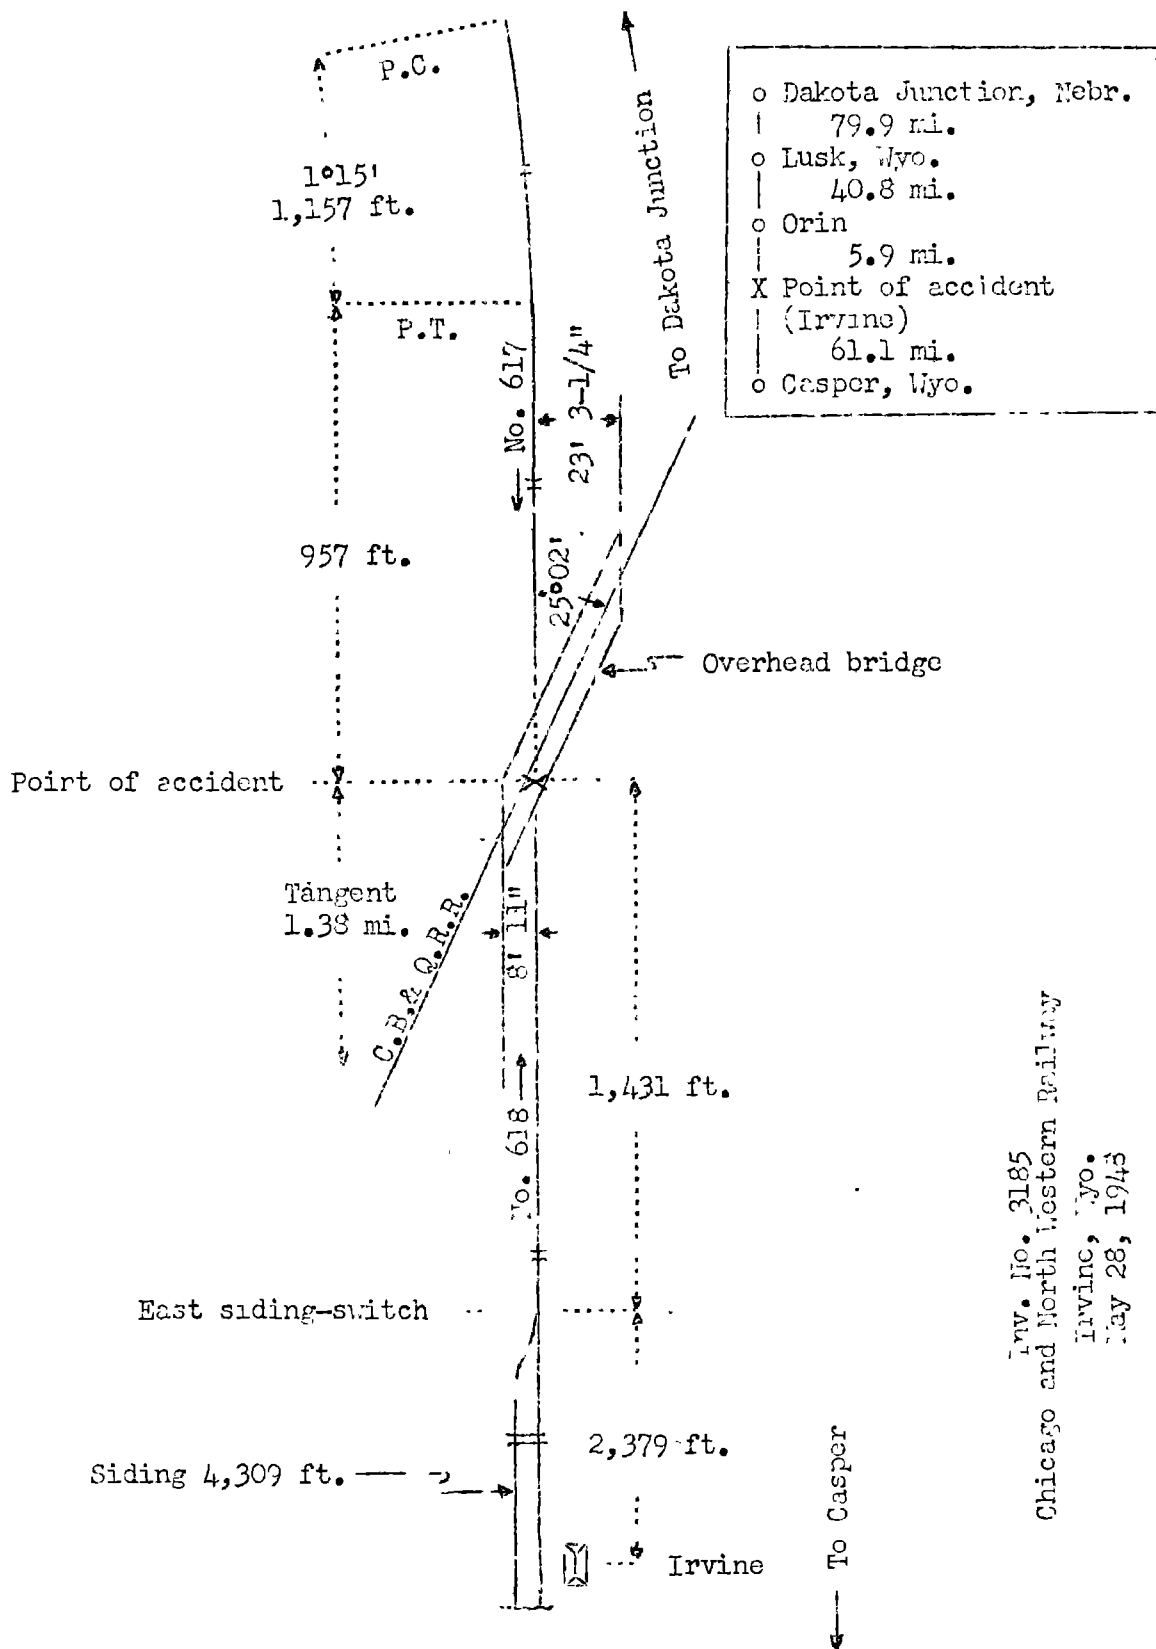
Inv. No. 3185
 Chicago and North Western Railway
 Irvine, Wyo.
 May 28, 1943

- o Dakota Junction, Nebr. 79.9 mi.
- o Lusk, Wyo. 40.8 mi.
- o Orin 5.9 mi.
- X Point of accident (Irvine) 61.1 mi.
- o Casper, Wyo.

To Casper

This accident occurred on that part of the Black Hills Division extending between Casper, Wyo., and Dakota Junction, Febr., 187.7 miles, a single-track line, over which trains are operated by timetable and train orders. There is no block system in use. At Irvine, 61.1 miles east of Casper, a siding 4,309 feet in length parallels the main track on the north. The east switch of this siding is 2,379 feet east of the station. The accident occurred on the main track 1,431 feet east of the east siding-switch. The main track is tangent throughout a distance of 1.38 miles immediately west of the point of accident and 957 feet eastward. From the east there are, in succession, a 1°15' curve to the right 1,157 feet in length and the tangent on which the accident occurred. The grade is 1.0 percent ascending eastward.
