REPORT OF THE DIRECTOR
BUPEAU OF SAFETY

ACCIDENT ON THE
CHICAGO & NORTH WESTERN RAILWAY

MARIBEL, WISCONSIN

INVESTIGATION NO. 2301

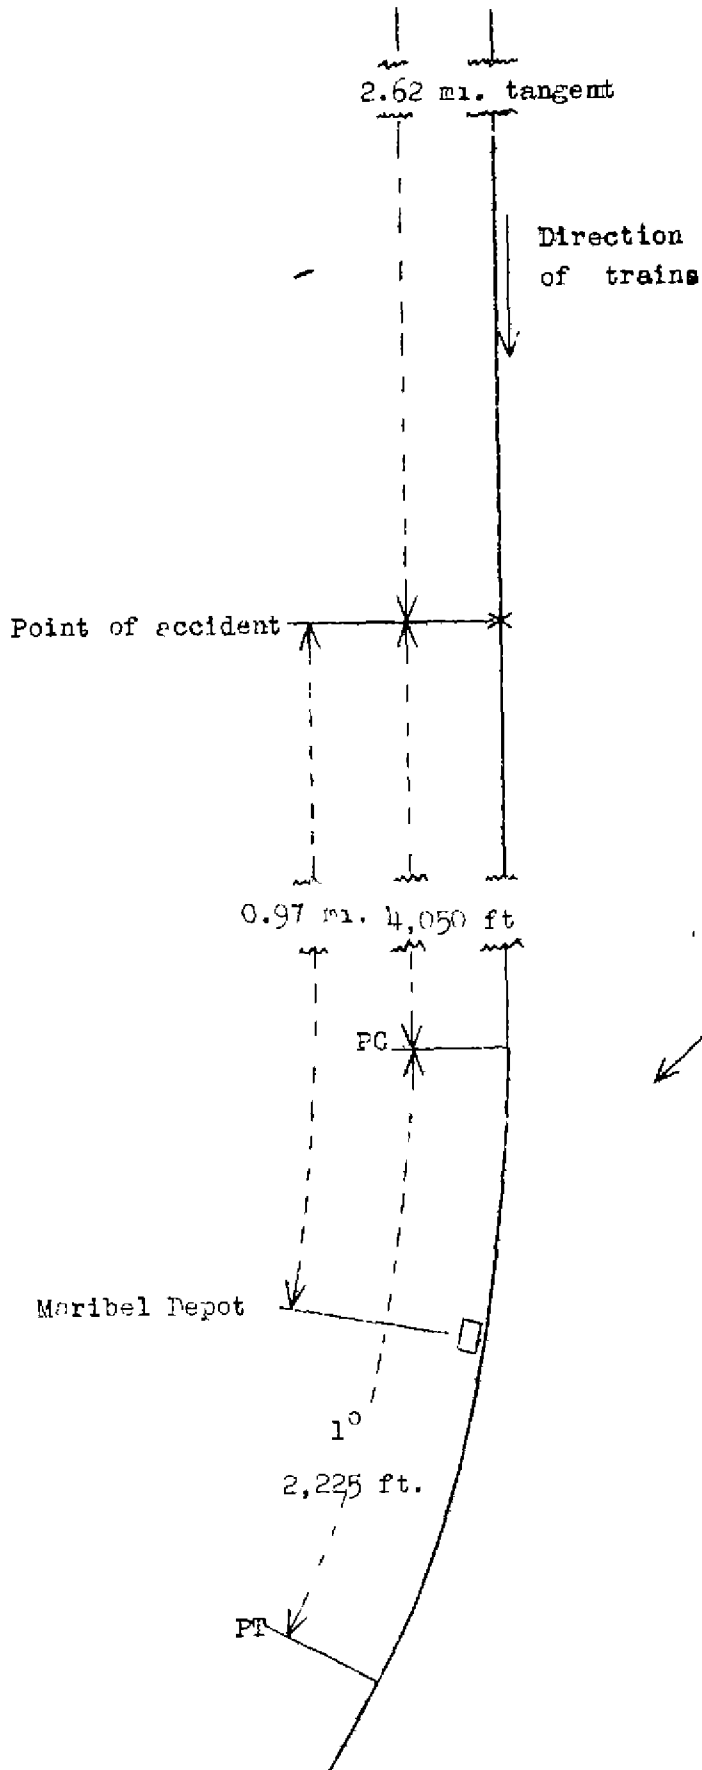
Inv. No. 2301
 Chicago & North Western Ry.
 Maribel, Wis.
 Oct. 18, 1938

o	Wisconsa, Wis.	
		71.03 mi.
o	Calumet Yard	1.52 mi.
o	Manitowoc	1.55 mi.
o	Rosemere	6.54 mi.
o	Francis Creek	6.28 mi.
X	Point of accident	0.97 mi.
o	Maribel	5.01 mi.
o	Denmark	16.92 mi.
o	Green Bay, Wis.

This accident occurred on that part of the Lake Shore Division designated as Sub-Division No. 5 which extends between Wisconsin and Green Bay, Wis., a distance of 109.82 miles. In the vicinity of the point of accident this is a single-track line over which trains are operated by timetable and train orders, no form of block-signal system being in use. The accident occurred at a point 5,145 feet east of the station at Maribel. Approaching this point from the east the track is tangent 2.62 miles to the point of accident and a distance of 4,050 feet beyond. The grade varies from 0.25 to 0.70 percent ascending westward for a distance of 1.39 miles to the point of accident and 0.75 mile beyond, the grade being 0.70 percent at the point of accident.
